# MODEL OF INFLUENCING FACTORS FOR HYDROGEN DAMAGES OF BOILER EVAPORATOR TUBES

M. DJUKIC<sup>1</sup>, V. SIJACKI ZERAVCIC<sup>1</sup>, G. BAKIC<sup>1</sup>, D. MILANOVIC<sup>2</sup>, B. ANDJELIC<sup>3</sup>

<sup>1</sup>Faculty of Mechanical Engineering, Department of Material Science, University of Belgrade, Serbia

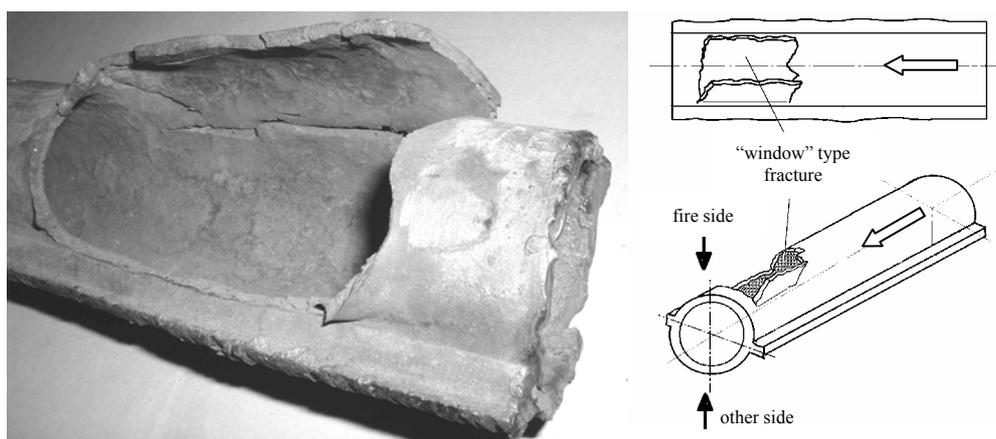
Analysis of the samples cut from the damaged evaporator tubes revealed three types of damages on the fire side of tubes: 1) "window" type thick-edge fracture with characteristic partial crack opening and thinning of the tube walls at the edge of the fracture, 2) uneven local wall thinning on the inner side in the form of relative shallow gouging of irregular shape in the vicinity of the fracture, 3) many small micro-crack on the tube inner side. The damage propagates along the welded joint from one welded joint to the other with the origin at one of them. On the inner side of a tube, there were no deposits but only defective magnetite layers of variable thickness.

Figure 1: "Window" type fracture with schematic view of the damage.

Measured wall thicknesses along the edge of the fracture were in the range of 2.9-5.75mm, less than nominal value of 6.0mm. The zones outside the damaged one were intact with nominal thickness.

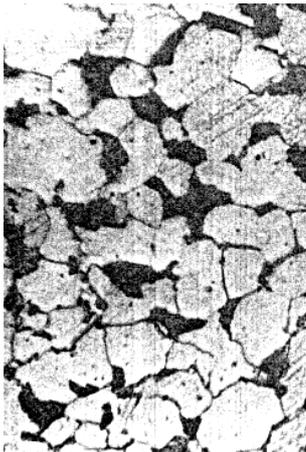
Microstructure of the central area of sample cross sections was as expected ferrite-pearlite with the presence of completely deteriorated pearlite. In these zones the presence of micro-fissures along the ferrite boundaries were observed as seen in Figure 2. Due to a complete decarburization, the microstructure was pure ferrite showing fractures along the boundaries as observed in the zones closer to the inner side, Figure 3. On the inner side shallow corrosion pits - gouges without any scalling were observed, Figure 4. Observed decarburization as well as the deterioration of pearlite microconstituent indicates that the hydrogen penetration occurred through the tube wall. Many discontinuous, intergranular cracks and fissures are the result of great pressure exerted by methane molecules or molecular hydrogen precipitated along the ferrite grain boundaries.

Figure 2: Ferrite – pearlite. Figures. 500x  
Figure 3: Ferrite. Decarburization. Intergranular cracks. 500x

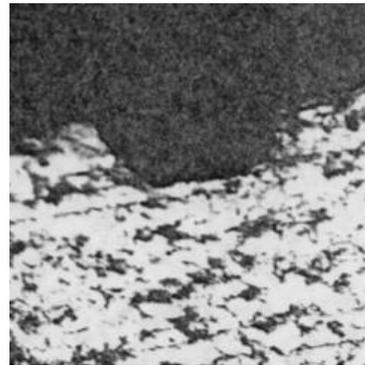
Figure 4: Ferrite – pearlite. Cavities. 200x

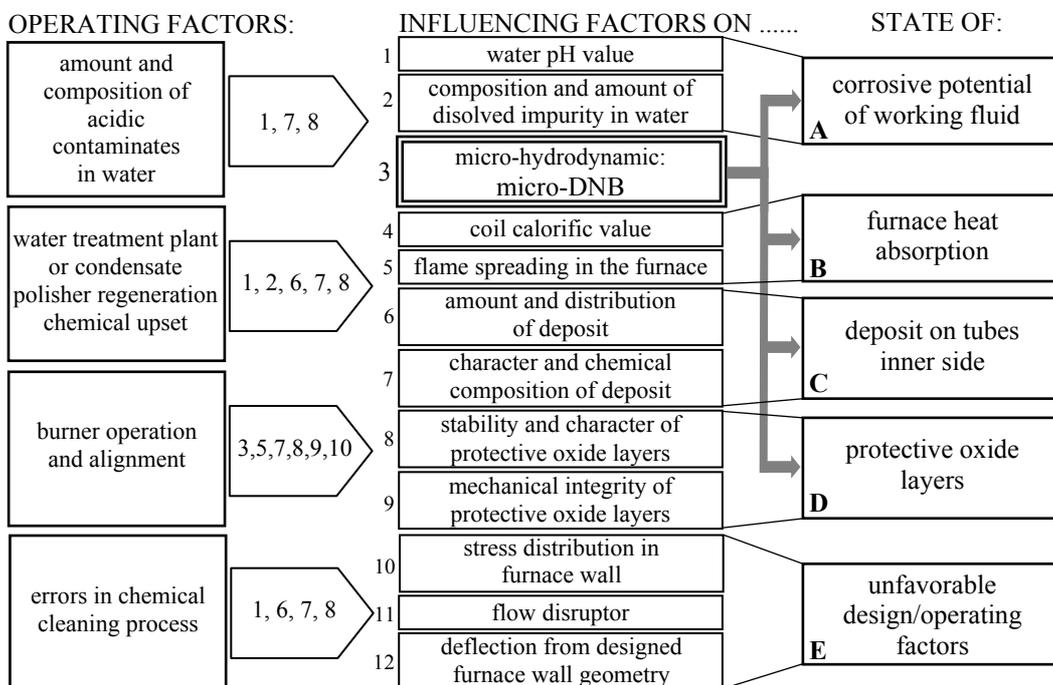
Hydrogen damage is a specific damage mechanism due to numerous major root cause influences. The most common contributing features of the root cause are: dirty boiler, leading to extensive deposits, followed by a low pH excursion (Dooley et al. [10]). However, hydrogen damage of evaporator tubes can occur as a result of the number of influencing factors. As a result of experimental investigations and analysis of reliability of evaporators on domestic TPP conducted over many years, we propose classification of influencing and corresponding operating factors factors presented in Figure 5 (Djukic [11]). Four major operating parameters have direct impact on one or more influencing factors. Their relationships are presented in the left part of Figure 5 by arrow with inscribed numbers corresponding to influencing factors. Furthermore, numerous influencing factors are grouped by their effects on state of: A) corrosive potential of fluid, B) furnace heat absorption, C) deposit, D) oxide layers and E) unfavorable design/operating factors.

Figure 5: Summary of influencing factors for hydrogen damages of boiler evaporator tubes

The appearance of micro-DNB of working fluid, on tube inner surface, has very unbeneficial effect on integrity of protective oxide layers and also provoked the rise of corrosive potential of working fluid, increased rate of impurities deposition and oscillation of tube metal temperature. Hence, micro-DNB present very prominent influencing factor. The presented model of influencing factors is always applicable to root cause analysis of boiler evaporator hydrogen damage and could also be beneficial to define short and long – term preventive actions.
