OVERVIEW ON FAILURE INVESTIGATION: FATIGUE AND STRESS-CORROSION CRACKING ON IAF FLEET

Lt. F. Bagnoli, Lt. L. Allegrucci
Chemistry Department – Flight Test Center
“M. De Bernardi Airport”
00040 Pratica di Mare (RM) Italy
rc.gms@tiscali.it

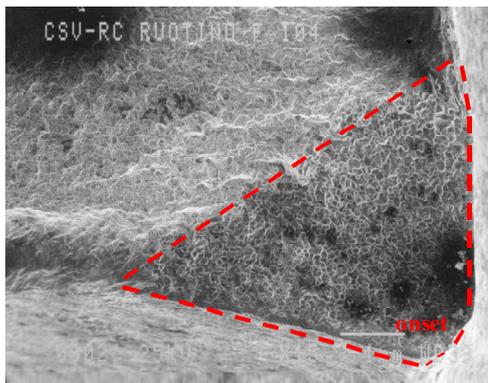
Figure 1

The fracture surface, examined by SEM, appears completely intergranular, Figure 1. The intergranular fracture results clearness since the crack onset, where there are neither corrosion pitting nor different type of initiation defects, Figure 2. The morphology observed was assumed to have resulted only from stress-corrosion cracking.

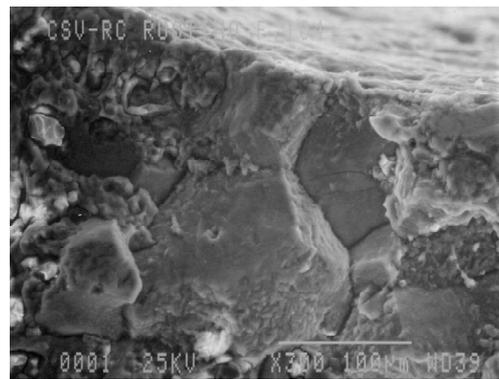
Figure 2

The results of chemical and metallographic analyses indicated that the part is an AZ81A-T4 magnesium alloy, made of equiaxed grains, UTS 275 MPa. This material offers a low resistance against the stress-corrosion cracking, with a threshold value about 70 MPa.

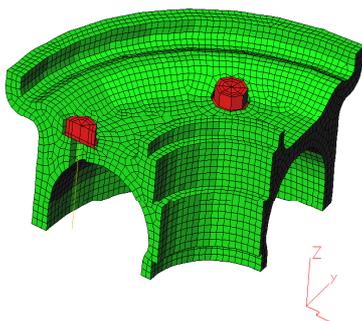
Figure 3

A hub model was loaded considering both static and centrifugal loads, Figure 3.

The results obtained showed that the highest stresses take place only in a restricted area located around the holes of the lock bolts, turned to the rotation axle.

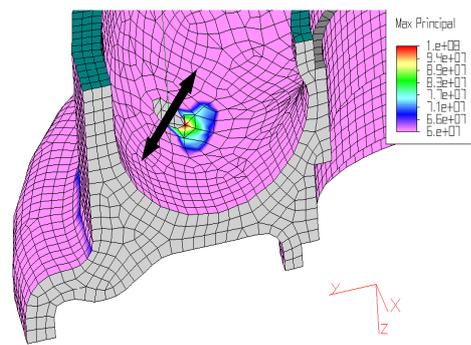
Figure 4

The direction of the principal stress was found perpendicular to that of cracks propagation, Figure 4.

Furthermore, the share of the stress deriving from the centrifugal loads was considerably lower than that from static.

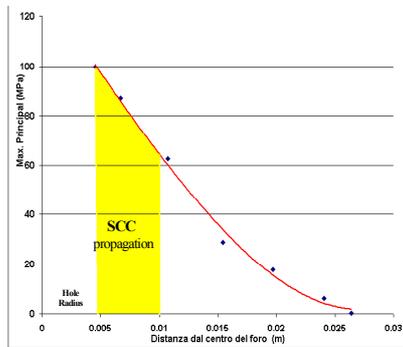
Figure 5

The cracks observed are the result of a stress-corrosion cracking mechanism and they can propagate up to about 10 mm from the center of the housing hole. Beyond this length do not exist the proper conditions for the sustenance of the stress-corrosion, Figure 5.

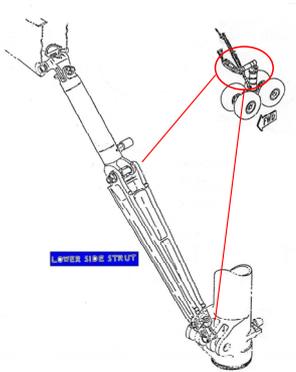
Figure 1

After many *touch and go* manoeuvres, suddenly a the main landing gear of an aircraft had not been retracted. The visual inspection pointed out the failure of *Lower Side Strut*. In particular, both upper and lower holes, linked to the main landing gear by the lower universal, as indicated in Figures 1 and 2, were found broken in three pieces, each hole showing six fracture surface, Figure 3. During maintenance operations, steel bushings are located in the holes to make up for the lack of the right thickness of the holes modified to remove corrosion products.

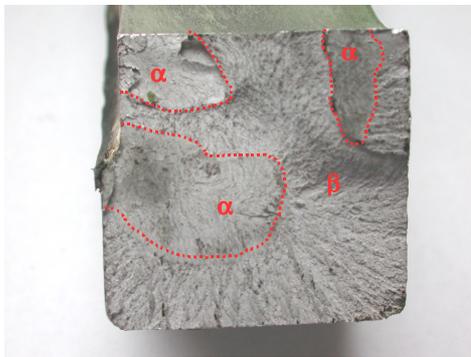
Figure 4

The fracture surface showed two different morphology, zones α and β in Figure 4.

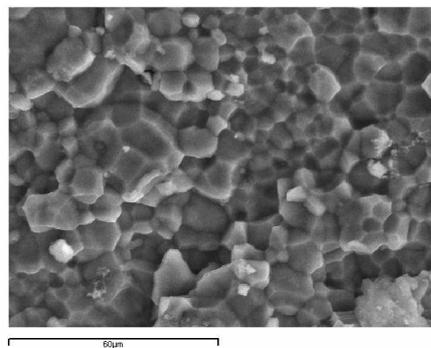
Figure 5

zone α : about 40% of total surface, it appears severely corroded and shows a completely intergranular mechanism due to stress corrosion cracking, Figure 5, on parallel planes, Figures 6 and 7. The intergranular cracks are originated in proximity to the steel bushing.

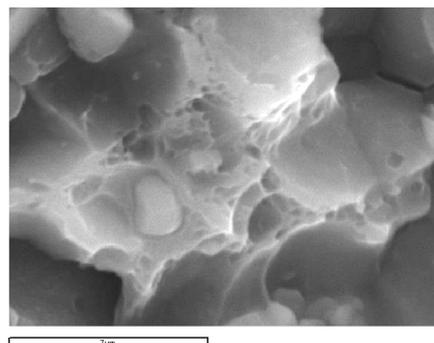
Figure 8

Zone β : about 60% of total surface, it shows a dimples morphology due to overload, Figure 8.

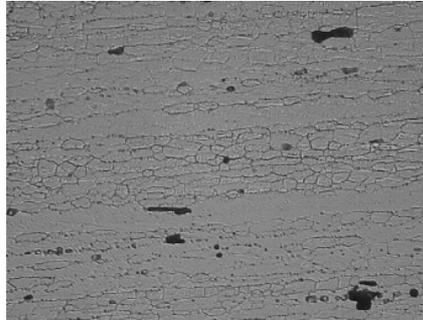
Figure 9

In agreement with the project requirements, chemical and metallographic analyses indicate that the part is an 7075 – T6 (HRB = 90) aluminum alloy with elongated grains in the direction of the working marks, Figure 9.

Due to this investigation and following these results it has been proposed to check by visual and ND methods the internal surface of the hole properly just at 6 o'clock zone.

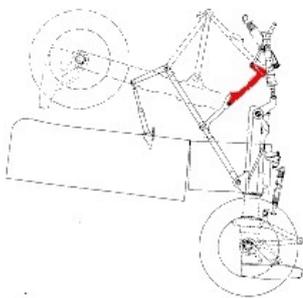
Figure 1

During a final landing approach the crew was warned that the nose landing gear of an aircraft had not been extracted. After landing a visual inspection showed that the upper lock link failed separating into two pieces after 31175 cycles since original manufacture and 886 cycles from the last installation, Figure 1.

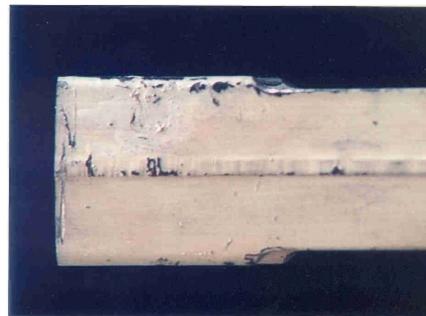
Figure 2

Visual and optical examination of this part, a forged aluminum alloy, showed clearness a coarse superficial finish flash line besides considerable rough repainting on all surface, Figure 2.

The failure occurred to this component was due to the presence of a rough flash line that had served as stress concentration site to initiate and propagate the fatigue and allowed an adverse grains orientation. Moreover, this orientation made the part more susceptible to a corrosion process.

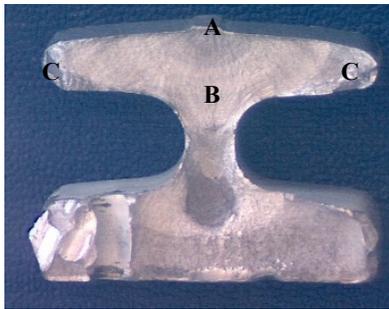
Figure 3

SEM analysis of surface fracture revealed the presence of three distinct regions, as indicated in Figure 3. In particular:

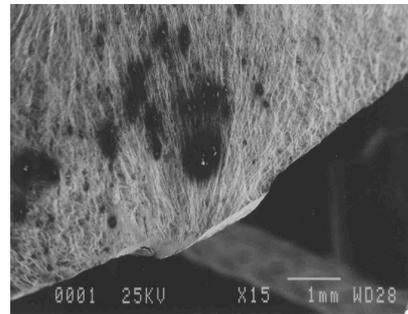
Figure 4

region A: about 20% of total surface, fine grained, semicircular shape to a maximum depth of 5 mm from the flash line acting as crack initiation site, Figure 4. In accordance with this shape it was found acceptable that the failure was initiated by fatigue process, whose details were obliterated by corrosion products;

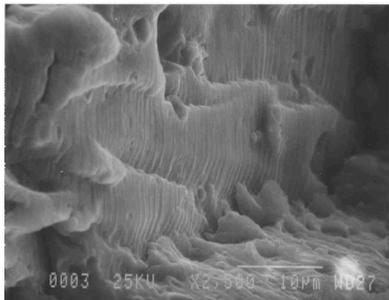
Figure 5

region B: about 40% of total surface, fine grained, semicircular shape, was found to contain fine fatigue striations as crack propagation mechanism, Figure 5;
 region C: about 40% of total surface, coarse grained, showed a dimples morphology due to overload.

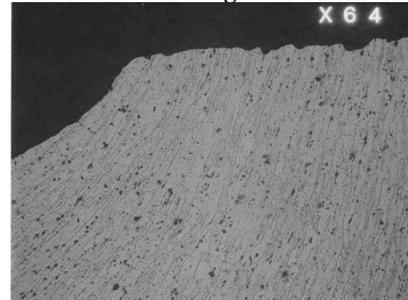
Figure 6

The examination of the metallographic section obtained near the flash line showed that the forging had an elongated grains structure oriented along the S-T direction, Figure 6.

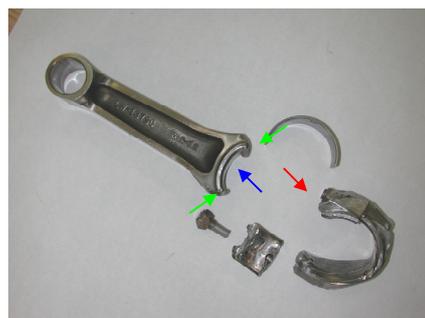
Figure 1

In consequence of a defect's report occurred on helicopter, a connecting rod broke and its shell bearing, as indicated in Figure 1, has been investigated to determine the first cause of the damage.

- the failure of the head (red arrow in Figure 1) with clear plastic deformations on both areas indicated (green arrows) in Figure 1;
- the failure of a bolt;
- wearing damage on the head internal wall (blue arrow in Figure 1).

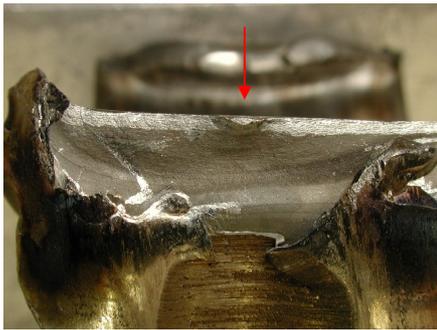
The primary fracture is shown in Figure 2 and the surface, light and fine grained, revealed the presence of typical concentric beach marks. The origin of this fatigue failure (arrow in Figure 2) was on the internal wall, and this coincides with a small region of fretting damage which can be seen in Figure 3.

The small fretted zone on the internal wall of the connecting rod, originated from the rotational oscillatory motion of the shell bearing, has been the fatigue origin, which is the primary fracture. This failure has been related to the inadequate restraint of the bearing shell.
