USE OF EBSD TO STUDY HYDROGEN INDUCED CRACKING IN PIPELINE STEEL

V. Venegas^a, F. Caleyo^a, J. L. González^a, T. Baudin^b, J. M. Hallen^a & R. Penelle^b

ABSTRACT

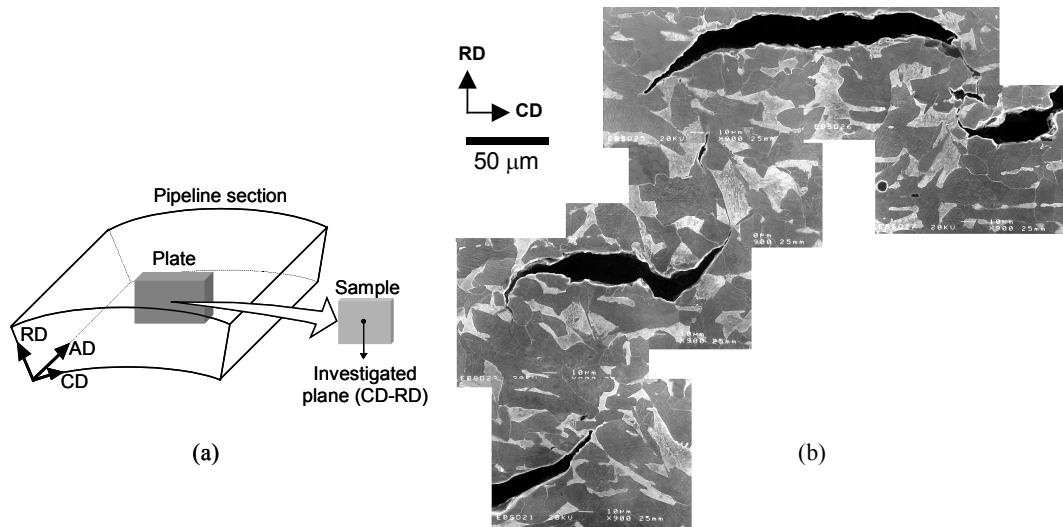
Figure 1b shows a SEM micrograph of the studied sample after etching with Nital. The sample shows the pearlite/ferrite microstructure typical of low strength carbon steels. Using the linear intercept method, the average grain size was estimated to be 20 μm . HIC appears in the form of stepwise cracks parallel to the pipe wall. The HIC cracks grow both intergranular and transgranular. In this specimen, ferrite/pearlite and inclusion/matrix interfaces provide crack propagation paths only in a few cases. Another feature to emphasize is that all the crack ends deflect toward the radial direction which shows the high degree of interaction between these cracks.

Figure 1. (a) Sample selection process. (b) SEM micrograph of the sample containing HIC cracks.

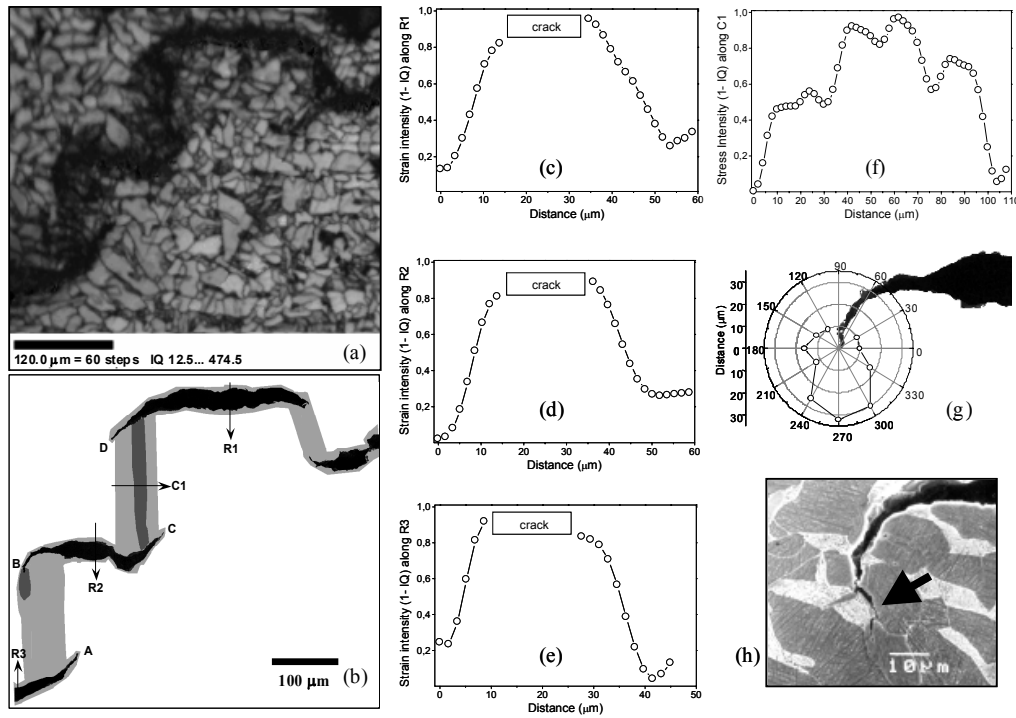
Figure 2a clearly shows that the most intense plastic zones are located between the approaching cracks and near to crack edges and tips. Quantitatively, this is confirmed by the high values of the strain intensity factor, expressed as $1-IQ$, found at these regions. Figs. 2b-2e show the variation of the strain intensity along the radial directions R1, R2 and R3 (indicated in Fig. 2b). The $1-IQ$ values decrease more than 70% for an average distance of $7\mu m$ from crack edges. This distance is assumed to be the average extension of the strain field in the pipe's RD. In the case of direction

Figure 2. (a) EBSD image quality map (IQ map) of the studied sample. (b) Schematic illustration of the strain fields surrounding the cracks. (c-f) Strain intensity measured as $1-IQ$ along the directions indicated in (b). (g) Extension of the strain field surrounding crack tip B. (h) Detail of crack tip B.

C1, which is parallel to the pipe's AD, the variation in strain intensity shows that the deformation zone along this direction is about 90 μm wide. This zone, and that between crack tips A and B, are affected by the shear stress resulting from the interaction between the approaching cracks.

On the other hand, the strained zones at crack tips A, C and D in Fig. 2a do not show a significant increase in their extension with respect to the extension of the strained zone at crack edges. This can be attributed to the presence of suitable oriented slip planes in the crack path that favor the relaxation of the shear stress at these tips by plastic deformation. In contrast, the polar diagram in Fig. 2g shows that the strained zone around tip B extends up to 30 μm downward in the pipe's RD. This difference can be attributed to the fact that at tip B, the material does not crack through slip planes as in tips A, C and D so that high stresses develop at this point. A detailed observation of tip B shows that this crack grows closely parallel to a ferrite/pearlite interface and then stops at a ferrite grain (Fig. 2h).

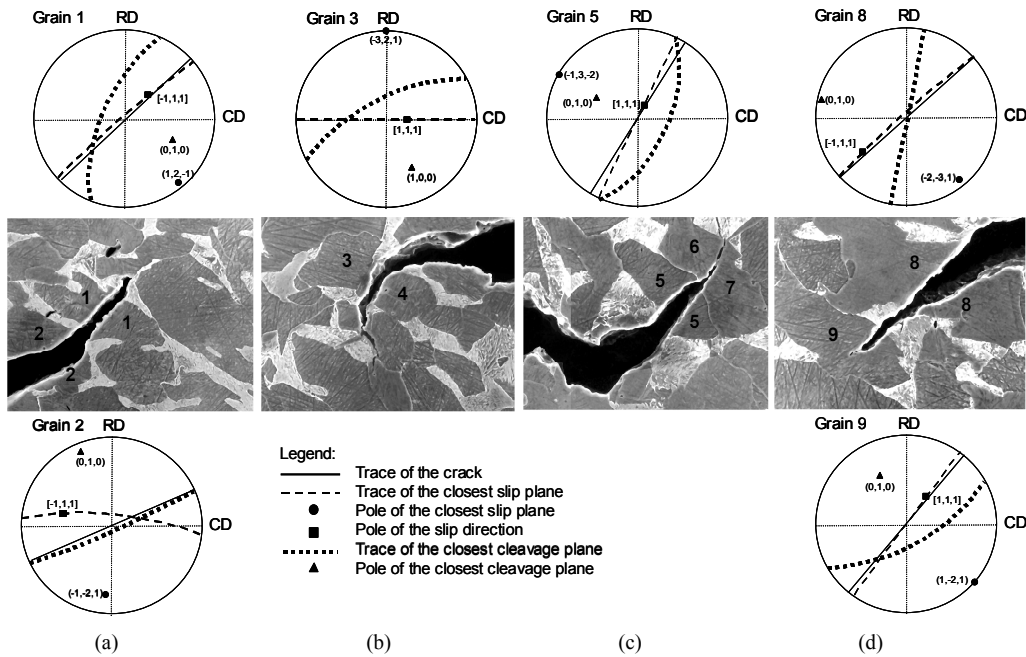
Figure 3 shows the orientation relationship between the crack trace and the closest bcc slip system and cleavage plane for the grains at crack tips A-D. For grains 1, 5, 8 and 9, the angle

Figure 3. Angular relationship between the trace of cracks and the slip and cleavage planes of the marked grains. (a) Crack tip A. (b) Crack tip B. (c) Crack tip C. (d) Crack tip D.

between the pipe wall and the trace of the slip plane closest to the crack plane is about 45° (42° in average; the largest deviation occurs for grain 5 for which this angle is 34°). Under this condition, it is reasonable to assume that these grains are more likely to plastically deform by shear, therefore relaxing the stresses around them and at the near crack tips. In addition, the orientation of the active slip planes in these grains determines the deviation of the planar crack paths leading to S shaped cracks (note that the presence of HABs suitably oriented such as that between grains 6 and 7 in Fig. 3c, also contributes to the propagation of the S shaped cracks). The results found for tips A, C and D agree with the decohesion mechanism found in HSLA steels with ferrite-pearlite microstructure in which decohesion along dislocation cell boundaries parallel to the activated slip planes is the main cause of hydrogen embrittlement (Naguno [5]).

However, this is not the case of tip B (Fig. 3b), for which the trace deflection that leads to the S shape occurs through a high angle boundary between grains 3 and 4. This happens because grain 3 has no cleavage planes favorably oriented for the planar propagation of this crack as occurs in grain 2 at tip A (Fig. 3a). In addition, the slip plane closest to the crack trace in this grain is oriented perpendicular to the pipe's radial direction so that slip does not activate in this case.

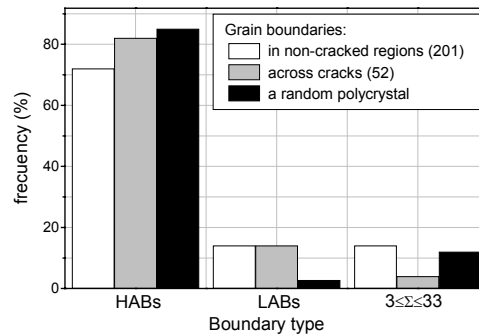
Figures 1 and 3 corroborate the intergranular and transgranular nature of the HIC crack propagation path in the studied material. Moreover, the results shown in Fig. 3 suggest that the distribution of grain boundaries has a noticeable influence on the way that HIC behaves. Accordingly, a total of 253 grain boundaries were investigated in the sample in order to establish the relationship between the HIC crack propagation path and the grain boundary character distribution. Fig. 4 shows the proportion of LABs, HABs and CSLs boundaries in the regions not affected by HIC (201 identifiable boundaries) and across the HIC cracks (52 identifiable boundaries). The distribution of grain boundaries in the studied sample is close to that predicted for a polycrystal with a random texture. However, the studied sample shows a higher number of LABs in both the cracked and non-cracked regions as well as a smaller number of the CSLs associated with the cracks. Not surprisingly, intergranular propagation occurs mainly through high angle boundaries while CSLs and LABs provide less than 18% of the propagation paths. This is specially true for CSLs which supply less than 5% of these paths. This agrees with the grain boundary energy classification generally accepted in which, as a rule, low energy boundaries such as low angle boundaries and low Σ CSLs are more resistant to fracture than high-energy random boundaries (Watanable [6]).

Figure 4. Grain boundary type statistic in cracked and non-cracked regions in the investigated sample. The statistic of the random oriented polycrystal is shown for the sake of comparison.
