DEGRADATION OF OIL TRUNKLINE STEEL CAUSED BY INTERNAL CORROSION

H. M. NYKYFORCHYN

Department of Corrosion-Hydrogen Degradation and Materials Protection, Karpenko Physico-Mechanical Institute of the National Academy of Sciences of Ukraine

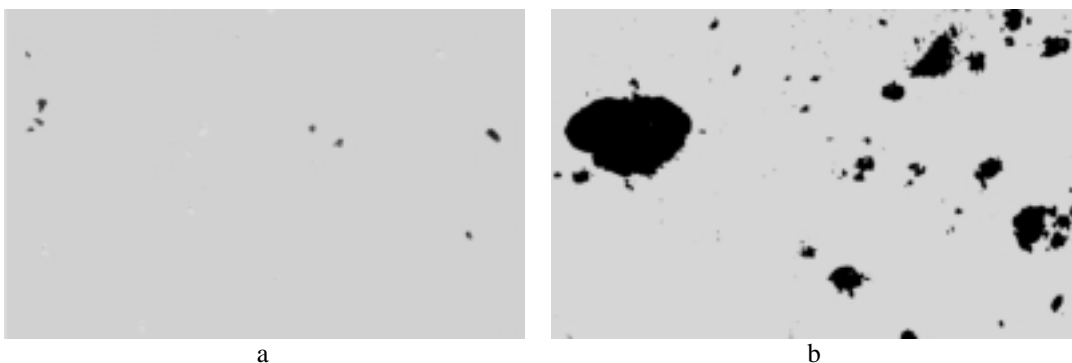
In cut out patches of the inner surface upper area (Fig. 1a), we observed numerous pointwise defects (pittings of depth 0.09-0.12 mm and several pits with an area of 0.78-0.84 mm²). On the average, there were about 1300 pits per 1 m² of the surface. At the same time, in cut out patches of the lower area (Fig. 1b), the character of corrosion damage is quite different. Against the background of numerous pittings of depth 0.04-0.08 mm, there are large pits with an area of 0.5-2.5 mm². We have in the mean, more than 10⁵ pitting-type defects and more than 1300 pits per 1 m² of the surface.

Thus, at the upper area of the pipe, whose initial thickness is 16 mm, the maximum rate of local corrosion averaged over 28 years of operation reaches 0.006 mm/year, whereas it is 0.09 mm/year at the bottom. It should be emphasized that these results are averaged over the entire period of operation because there are no annual observation data.

Figure 1: General view of corrosion damages of an internal surface of the top (a) and bottom (b) pipe parts.

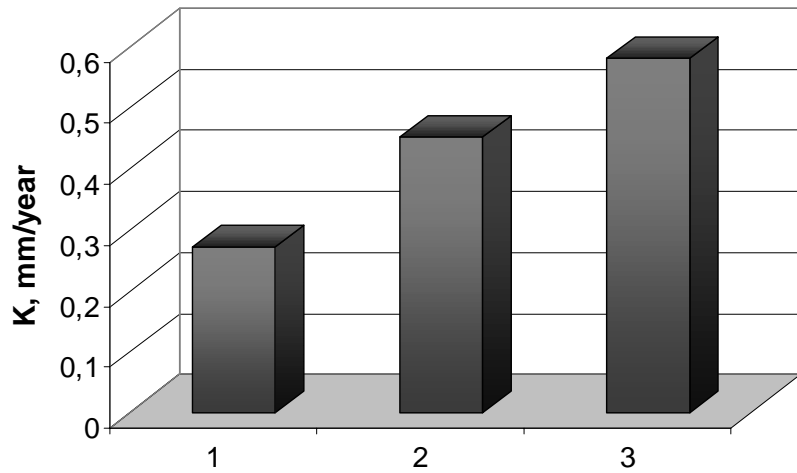
Corrosion rate K of pipeline steel was determined by the gravimetric method in the model environment, simulated the residual water [1]. Corrosion rate of the lower area was in 2 times and the upper area – in 1.7 times higher than for unoperated material (Fig. 2).

Figure 2: Corrosion rate of the virgin steel (1), upper (2) and lower (3) areas of the pipe.

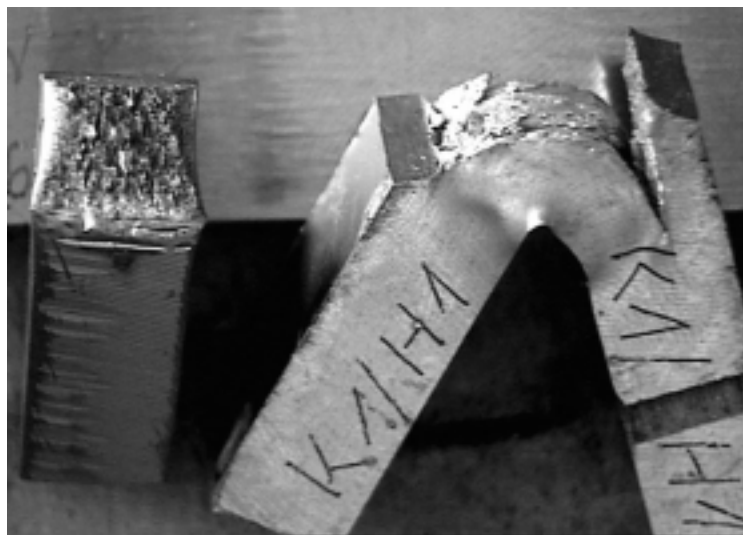
The maximum value of KCV (180 J/sm^2) exhibits the as received steel, whereas in the case of the upper area of the being in service material it is twice as low (95 J/sm^2). Such a dramatic drop in the toughness is in agreement with the similar tests done by Krasowsky [4]. This indicates the common problem of the degradation of mechanical properties of the steels exploited in the oil trunklines.

FIGURE 2: The fracture of specimens cut from the pipe being in service and subjected to the toughness tests: specimen from upper (left) and lower (right) areas of the pipe.

In the case of the lower area of the pipe being in service, it has been not possible to evaluate the toughness, since the reorientation of the crack path along the pipe wall (Fig. 3). This reflects the so called hydrogen induced stratification well known defect of industrial pipe lines transporting the crude oil containing the higher amount of the hydrogen sulfide and the sulfide reduced bacteria. Therefore, the above findings, together with the results of the hydrogen extraction and permeation tests (Slobodyan [5]) confirm the role of hydrogen in the degradation of steel of the trunk-oil pipe lines.
