CRACKING OF BRASS FITTINGS IN WATER DISTRIBUTION SYSTEMS

R. Pascual¹⁾, C Bagnall²⁾, I Le May¹⁾

¹⁾Metallurgical Consulting Services Ltd, 3611 48 Ave., S.E., Calgary, AB, T2B 3N8,
Canada

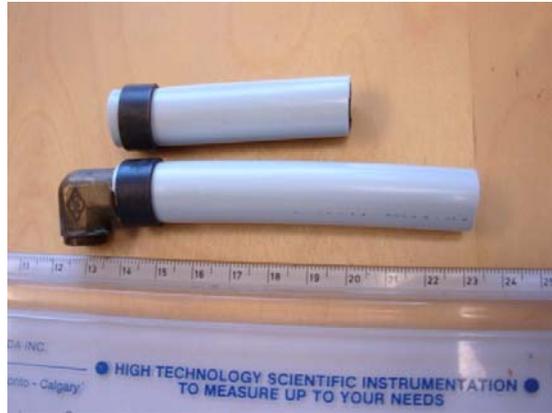
Fig. 1 shows a failed elbow that had been attached with copper crimps to 12.5 mm PEX tubing in a domestic installation. Fig. 2 shows the elbow side in which oxide has formed close to where fracture occurred, while Figs 3 and 4 show the two sides of the fracture surface.

Fig. 1: The two parts of the failed fitting

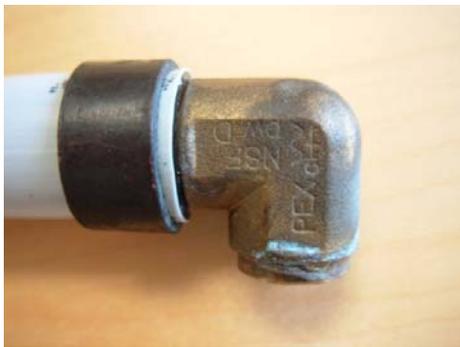
Fig. 2: View of the elbow side of the failed fitting

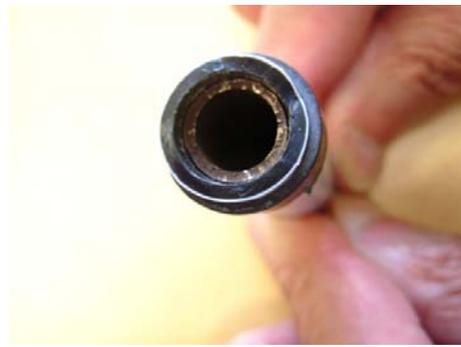
Fig. 3: : One of the fractured fitting pieces attached to the PEX pipe

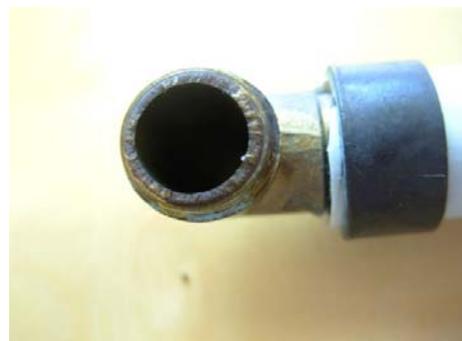
Fig. 4: Fracture surface on the elbow side

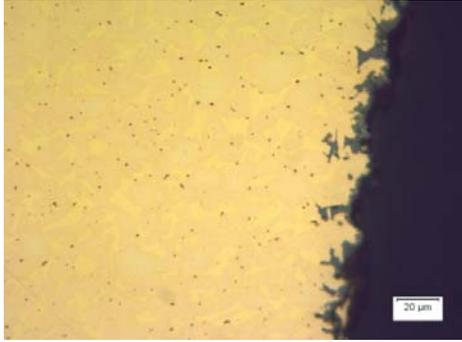
The piece of elbow shown in Fig. 3 was sectioned longitudinally. The results are seen in Figs 5 and 6. Dezincification can be seen on the cross section surface in Fig. 5. In many regions, dezincification was observed to extend perpendicularly to the surface as shown in Fig. 6.

Fig. 5: 500x. Dezincification at the internal surface

Conditions generally present when dezincification occurs include: water with high levels of oxygen and CO₂; low pH water combined with oxygen that forms zinc oxide; water with high Cl⁻ content; or neutral or alkaline waters high in salt. It is usually recognized by the presence of a white deposit of zinc oxide, as here. When dezincification occurs, depletion in zinc is observed, leaving the affected region mechanically weak. In this case, dezincification started at several places on the internal surface. Penetration reduced the thickness of the fitting until fracture took place. Dezincification may occur locally because of internal stress generated during machining..

Brass with high zinc content is more likely to be affected. Fittings to be used with PEX tubing have to comply (in Canada) with specifications established in the relevant CSA standard [4]. Chemical analysis indicated that the material conformed to this. The choice of fittings with higher copper content is recommended when aggressive environmental conditions are present. This will still comply with specifications in the relevant standard but would reduce the possibility of dezincification. Alternatively a dezincification-resistant brass, usually with the addition of arsenic, could be used.

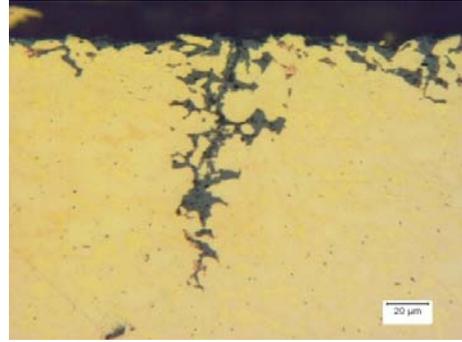
Fig. 6: 500x. Dezincification extending in the interior

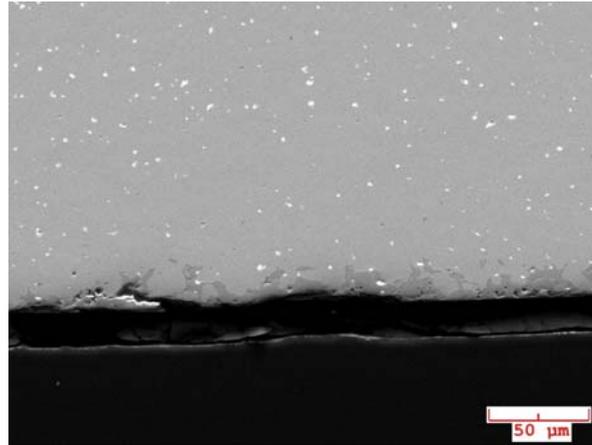
SEM observation of the cross section was also made. Fig. 7 shows a typical observation. Dezincification can be also seen on the surface of the sample.

Fig. 7: 2000x. SEM view of dezincification on the internal surface

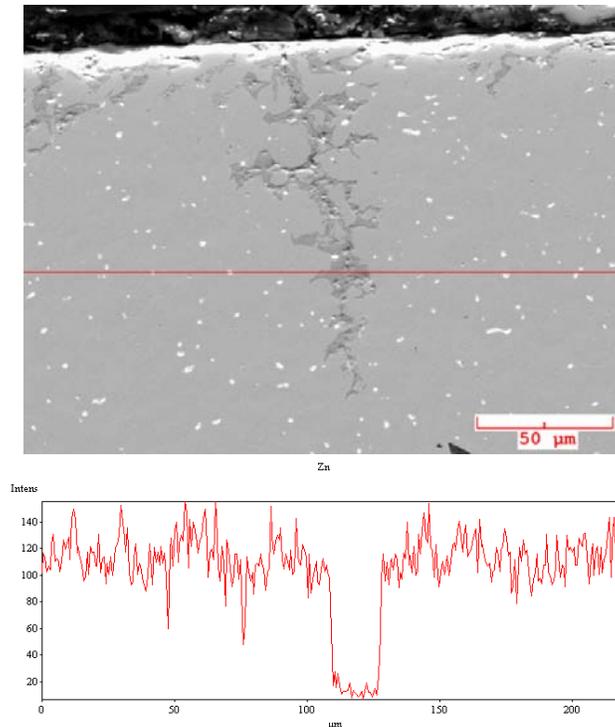
Optical and SEM observations show features typical of dezincification, and this is shown conclusively from scanning the Zn peak along the line shown in Fig. 8, which traverses the dezincified region. It can be seen that the intensity of the Zn peak intensity is reduced strongly in the region.

Fig. 8: 1500x. Zinc peak intensity scan along the red line.

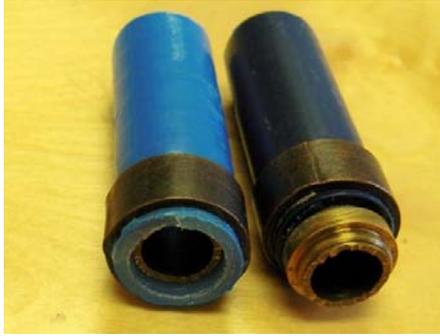
The second example is also from a domestic installation and involves a fitting from a hot tub water line that was less than one year old when it broke. The fitting connected two 12.5 mm PEX pipes using copper crimp rings and fractured inside the blue pipe shown in Fig. 9.

Fig. 9: The two pieces of the failed fitting.

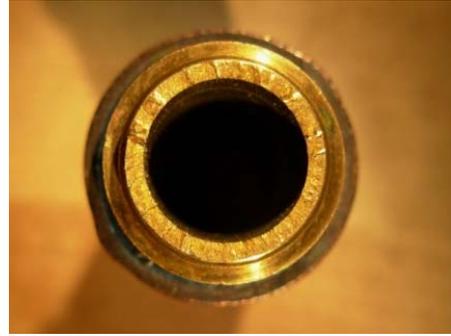
Fig. 10: Fracture surface of the failed fitting

One side of the fracture surface is seen in Fig. 10, and radial steps are seen on the surface. Examination showed that the steps all ran in the same direction suggesting the section had been subjected to torsion.

Even if the cracks have started by a stress corrosion cracking mechanism, final failure seems to have taken place by ductile fracture due to stress overload. The stress acting on the fitting at failure does not seem to be normal to the fracture surface but appears to have had a strong torsional component. This raises the possibility that an external force has been applied torsionally to the fitting at the moment of failure. Without that, the fitting could have lasted for a longer period but would eventually have failed.

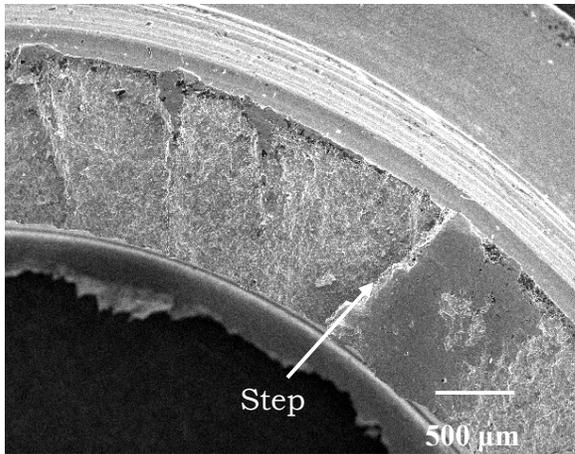
Fig. 11 shows a low magnification view of the fracture surface, with a step indicated by the arrow. The top surface of the step is flat indicating rubbing with the other fracture surface.

Fig. 11: 35x. General view of the fracture surface.

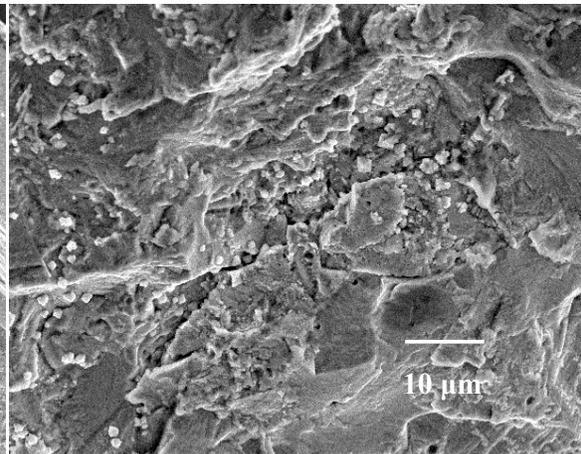
Fig. 12: 2000x. Inner edge: oxidation and intergranular fracture.

A higher magnification view at the inner edge of the fracture surface (Fig. 12) revealed the presence of corrosion products as well as a crack running diagonally across the picture: regions of intergranular cracking are observed. Fig. 13 provides another example of intergranular cracking and brittle fracture in the center of the fracture surface. A view of the outer region of the fracture surface can be seen in Fig. 14. Ductile fracture is prevalent in this region. A crack is seen in the region further from the edge.

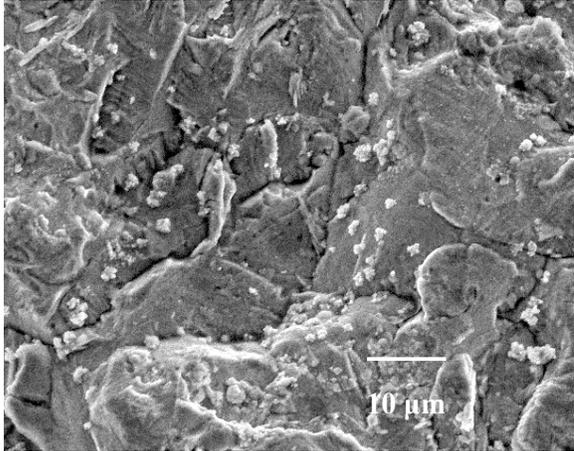
Fig. 13: 2000x. Center region. Intergranular fracture.

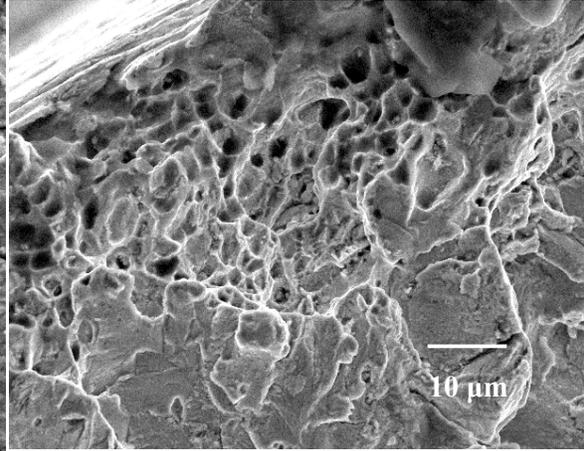
Fig.14: 1500x. Ductile fracture on the outer edge.

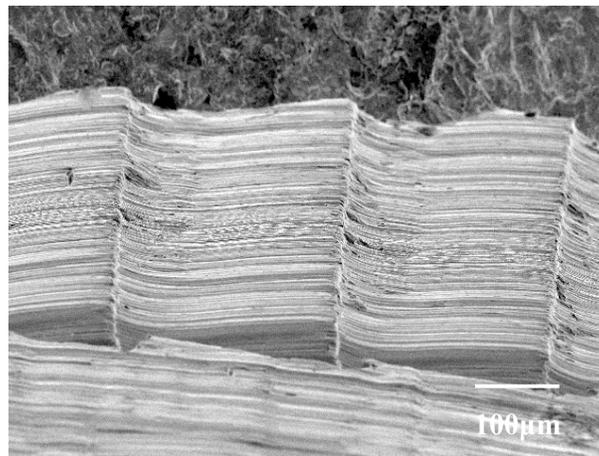
Fig. 15 shows a region of the inner edge of the fracture surface. The sample has been tilted in order to observe the inner surface of the fitting. Rough machining marks can be seen running both longitudinally and parallel to the fracture surface.

Fig. 15: 200x. Machining marks on inner surface.

In the brass fitting under analysis, rough machining markings were observed (see Figs 15, 18 and 19). These can generate high residual stresses in the material which can produce the

conditions for stress corrosion cracking. These stresses could be reduced substantially by modifying the machining process or by increasing the wall thickness of the fittings.

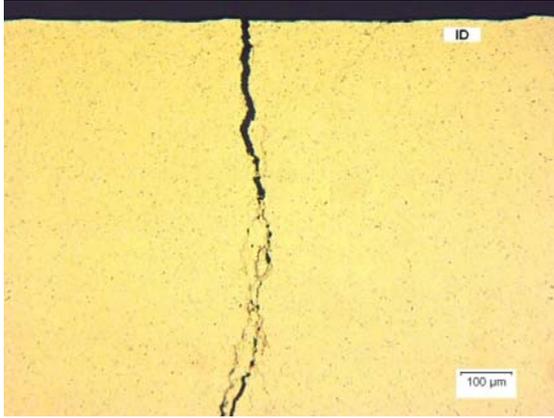
Observations of the longitudinal cross section were made using optical and as well as scanning electron microscopy. Fig. 16 shows a crack starting at the internal surface of the fitting and extending perpendicularly to the wall into the interior, branching being observed, a higher magnification view of this being given in Fig. 17.

Fig. 16: 100x. Crack starting at the internal surface.

The examinations of the failed fitting show that the fracture process started at the inner wall surface and extended to the interior. The characteristics of the fracture surface near the inner surface and of the cracks observed branching towards the interior of the sample indicate that the mode of fracture was stress-corrosion cracking.

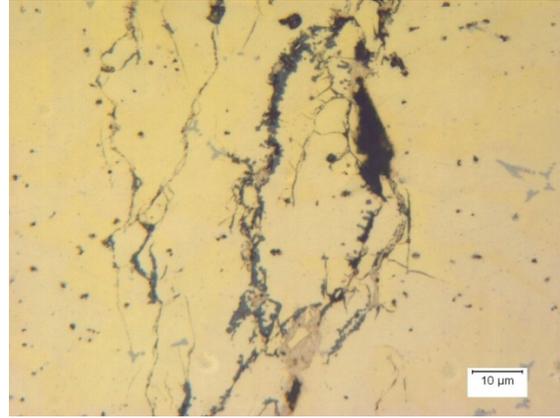
Fig. 17: 1000x. Details of branched crack.

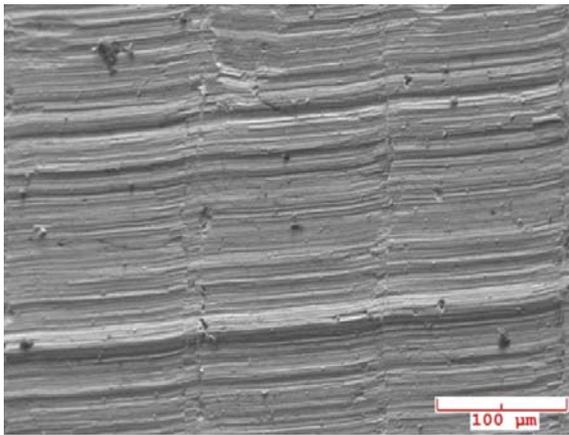
Rough machining markings were observed in the interior wall - see Figs 18 and 19.

Fig. 18: 500x. Machining markings on inside surface.

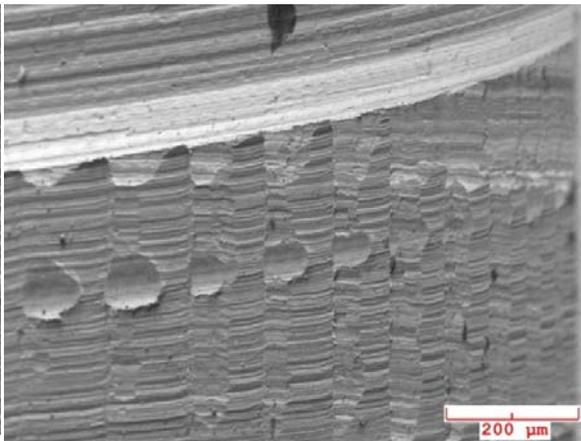
Fig. 19: 250x. Machining markings on inside surface.
