Some practical crack path examples

Les P. Pook

Department of Mechanical Engineering, University College London, Torrington Place, London WC1E 7JE, UK

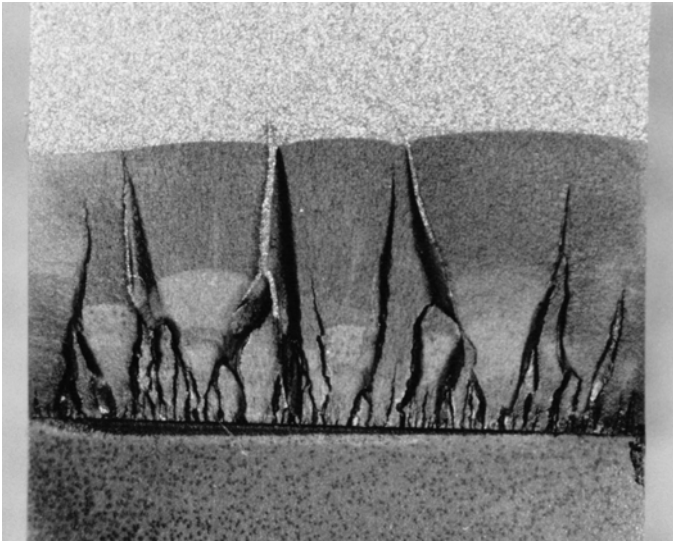
Some fatigue tests were carried out in 1989 on 20 mm thick medium strength structural steel angle notch specimens [7] with initial β values of 75°, 60° and 45°. Figure 5 shows the fracture surface of one of the specimens, initial $\beta = 60^\circ$. The light area at the top is where the specimen was broken open in liquid nitrogen. These examples illustrate the strong tendency to Mode I crack growth in isotropic materials under essentially elastic conditions.

Figure 5. Fracture surface of medium strength structural steel angle notch fatigue test specimen, initial $\beta = 60^\circ$.

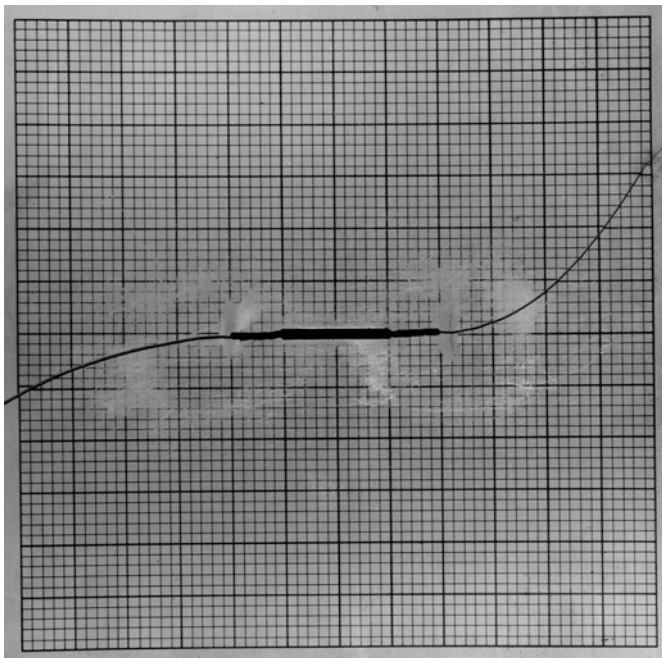
Figure 6. Crack path in a Waspaloy sheet under biaxial fatigue load. The grid is 2.54 mm.

the fatigue load perpendicular to the crack was kept constant. Cracks were first grown from each end of an initial slit under uniaxial loading. An in phase load was then applied parallel to the crack, and crack path behaviour observed. Figure 6 shows the crack path for a load parallel to the crack of twice the load perpendicular to the crack. The crack path became unstable and deviated from its initial path as soon as the load parallel to the crack was applied. At the time the tests were carried out it wasn't possible to do more than describe the results. However, reanalysis of these and other results in 1997 [1, 10] showed it was possible to correlate crack path stability in terms of a parameter called the T -stress ratio.

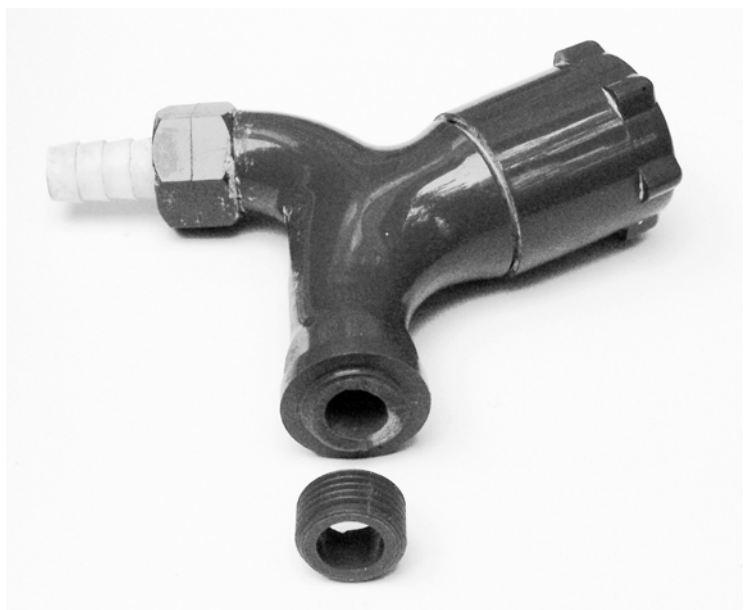
In 1991 a plastic domestic tap in the author's utility room was observed to be leaking where it was screwed into a fitting on the supply pipe. The tap had a fitting for a hose pipe, and appeared to be a replacement for the original brass tap. When an attempt was made to unscrew the tap it failed completely. The two parts of the broken tap are shown in Figure 7 and a close up of the fracture surface in Figure 8. The dark area is fatigue and the light area the final static failure. The age of the tap at the time of failure is unknown, but as one fatigue cycle is applied each time a tap is turned on and off it is likely that thousands of cycles had been applied. Safety critical pressure containing components are often designed to leak-before-break [11] in order to avoid catastrophic failure. It is fortunate that the tap did so otherwise the utility room would probably have been flooded. The failed tap was replaced with a brass tap, and it was observed that the detail design in the vicinity of the threads was exactly the same. The replacement tap is still in use. The episode is an example of the danger of using a different material for a component without making appropriate changes to detail design.

Figure 7. Plastic domestic tap.

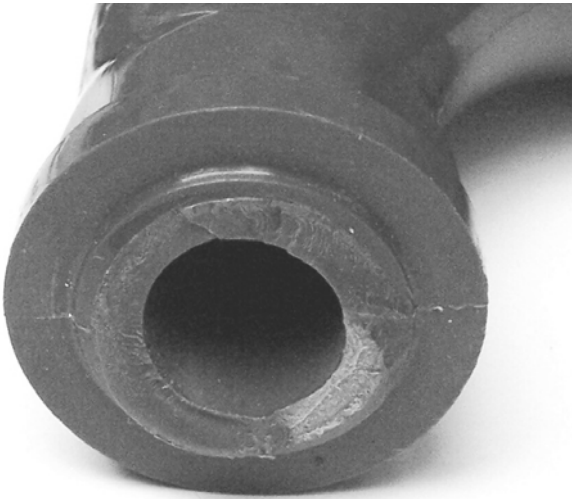
Figure 8. Crack surface of plastic domestic tap.

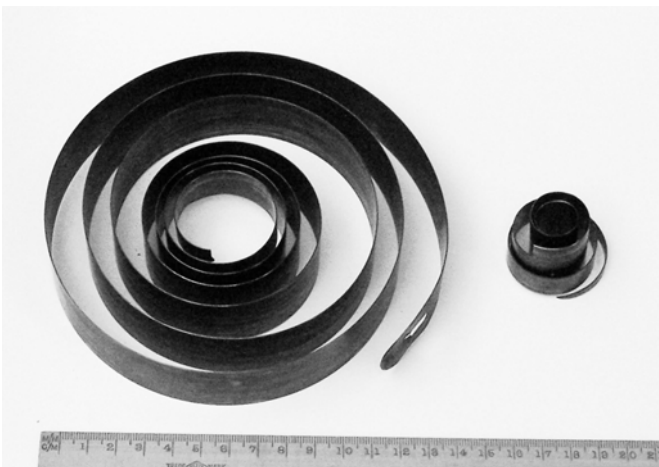
Figure 10. Failed wall clock mainspring.

ple shown in Figure 9 was originally used in a school, but since 1968 it has been in use in the author's kitchen. In 1994 the mainspring failed while the clock was being wound. Examination showed that this was the final failure following fatigue crack growth. A general view of the failed mainspring is shown in Figure 10. Fatigue has been a problem in clock mainsprings for centuries, and traditionally they are designed using rules of thumb based on experience [12], rather than by detailed analysis. The total fatigue life is not known, but the clock is wound weekly so it must be thousands of cycles.

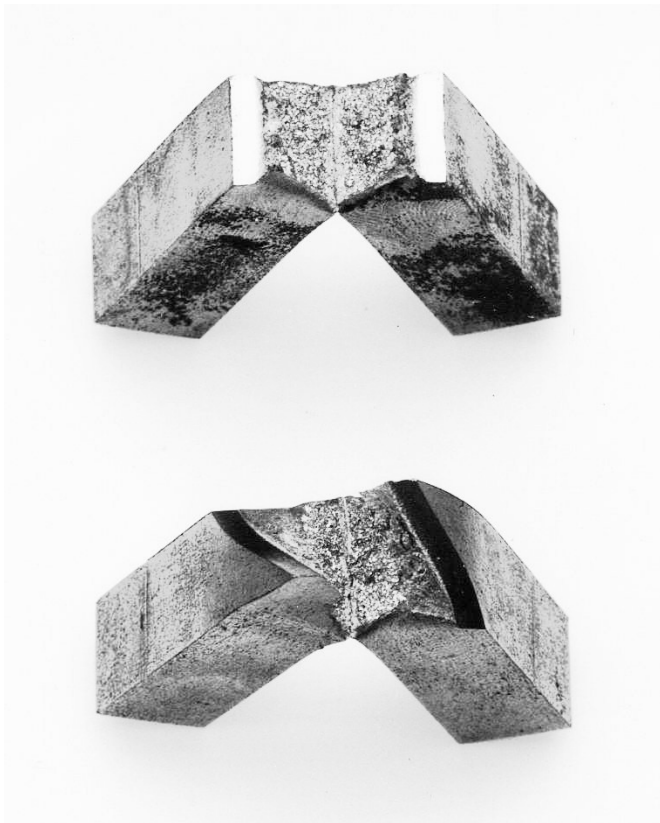
Figure 12. Fracture appearance of mild steel Charpy specimens tested at 10 C. Top, standard specimen, $\beta = 90^\circ$. Bottom, angle notch specimen, $\beta = 45^\circ$.

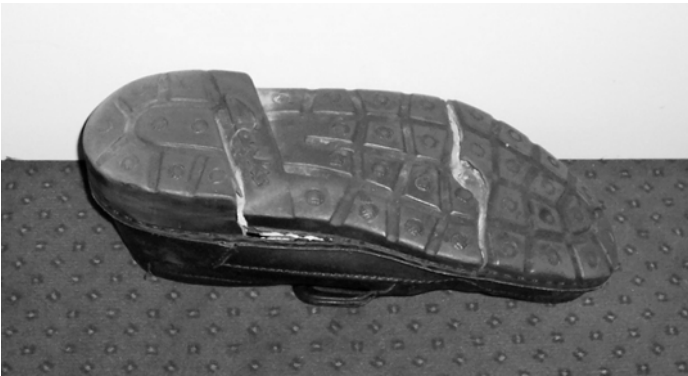
In 2005 the author found that the plastic soles of pair of walking shoes had become badly cracked and one no longer fitted properly. This more severely damaged shoe is shown in Figure 18. The sole of a shoe is subjected to repeated bending. Going uphill a sole is also subjected to repeated tension as the rearward force applied by the wearer's heel is transferred to the ground. This particular pair of shoes had covered several hundred kilometres, which is equivalent to around 3×10^5 cycles. In the shoe shown two separate cracks had initiated in grooves near the toe, grown past each other and then curved together, in a well known crack path behaviour [15], so that a piece of sole became detached. The heel had also cracked and, in what appears to have been the final event that reduced the stiffness of the shoe so much that it became unusable, the sole separated from the upper at the end of this crack. The use of a plastic, instead of rubber, for the soles has reduced the rate of wear but led to fatigue failure. This is another example where a change of material has resulted in fatigue cracking.

Figure 18. Cracks in sole of walking shoe.
