Structural interventions on the drums of the Parthenon’s north colonnade

Marilena Mentzini

Structural Engineer, Ph.D., Ministry of Culture and Sports, Greece

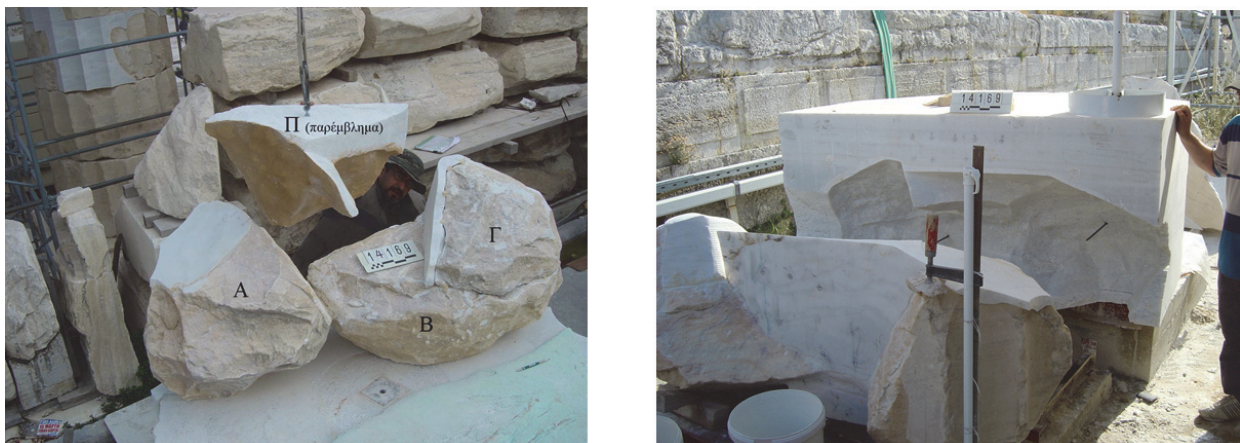
Figure 1: Joining together the ancient fragments A, B, Γ, with the new insert Π to keep them in the right position within the member's volume using cement mortar (left). The joining of this group and the main block of a new marble with "montage" reinforcement bars is presented in the right photo. In the foreground view the opposite fractured surface and the points, where reinforcing bars will be inserted during the next step of intervention, are presented. (Author's note: All pictures in this paper are from the archive of YSMA).

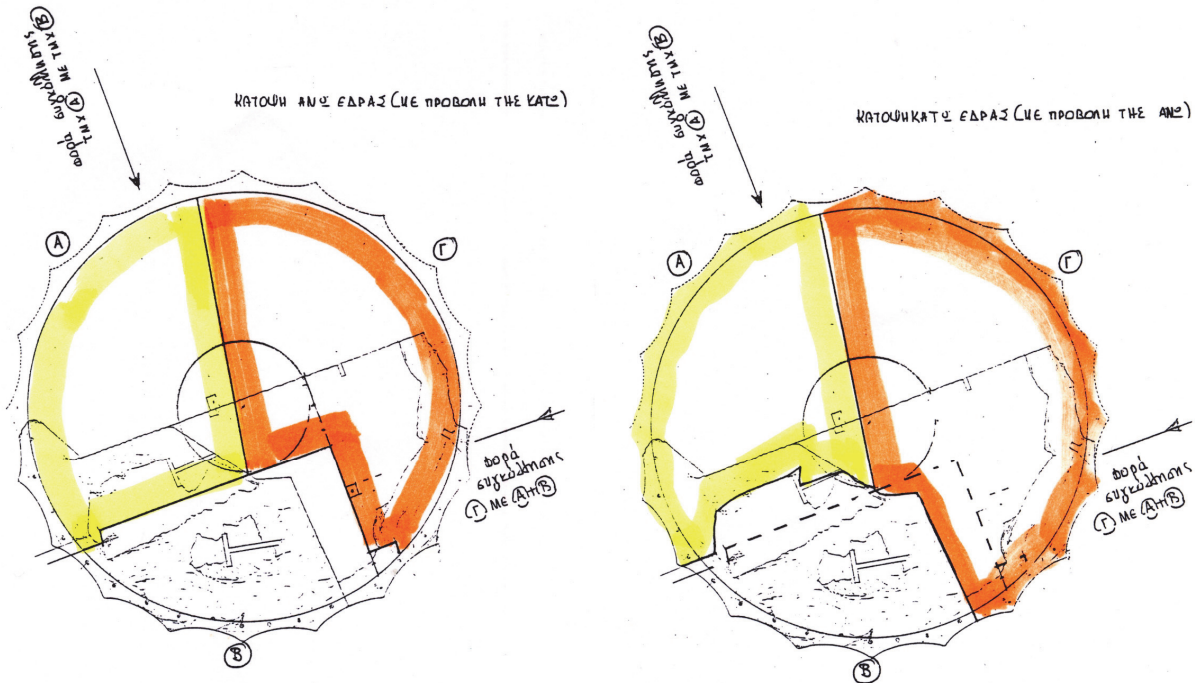
Figure 4: Sketch of the upper (left sketch) and lower (right sketch) side's plan of the drum where the place of the two supplements (A highlighted by yellow and Γ by orange color) and the direction of the required reinforcement are depicted. On the right sketch the dotted lines correspond to the upper side of the ancient part.

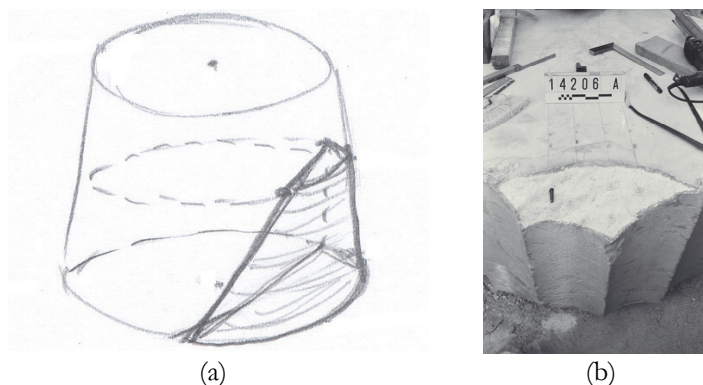
The ancient member almost maintains its shape, although two parts are missing: one, which forms a gap of wedge's shape in the upper side of the drum and an adjacent one, which extends all over the drum's height. In addition a crack runs across its lower side, which produces, as it was found out, an inclined fracture level (Fig.6a). The supplement used to fill the first mass loss is joined to the main volume by titanium bars which resist shear forces (one horizontal bar - Fig.6b and the remaining ones in different directions after the fitting of the two volumes using suitable cement mortar, from the upper side of the supplement - Fig.7a) to avoid sliding. The supplement used to fill the second gap is joined to the main

Figure 6: (a) Sketch of the inclined fracture plane produced by the crack which runs across the lower side of the drum (Drawing: M. Mentzini, YSMA Archive). (b) As a first step, the supplement used to fill the first mass loss is joined to the main volume by one horizontal titanium bar.

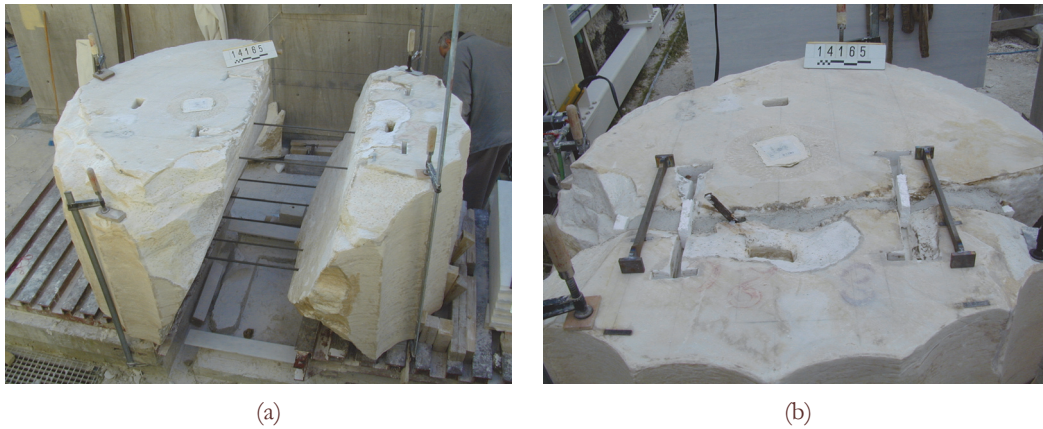
The ancient member was broken in two main fragments (probably due to the Morosini's explosion) which were joined together through iron clamps during the previous restoration of N. Balanos. Nowadays, the two pieces are joined together

using horizontal titanium internal bars as reinforcement and suitable cement mortar to avoid their overturning (Fig.9a). In addition the double “T” iron connectors were replaced by new titanium ones which contributes to the strength required (Fig.9b). Furthermore three supplements of new marble are created to complete the drum’s shape. Two supplements fill the gaps in the upper side of the drum and they are joined to the ancient volume only through montage reinforcement because of their balance state due to their shape (Figs.10a,b), while the third supplement was used between the two main fragments, forming a wedge. The reinforcement required for the latter one to resist shear stresses to be developed, was inserted from the drum’s lower side, after its fitting with the rest drum’s volume using cement mortar (Fig.11). In this way (easier to adjust the pieces) the holes are invisible after the drum will be placed on the column.

Figure 9: (a) The two main fragments of the drum are joined together using titanium bars. (b) Replacing the double “T” iron connectors by new titanium ones on the upper side of the drum.

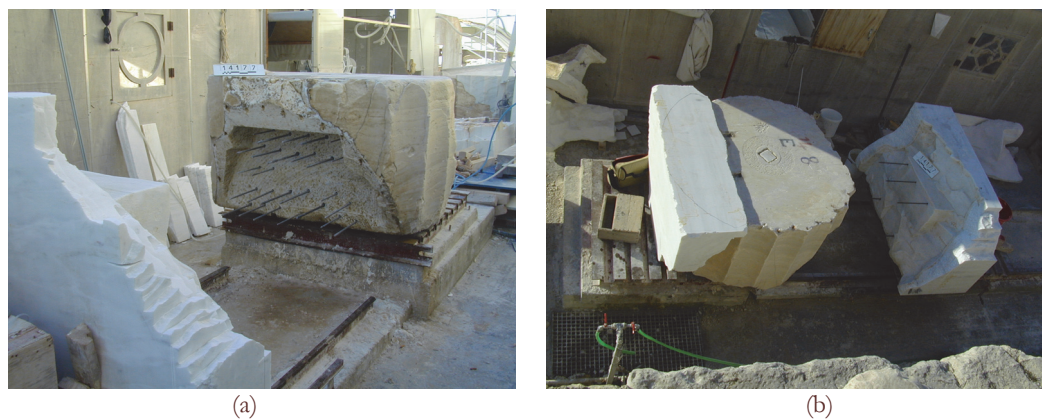
The ancient member is characterized by two losses of material sited in opposite areas all over its height. To restore the drum's volume two supplements of new marble are created. Their join to the ancient remain core was accomplished by inserting titanium bars which were parallel to the member's upper side from the fractured area (Figs.12a,b). This reinforcement is the proper one to avoid overturning of the supplements, before the overturning of the drum as a whole.

Figure 12: (a) Joining the first supplement. (b) Joining the second supplement. On the left the first –raw- supplement is already joined.

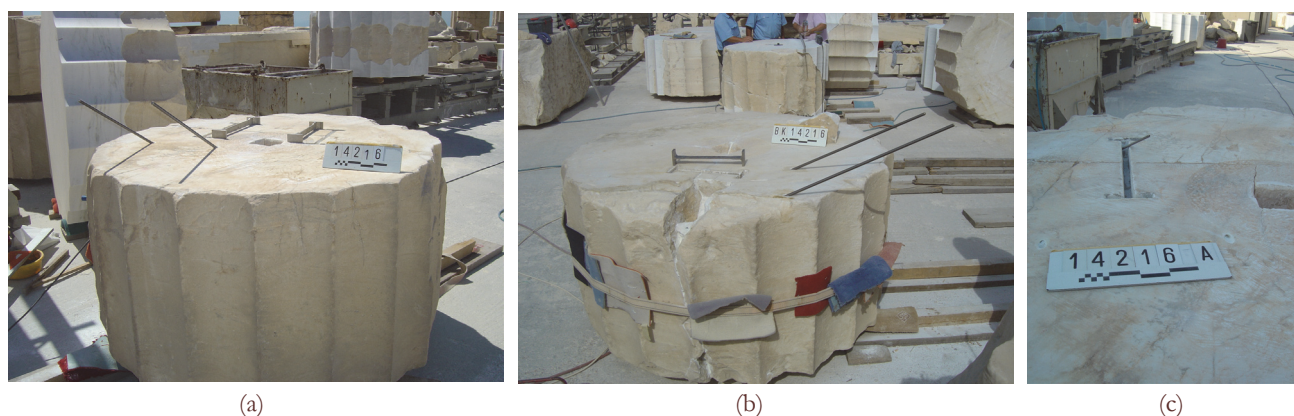
Although the drum seems intact, a fracture plane runs across its upper side and through its mass –all over its height- reaching the center of the lower side. Both upper and lower sides were carved during N. Balanos' restoration and three iron clamps -of double "T" shape- were inserted (two clamps on the upper side and one on the lower one). Nowadays the restoration of the drum requires more reinforcement, therefore the iron clamps were substituted by new ones made of titanium and some extra reinforcement was also added. The additional reinforcement (titanium bars) was inserted in certain areas through both sides of the drum and their direction was 30° with respect to the horizontal level in order to succeed the proper combination of bars' strength and forces lever arm (Figs.13a,b,c). The required moment was calculated so as to avoid the separation of the drum in two fragments i.e. to succeed the stability of each one.

Figure 13: (a) Inserting reinforcement on the upper side. (b) Inserting reinforcement on the lower side. (c) Inserting reinforcement bar to repair a small crack on the upper side through the Balanos' mortise, before replacing the clamp.

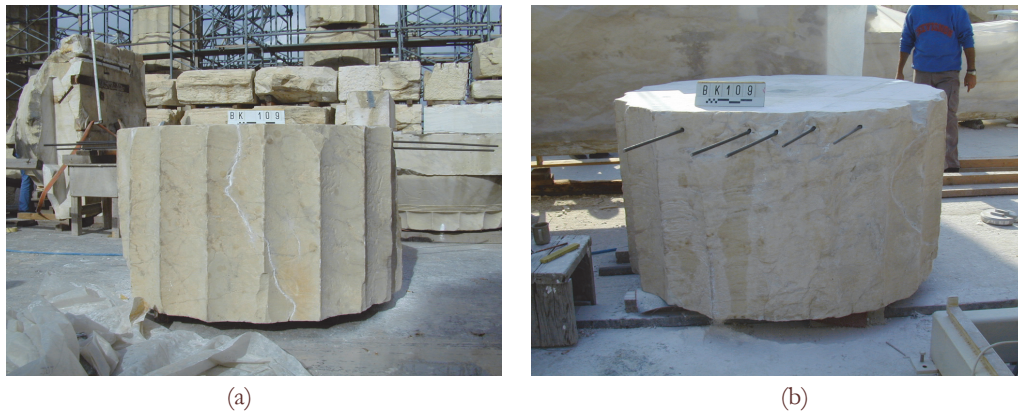
Although the drum maintains its shape, a fracture plane runs across its upper side and through its mass - all over its height - reaching the lower side of the drum all over its width (Fig.14a). Three iron clamps - of double "T" shape - were placed in mortises carved on the surface of the drum, during N. Balanos' restoration, to repair the crack only on the upper side. Nowadays the restoration of the specific drum requires more reinforcement. The iron clamps were replaced by new titanium ones and the additional reinforcement (titanium bars) was inserted normal to the fracture plane, from areas of the drum's view which exhibit marks of decay and having lost their original ancient surface (Fig.14b, Fig.15), so as to achieve the

Figure 14: (a) View of the fracture plane. (b) Inserting the reinforcement on the lower side of the drum. In this picture the drum is upside down.

proper combination of bars' strength and forces lever arm in order to avoid the separation of the drum in two fragments i.e. to ensure the stability of each part.

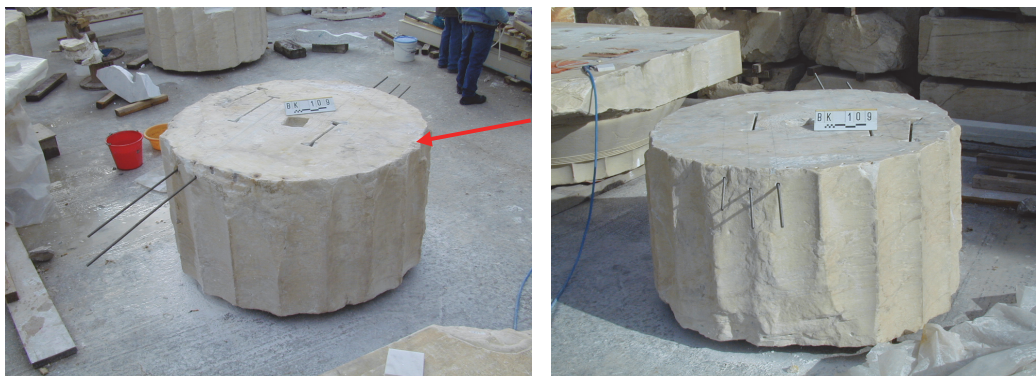
Figure 15: Inserting the reinforcement on the upper side's area. The red arrow in the left figure points out the crack's tips.

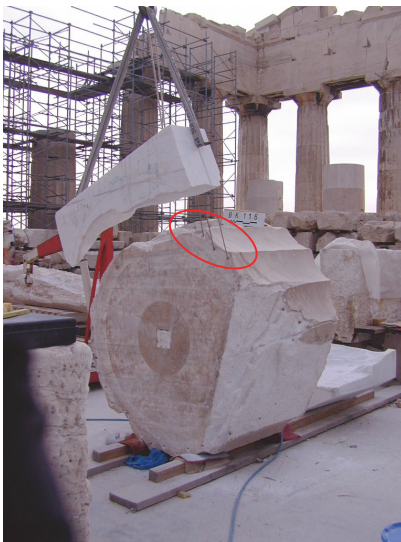
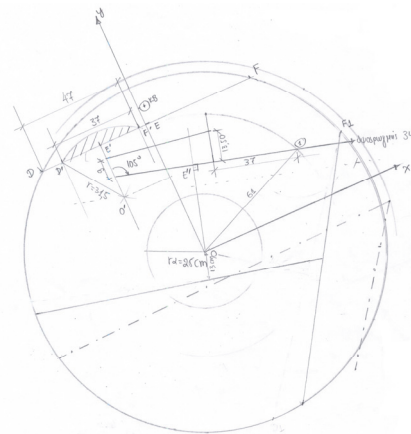
Figure 17: Adjusting a new marble (supplement “DF”) onto the upper side of the drum (left). Near by, the reinforcement required to restore the fragment “ ΔFF_1 ” is presented (ellipse in the left figure). Drawing of the parts to be joined together and their geometry for the calculation of the stress field and consequently the reinforcement required (right) (Drawing: M. Mentzini, YSMA Archive).

2. The join of the fragment " ΔFF_1 " to the ancient remain core to avoid separation was accomplished by inserting inclined titanium bars forming 38° to the horizontal level, through holes of the drum's view (created from N. Balanos during the intervention). One of the bars used for the join of the supplement "DF", contributes to the strength required (Fig.17).

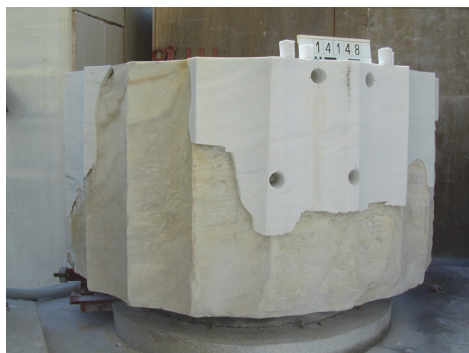
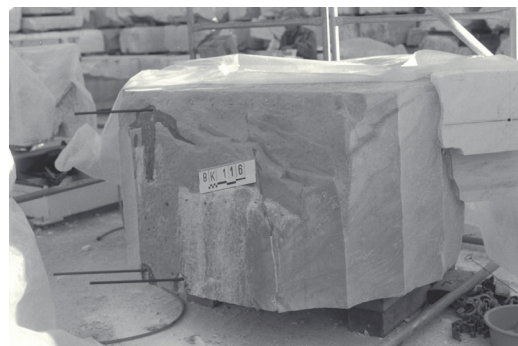
Figure 18: After joining the supplement “DF” to the main volume of the drum, the holes (in order to adjust the titanium plate anchor) on its surface sealed with the pieces of the extruded new marble (on the left). Repairing the crack “ df_2 ” (on the right).

1. To restore the drum's volume two supplements of new marble are created. The join of the supplement "DF" to the ancient remain core was accomplished by inserting titanium bars (to resist tensile and compression forces and subsequently to avoid overturning of the main volume or/and separation from the main volume) from its external surface, after the two volumes came into contact using cement mortar and montage reinforcement (Fig.17). In the next step the main reinforcement (titanium bars) was inserted from outside. In order to achieve the proper anchorage length of the bars, because of the thin thickness of the new volume, the end of the bars has been specially threaded to fit a screw nut through a titanium plate anchor (Fig.18 on the left).

- required. On the lower side of the drum the reinforcement was inserted from outside, from areas of the drum's view, which appeared marks of decay, losing their original ancient surface (Fig.18 right).
4. Finally, the join of the supplement to the ancient marble to fill the loss “ D_1F_1 ” was accomplished by inserting titanium bars both on the upper and on the lower side of the drum through the fractured area with direction parallel to the member's upper side (Fig.19 left). This reinforcement is the proper one to avoid overturning of the supplement, before the overturning of the drum as a whole. In order to achieve the proper anchorage length of the reinforcement on the supplement's lower area, because of the thin thickness of the new volume there, the end of these bars has also been specially threaded to fit a screw nut through a titanium plate anchor (Fig.19 right).
