Structural integrity assessment and rehabilitating of Hercilio Luz bridge

ABSTRACT. The Hercílio Luz suspension bridge, built in 1926, has been out of service since 1991 due to high corrosion levels and structural element impairment. A complete rehabilitation project was developed which included the replacement of the impaired items and foundation strengthening. For this, an auxiliary structure was employed to support the central span during the rehabilitation process. A carefully studied load transfer process, where the central span loading is transferred from the eye-bar towards the auxiliary structure will be performed. For this purpose, a synchronized jacking sequence will be used, which was predefined by means of numerical model analysis. All structural elements had their designs evaluated and some geometric changes were implemented. This paper presents all the methodology developed in the rehabilitation project of Hercilio Luz bridge, as well as the development stages up to the present date.

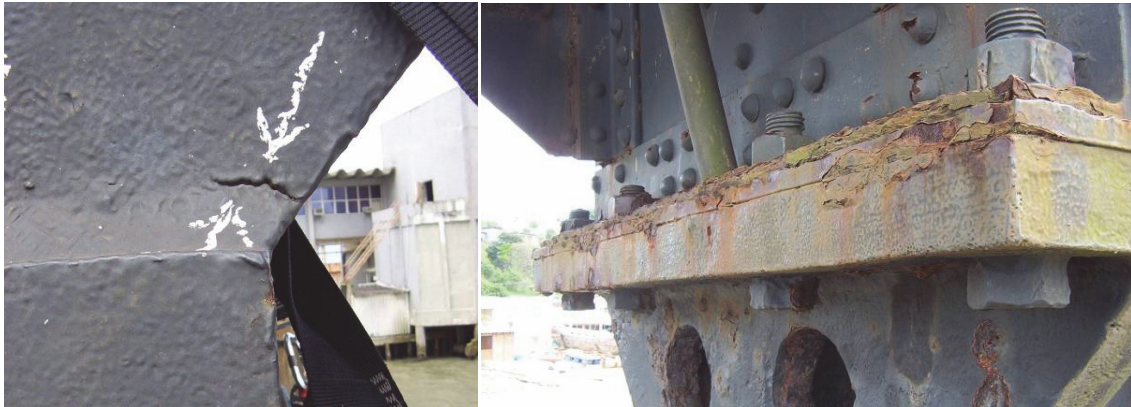
The last visual inspections were made between 2009 and 2013. Fig. 8 presents the fissures and the high corrosion level at the pylon base. The high corrosion state of the steel deck is presented in Fig. 9.

Figure 8: Fissures and the high corrosion level at the pylon base.

The thickness of some structural elements was reduced due to the high corrosion state of the structure and, as a consequence, the stress level increased. For that reason, several structural elements will need to be replaced, such as eye-bars, eye-bar supports, pylon bases, hangers, deck and some truss elements.

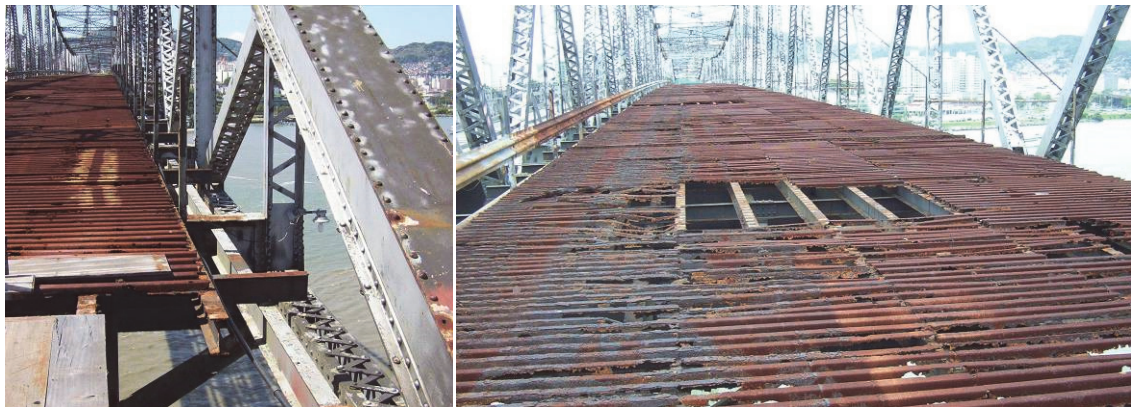
Figure 9: The high corrosion state of the steel deck.

The Hercilio Luz Bridge steel structures were the most affected by the time effect. The bridge deck, initially composed by steel beams covered by wood plates, will be replaced by an orthotropic steel deck. All the elements with complex geometries had their resistance evaluated based on FEM models. The cast parts, such as the pylon base and the eye-bar supports will be replaced by new cast parts. Fig. 17 presents the stress diagram at the pylon base. Figs. 18 and 19 present the stress diagrams of the eye-bar support and the eye-bar anchorage on the massif, respectively.

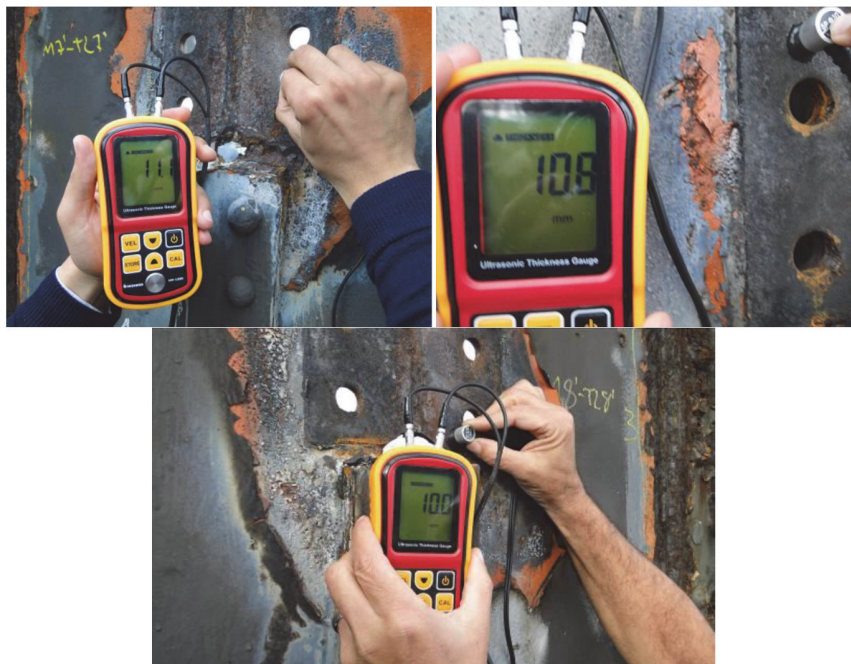
An uneven thickness loss along the elements were observed, caused by constructive details that exist in riveted structures. For this reason, thickness measurements were made in several points, mainly on those with advanced stage of corrosion (Fig. 10).

Figure 10: Thickness measurement in regions with advanced stage of corrosion.

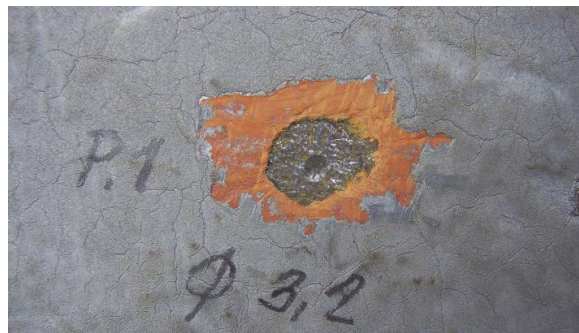
Due to the fact that the original project is very old, there were no records of the composition of the steel employed in the construction. In order to characterize the kinds of steel present in the structure, hardness tests were performed in the main structural elements, such as pylons, eye-bars and truss elements (Fig. 11), in accordance with ASTM standard [20]. The yield stress and ultimate strength of the steel were obtained through tension tests (Fig. 12).

Figure 11: Hardness test in main structural elements.

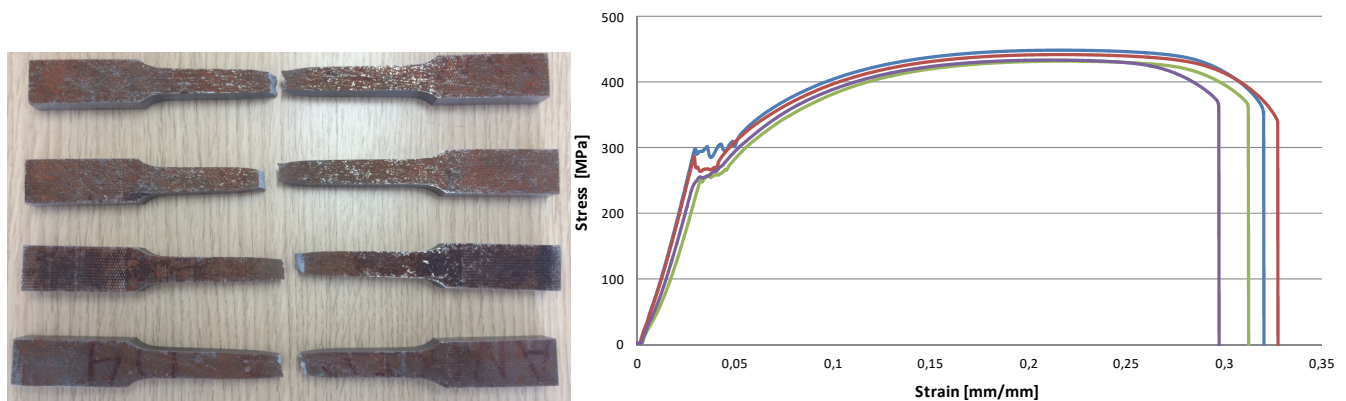
Tab. 1 presents yield stress, ultimate strength, elongation at fracture and cross-section reduction for each specimen evaluated. The yield stresses were near to values found for the steels employed on Eiffel Bridge (Portugal) and Bridge over

Figure 12: Samples and “stress-strain” curves obtained through tension test.

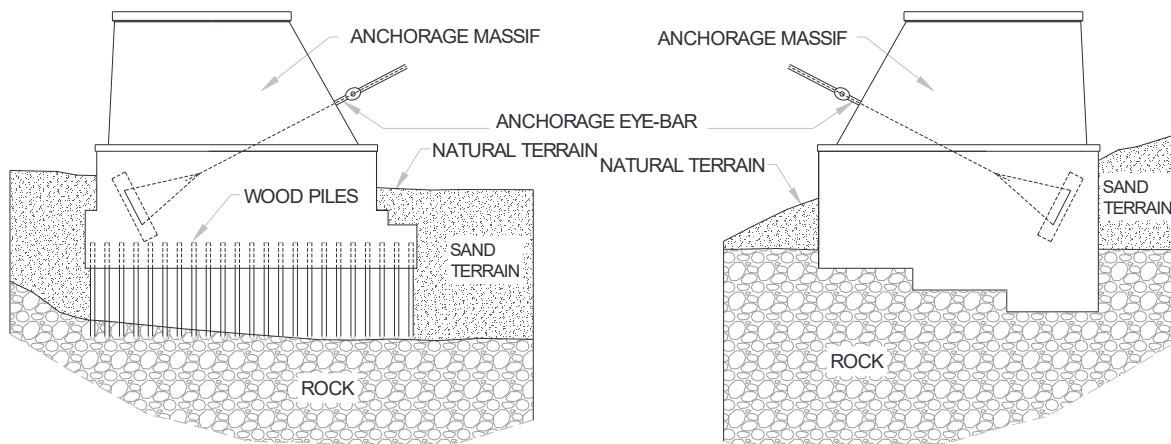
During inspections, surface wear was found in the concrete structures. Furthermore, it was found that the blocks and anchorage massifs were made of Cyclopean concrete. The original foundation project indicates that one of the anchorage massifs is set directly over the rock and the other over wood piles (Fig. 13). The wood piles are inaccessible. Therefore, it was not possible to verify their state of preservation and the structural integrity of the wood piles, due to age, cannot be guaranteed.

Figure 13: Anchorage massifs.

All foundations should be reinforced because of incertitude concerning their structural impairment. The blocks and anchorage massifs will be reinforced through adding a new layer of concrete around them and the construction of concrete piles under them.

The anchorage massif, which is set over the rock, will be used and only its surface repaired, while the anchorage massif set over wood piles will be demolished and integrally rebuilt with the original geometric shape. Fig. 16 shows the position of the new anchorage eye-bars in the massif set over the rock.

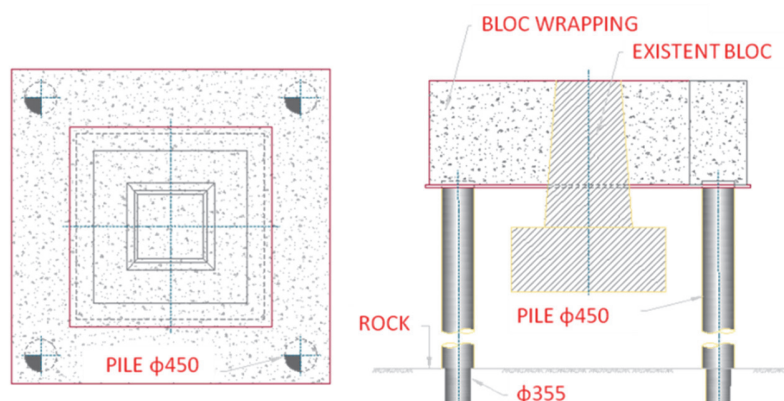
Figure 15: Typical reinforcement of the Bridge's access span bases.

The access span foundations were originally designed as rock supported concrete blocks. Since it is not possible to verify the real condition of the block support, a block reinforcement project was developed. The blocks will be expanded by being wrapped by a new bigger block that will be supported by 450 mm diameter concrete piles (Fig. 15).

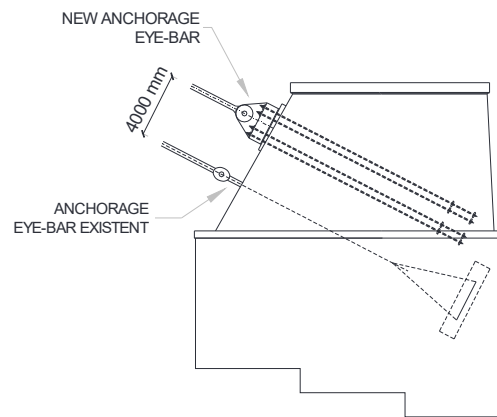
Figure 16: New position of anchorage eye-bars in the massif set over the rock.
