# **FAILURE ANALYSIS OF A PARTICULATE COMPOSITE CUTOFF WHEEL WITH FIBER REINFORCING**

Thomas J. Mackin and Helen M. Inglis

Department of Mechanical and Industrial Engineering, University of Illinois,  
1206 W. Green Street, Urbana, IL 61802, USA

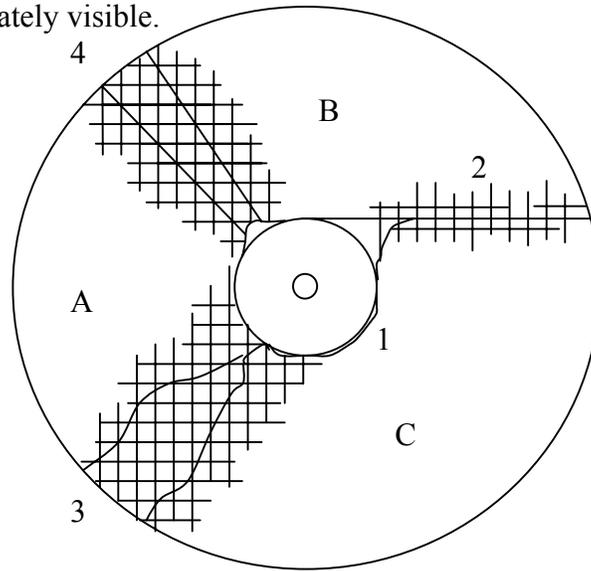
**Figure 1:** Schematic of the failed wheel.

There are four large cracks in the fractured disk. A circumferential crack (labeled “1” in Figure 3) runs completely round the disk along the circumferential footprint of the clamping washer. The fibers are cleanly broken. The other three cracks are radial cracks. Crack “2” runs at  $90^\circ$  to one fiber direction. The bridging fibers are cleanly broken along the length of the crack. Cracks “3” and “4” run at  $45^\circ$  to the fiber directions. They are characterized by large areas of fiber delamination and by considerable loss of the abrasive material. Crack “3” initiates in a non-radial direction, but changes direction to become a radial crack. As expected, therefore, all cracks show a preference for propagating in one of the directions of principal stress, that is, the radial or circumferential direction. The injury was caused by fragment “B”.

The clean fracture surface as well as the location and geometry of crack “2” support the hypothesis that the wheel fractured along crack 2 under application of a bending load as the wheel was cutting the brass bar. At the edge of the mounting flange, this stress would be concentrated due to sharp or uneven bearing surfaces between the flanges and the wheel. The cracking pattern suggests that failure initiated at the mounting flange and ran circumferentially around the flange. As the crack propagated it branched outward. It is important to emphasize, again, that a blotter pad was not used between the flange and the wheel. The circumferential stress concentration at the mounting flange damaged the fibers underneath the flange. These fibers are essential to the damage tolerance of the wheel, allowing for graceful failure, and large failure strains. In fact, if the fibers are properly utilized, the wheel fragments should hit the safety guard before any fibers have broken. The fibers are intended to pull-out and bridge the cracks in the underling matrix. However, the contact stress generated by the mounting flange damaged the fibers, causing localized fracture at the contact site. As a result, the fibers did not bridge the crack in the wheel and catastrophic failure ensued.

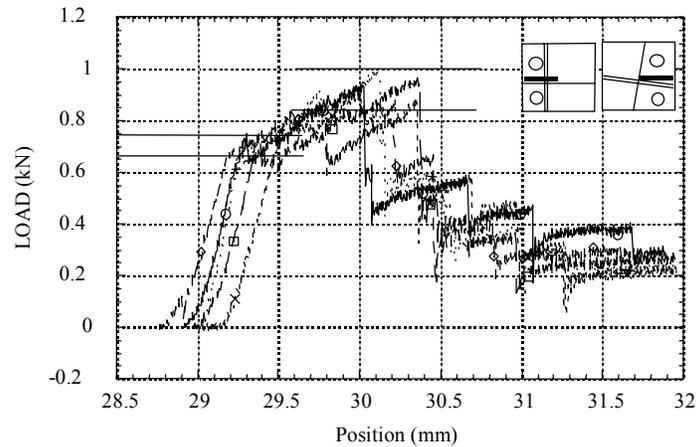
Compact tension tests were conducted to determine comparative measures of fracture toughness for the different wheels, and for different fiber orientations. The test sample geometry and dimensions are in accordance with ASTM E399 [2]. Typical load displacement curves from one wheel and specimen orientation are shown in Figure 2. In all cases, cracking initiates in the matrix. The toughness of the matrix

itself (given by the initiation toughness) is inferred from these tests and summarized in Table 1. The crack propagates across the entire remaining ligament of the test specimen, leaving an intact fiber-bridging zone behind the crack tip. Since the bridging zone is equal to the remaining width of the test sample, this becomes a problem of large scale bridging that is not properly treated using the concepts of linear elastic fracture mechanics [3,4]. Nonetheless, it is possible to calculate a peak load and an associated apparent (or plateau) toughness that can be used to compare samples of identical dimensions. It was observed that the initiation toughness did not show dependence on the fiber orientation, while the plateau toughness did show some dependence on the fiber orientation. This correlates with our understanding that the brittle matrix dominates crack initiation and propagation, but that final fracture occurs only once the bridging fibers have broken or become debonded. It is well known that the stresses exerted by bridging fibers will depend upon the orientation of those fibers, and that aligned fibers are more effective than mis-aligned fibers [5].

**Figure 2:** Typical results of compact tension tests. Inset shows the relative fiber orientation for these data.

The effectiveness of fiber reinforcing to increase the fracture toughness of a brittle material is demonstrated through the experimental results **reported above**. The fracture tests presented in Figure 2 and summarized in Table 1 clearly show that the bulk of the toughness comes from fiber bridging stresses. Furthermore, that toughness was shown to depend upon the fiber orientation relative to the crack plane: perpendicular fibers offering the greatest energy absorption. The material testing clearly indicates the effect of fiber orientation on the energy which is absorbed during failure, and show the same trend in the effect of fiber orientation on comparative fracture toughness. The energy required to break fibers which are aligned with the load direction is much greater than that required to delaminate fibers which are at or near 45° to the load direction. If all the cracks in the abrasive wheel had been bridged by transverse fibers, the wheel would have failed, but in a safe manner. This requires redesign of the reinforcing fiber directions to ensure that there are fibers in the principal loading directions of the wheel.

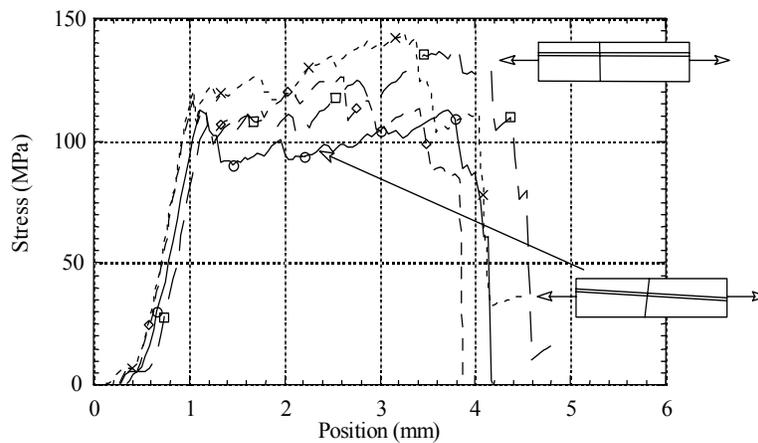
Stress-displacement curves obtained from 4-point bending tests were compared for the different specimens and fiber orientations (Figure 3). There is a marked reduction in the amount of energy absorbed through cracking for different fiber orientations. In addition, the energy absorption of the failed wheel was lower than that of the exemplar wheels for all fiber orientations. Examination of the failed specimens showed that those samples with fibers in the loading direction failed by breaking the fibers, while those with fibers at 45° to the load failed by delamination of the fibers from the matrix.

**Figure 3:** Typical results of bending tests. Inset shows the relative fiber orientation for these data.
