Scientific Support for the Investigation of a Helicopter Collision

ABSTRACT

This paper discusses some aspects of scientific support provided during the investigation of an accident in which two Black Hawk helicopters collided during an exercise; both helicopters were destroyed in the collision, with substantial loss of life. One aircraft was reconstructed at DSTO, with extensive analysis of parts, to allow determination of the collision mechanics. The investigation succeeded in its main aims of determining the location of the collision point, and the likely track of each aircraft, as well as the details of the collision. Extensive support was also provided on many other aspects of the accident. The investigation required development of several innovative approaches, including a way of analysing the wreckage distribution to establish the collision location, as well as producing some challenges in component failure analysis. This paper provides a brief discussion of the reconstruction and the wreckage analysis.

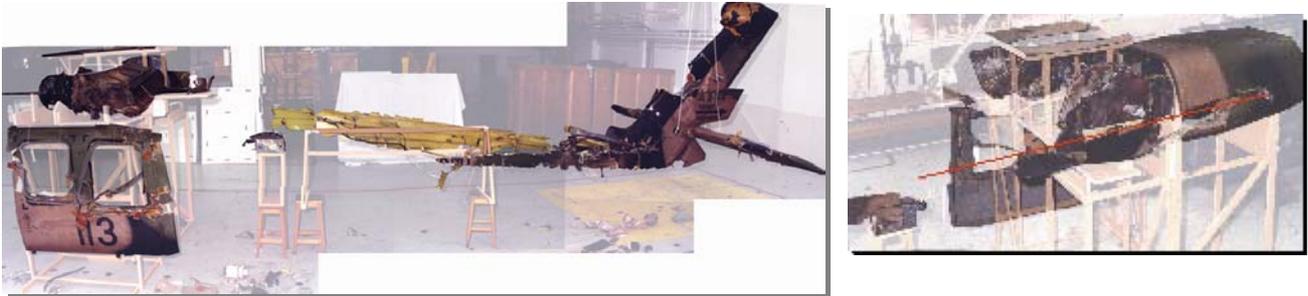
The wreckage was consolidated at the AMRL facility at Fishermans Bend, Melbourne. It included substantial sections of main rotor blades (MRBs) and tail rotor blades (TRBs) from both aircraft, and a range of components from BLACK 2 which had been flung away from the burning wreckage during the accident. Significant items included the severed tail assembly, the APU, DME antenna, aft sections of the engines, the right engine exhaust system and engine cover door, left cargo door, right side drive train access door and a pneumatic 'Buddy Start' fitting, all of which had blade impact witness marks. A three dimensional mock-up, as shown in Figure 1, was constructed in order to re-build what was left of BLACK 2. Because BLACK 1 was essentially complete when it impacted the ground, with the exception of its MRBs, very little physical evidence was available from it because of the intense fire which engulfed the wreckage and melted the aluminium components.

Figure 1 View of the recovered tail section along with other major components.

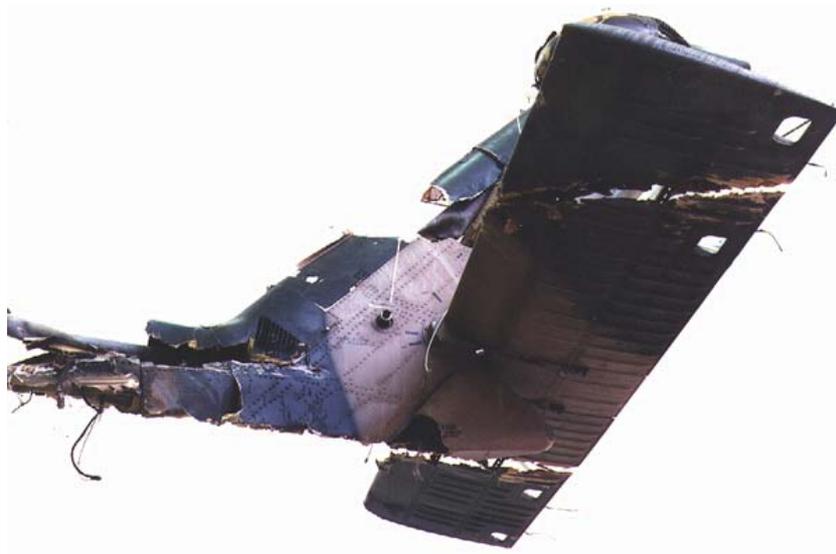
Figure 2 The reconstructed tail section of BLACK 2 looking in-plane with the upper cut through the tail section and the lower cut through the tail boom.

Using the mock-up of BLACK 2 it became clear that a number of the cuts caused by the passage of MRBs began to line up. Reconstruction of the tail section of BLACK 2 as shown in Figure 2,

revealed the alignment of rotor blade strikes in the fin and stabilator, and the tail boom and stabilator. The tail section had evidence of four MRB strikes. The first two were clearly identified from two cuts through the horizontal stabilator, one of which severed the tail rotor drive shaft, and a third from a blade tip penetration near the 45 degree gearbox. However, a fourth strike was not evident until a small fragment of the fin leading edge was replaced in its position on the fin. This strike was barely a glancing blow, and its discovery emphasises the need for thoroughness in parts recovery and airframe reconstruction. The horizontal stabilator actuator was recovered and, because it lost all inputs from the flight control system during the first MRB strike (severed hydraulic line), its configuration was able to determine the stabilator angle, which was then used to estimate the speed of BLACK 2.

The MRB tracks through the airframe of BLACK 2 indicated that during the collision, BLACK 1 was inclined at 25 to 35°, left side low, relative to BLACK 2. This can be most clearly seen from the cuts through the horizontal stabilator.

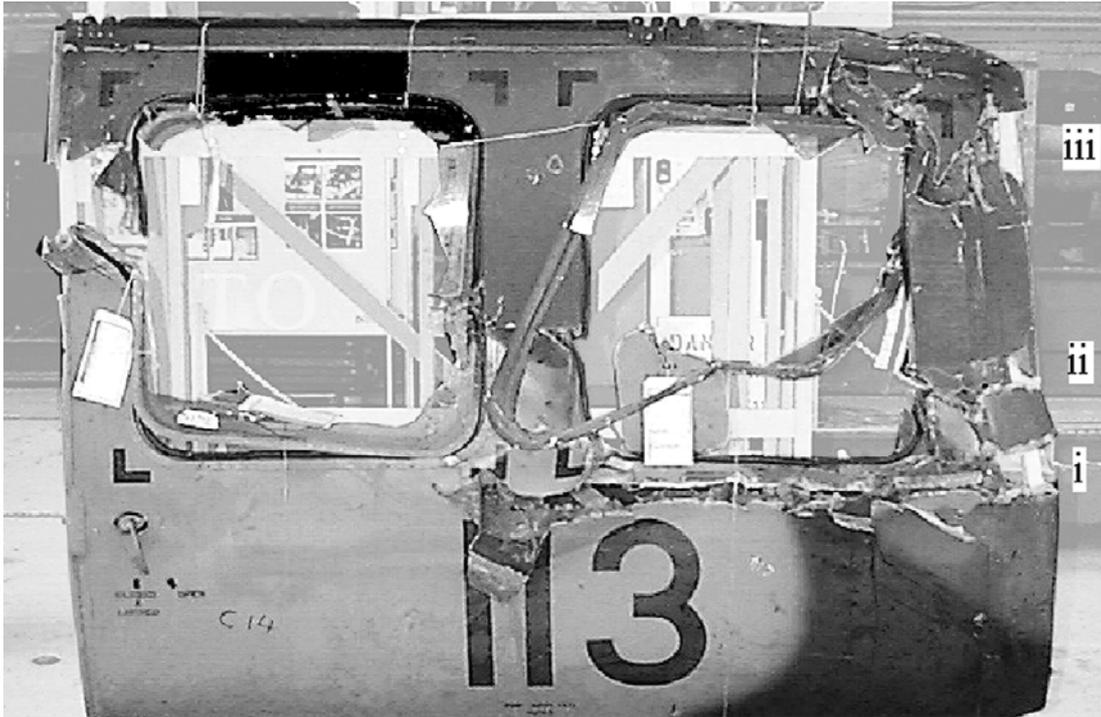
Figure 3 Reconstructed left side cargo door from Black 2 showing three cuts.

The left cargo door (Figure 3) had three distinct cuts/impact marks while the right cargo door had one impact mark. (The evidence for this section includes the cargo doors because they were open (slide to the rear) during the collision. In their closed position, they are part of the cargo area).

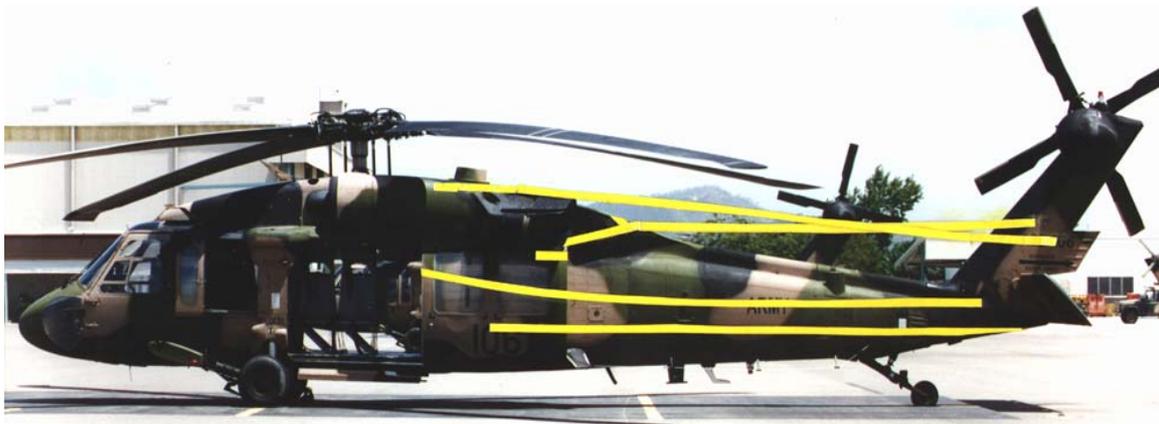
After extensive examination, only **four** distinct MRB strikes could be identified - significantly fewer than initially thought. Because large sections of the four MRBs from BLACK 1 were found well clear of the wreckage, each blade passed through the fuselage of BLACK 2 only once before breaking away and being projected into the distance.

Hence it can be estimated that the collision took approximately 0.25 seconds to complete, ie four blade passes at 17.2 passes per second. This conclusion supported the views of several witnesses who described the impact as an explosion. The tracks of the four strikes are illustrated in Figure 4.

Figure 4 The port side of a Black Hawk showing the deduced positions of the mrb cuts/strikes on BLACK 2

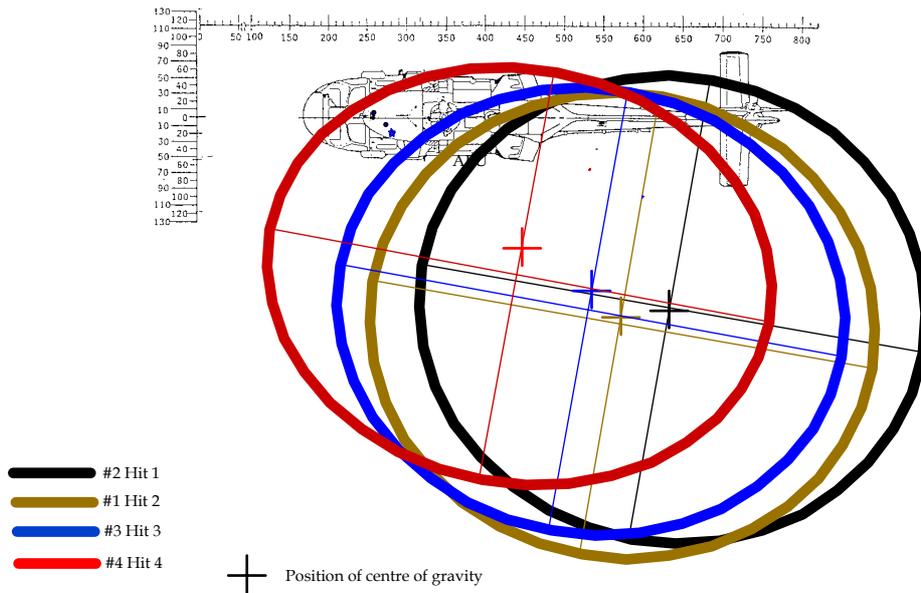
By using the aircraft centres of gravity (CoG) obtained from triangulating back from the known points of impact, a relative movement of BLACK 1 to BLACK 2 could be estimated (Figure 5). Given the normal blade pass frequency was known (17.2 blade passes per second) and the relative movement of the CoGs, the approach velocity could be estimated. Over the four MRB strikes, the centre moved longitudinally along the fuselage of BLACK 2 by approximately 4.6 metres.

Figure 5 The estimated rotor disc sizes and locations, and the progression of the BLACK 1 centre of gravity through the collision. Note that the angle of bank has been increased from 25 to 35 as the collision progressed, corresponding to the physical evidence from the cuts.

Given that the horizontal stabilator actuator setting indicated that BLACK 2 was travelling at between 50 and 70 kt, BLACK 1 appeared to travelling at a speed of between 70 and 114 kt. The resultant approach angle when viewed from the ground was approximately 14°.

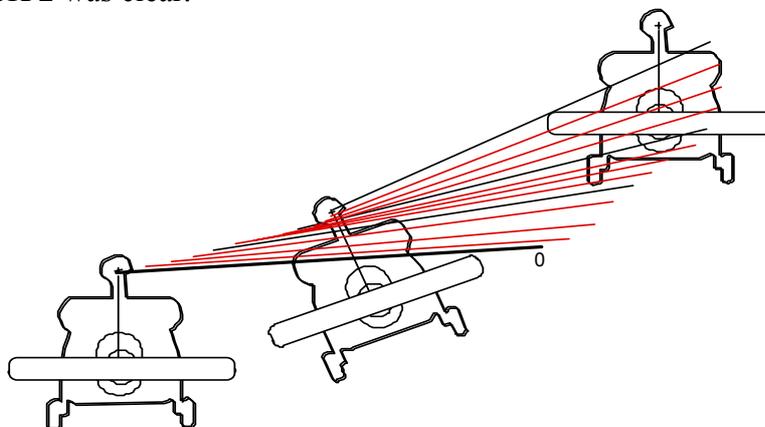
In an effort to understand the dynamics of the rotor disc during manoeuvres, the AMRL Black Hawk simulator was used to explore ways in which a 25° to 35° angle of bank could be generated by BLACK 1 on its approach to BLACK 2. A range of simulations of BLACK 1 was conducted which sought to combine the deduced approach speed towards BLACK 2 and expected evasive manoeuvres by BLACK 1. The first simulation modeled a 65 kt speed and full left cyclic input. This demonstrated that the energy of the manoeuvre during the first approximately 10 blade passes is consumed in rotating the aircraft. By this point, the blades have achieved a bank angle of approximately 20° assuming a rigid rotor (Figure 6). Thereafter, the aircraft commences to move to the left. When an 8 m/sec side speed is introduced to the simulation and the blade tracks are superimposed on an adjacent aircraft, ie BLACK 2, a clear correlation with the MRB witness marks through BLACK 2 was clear.

Figure 6 Full left cyclic applied at blade pass 0, moving 8m/s to right, 2m/s climb, relative to other aircraft.

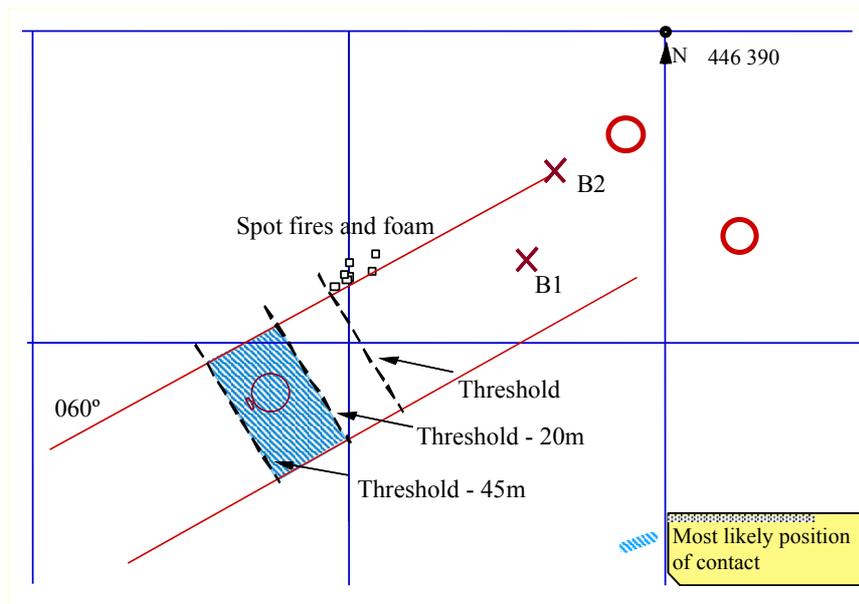
Figure 7 Location of spot fires, light foam material, and likely location of collision.

Given the extremely light weight of the fuel cell foam and the relatively tight grouping of the foam and spot fires, a probable area of collision could be estimated using the 20 metre and 45 metre limits identified by trajectory analysis. The width of the area was estimated as 45 metres for the same reason. Figure 7 shows the overall area, with the airframe ground locations B1 and B2, as well as some target revetments shown as circles. The shaded area represents an estimate of the likely position of BLACK 2 at the time of collision.

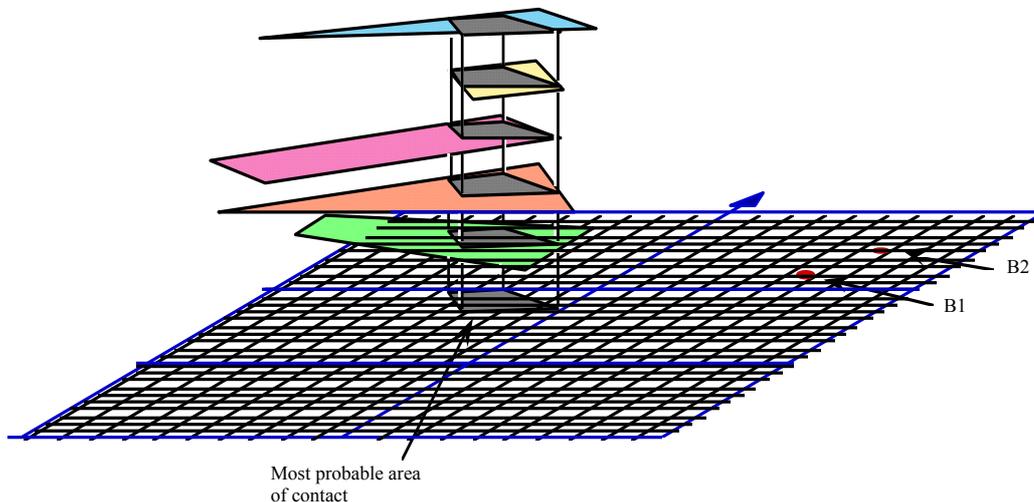
The crucial feature of this approach is to increase confidence in the estimate of collision position by superimposing several estimates. Figure 8 shows the superposition of five separate estimates of the location in this accident; a most likely area of probable impact was defined based on the area common to all five estimates. A lower probability was given to areas which were contained in only four of the five estimates, and so on. In this way, a contour map of probable likely location was generated. The result was a high level of confidence that the location had been identified to within one rotor diameter. Furthermore, placing the two aircraft at this location then effectively identified the tracks of the two aircraft, and met the requirements of the Board of Inquiry.

Figure 8 Identification of the most probable area of contact by superimposing best estimates of contact regions.
