FAILURE ANALYSIS OF A WIRE ROPE BELONGING TO THE TRACTION SYSTEM OF A CABLE CAR

André Luiz Pinto¹, Carlos Sérgio da Costa Viana¹, Luiz Paulo Mendonça Brandão¹, Marcelo Savi² and Pedro Manuel Calas Lopes Pacheco³

¹Instituto Militar de Engenharia, Dept. of Mechanical and Materials Engineering, Rio de Janeiro, Brazil

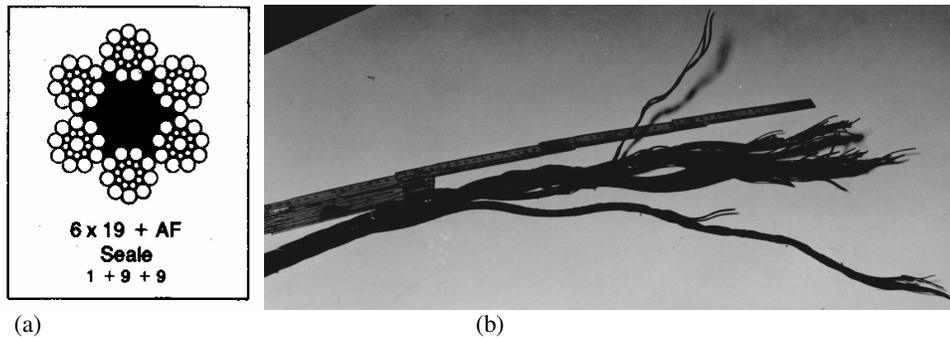
The wire rope used at the traction system was a 6x19 Seale type with fiber soul schematic presented in Figure 1a¹. The rope diameter was 24mm, while each cable leg was composed by 9 external wires of 1.1mm of diameter, 9 internal wires of 1.1mm and one central wire of 2.1mm. The minimal effective resistance

specified was 327.8kN while the specified resistance limit of the wire is 1.77GPa. A picture of the fractured cable is presented in Figure 1b. The criterion for substitution of the wire rope was based in its external wear, therefore regular measurement of the external diameter of the rope is recommended².

Figure 1 – (a) Schematic drawing¹ of the (b) fractured traction cable structure.

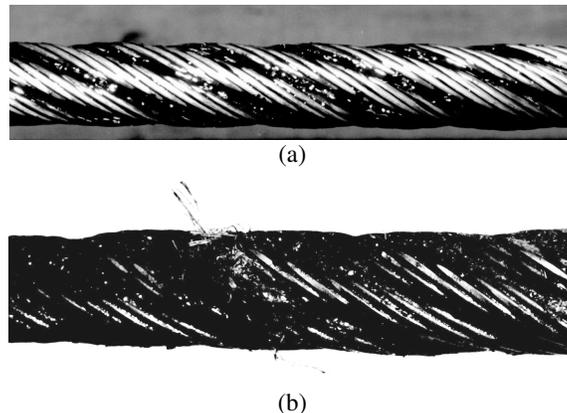
Figure 2 presents a comparison between a new rope and a sample obtained from fractured cable. Visual inspection near the fracture revealed that the wires presented natural wear as a result from the time in service. It should also be pointed out that there are nylon fiber squeezed between the rope legs, suggesting that something might have occurred with the fiber soul. In fact, the observation of the fiber soul near the fracture showed that it had completely lost its fibrous nature (presented in Figure 3a), having been transformed in a fragile polymer block as showed at Figure 3b.

Figure 2 – (a) New cable perfectly oiled. (b) Region from the fractured cable near the fracture presenting part of the nylon fiber soul squeezed between the cable legs.

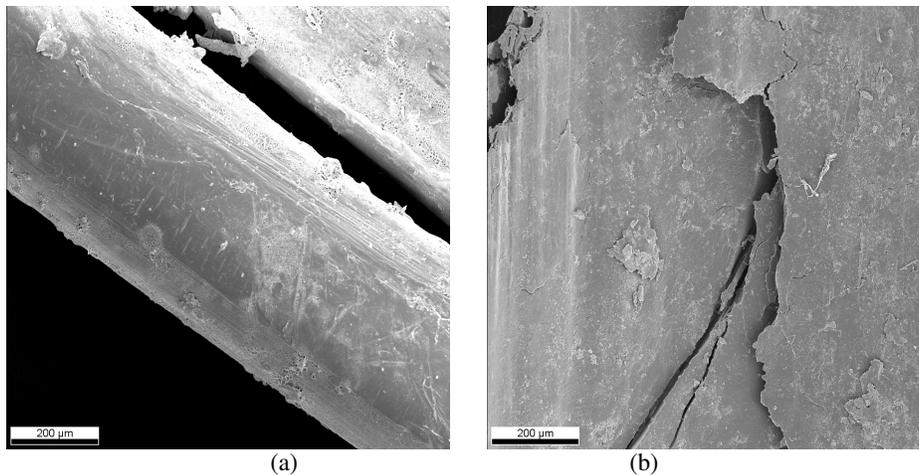
Figure 3 –SEM micrographs of the nylon soul from (a) a new cable and (b) from the region where the failure occurred showing how the fiber has been transformed into a monolithic fragile block.

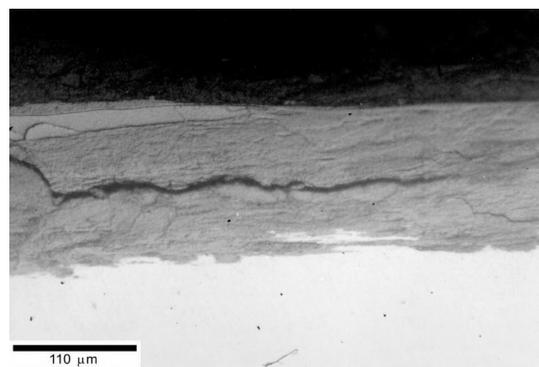
Degradation of the fiber soul resulted in insufficient oiling of the interior of the steel cable which generated a corrosion process as can be seen at Figure 4. This corrosion coupled with cyclic loads induced by the pulley system seems to have resulted in a fatigue-corrosion mechanism. Several wires have presented cracks which completely degraded the wire integrity as can be seen in Figure 5. The fracture surface presented clear signs of fatigue, as the striations shown in Figure 6 clearly evoke. Final fracture occurred by the overload of the reminiscent resistant section as can be seen in Figure 7 where microcavities testify the maintenance of the ductile behavior of material.

Figure 4 – Optical micrograph of a polished longitudinal section where an oxide layer can be clearly identified.

The occurrence of this failure has led to a series of countermeasures by the wire rope user. Lubrication oil has been changed, a cable life control based upon the number of load cycles was implemented and, what is most important, magnetoscopy of the role cable system was conducted since daily external diameter measures could not detect defects in the interior of the cable.

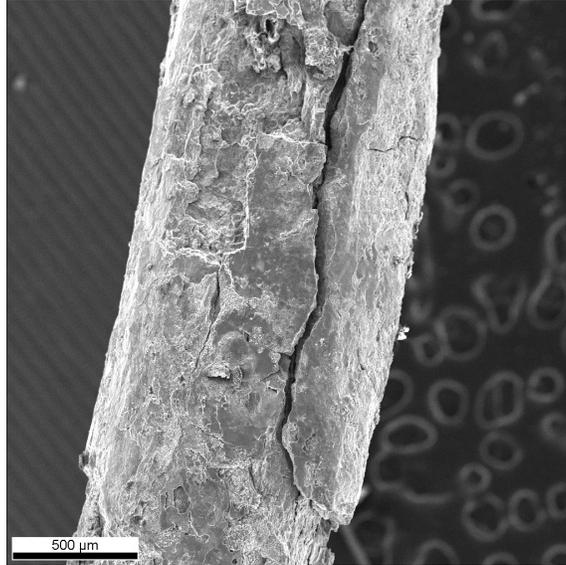
Figure 5 – SEM micrograph of a wire where a fatigue crack was found.

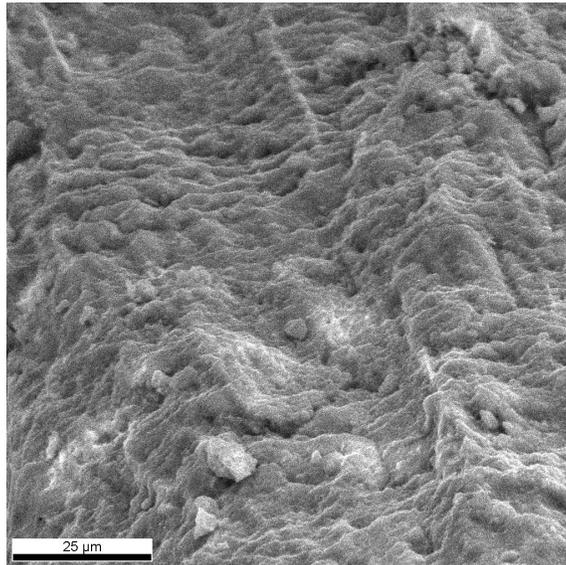
Figure 6 – SEM micrograph at a $\phi = 1,9\text{mm}$ wire presenting distinctive striations formed as a result of the corrosion fatigue process.

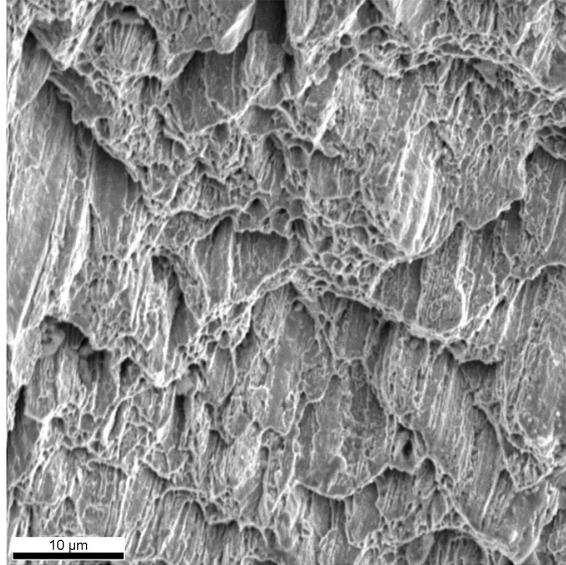
Figure 7 – SEM micrograph of the final fracture of the $\phi = 1,1\text{mm}$ wire from the cable presenting dimples.
