# **PRACTICAL SOLUTION FOR AVOIDING FAILURE OF ABSORPTION TOWER AT A NITRIC ACID PLANT --- Replacing Welding by Mechanical Joining ---**

## **ABSTRACT**

After ten years of operation, the absorption tower at a nitric acid plant was failed due to stress corrosion cracking. SCC was caused by combination of both welding residual tensile stresses and chloride ions accumulated due to rain and/or vapor contaminated with chloride. Irregularity of fillet weld surface helped in occurrence of cycles of wetting and drying conditions of weld surface that in turn resulted in chloride concentration.

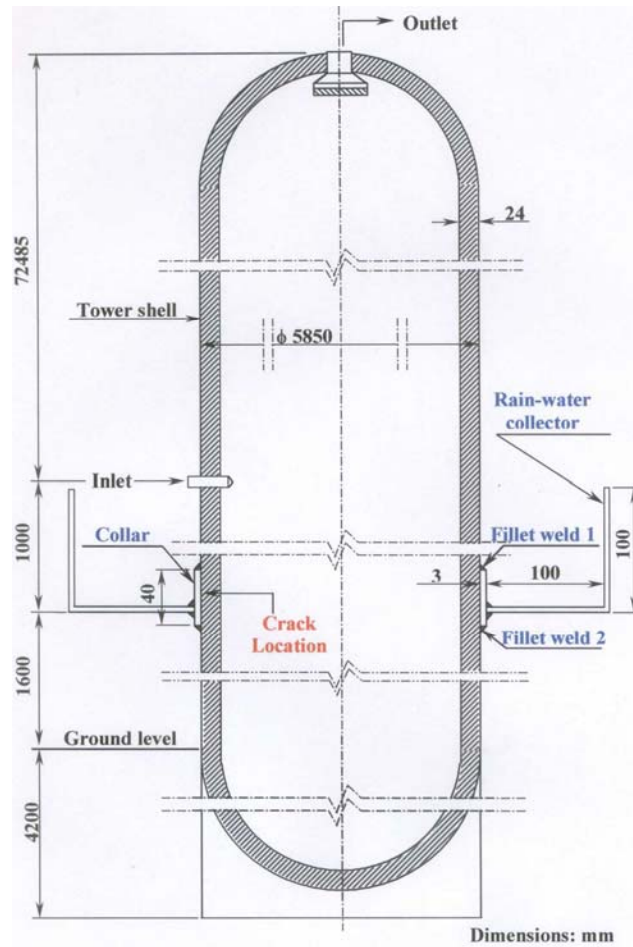
Figure 1 shows a schematic illustration of longitudinal section of the tower and its attachments. The tower was surrounded from outside with a collar located at 5200mm from its bottom. The collar was made of 3mm thick type 304L stainless steel with 40mm height and it was fixed to the tower' shell using fillet welds. The collar was used as a fixation ring for a round shape rain water' collector that was made also from 3mm thick type 304L stainless steel with 100mm width and 100mm height. Rain water' collector was fixed to the collar using two sides fillet welds.

Figure 1. Schematic illustration of a longitudinal section of the tower showing rain water' collector and its fixation collar where leaks were occurred.

It was clear that cracks were initiated first at the outer surface of upper fillet weld of collar with tower' shell (fillet weld 1 in Figure 1) then, penetrated through this fillet weld. Irregularity of fillet weld could help in cycles of wetting and drying conditions of its surface that in turn resulted in chloride concentration. After cracks penetrated this fillet weld, rain water has passed and accumulated through clearance located between collar and shell and this created a stagnant condition. This stagnant condition combined with high stress concentration between fillet weld 1 and fillet weld 2 (Figure 1) created a sufficient condition for initiation of SCC at the outer surface of the tower' shell zone covered by the collar (Figure 2).

The leaking zone around the circumference of the absorption tower' shell in addition to 250mm above and below it was replaced with new part of the same stainless steel. The newly inserted shell ring, replacing the leaked zone is 500mm height with the same diameter and thickness of shell.

However, combination of corrosive medium and tensile stresses should be eliminated in order to avoid such failure in the future. Since chloride ions as a corrosive medium are difficult to be avoided then, tensile stresses due to welding should be considered. In this respect, fixation of the rain water' collector around the tower' shell was done using mechanical means instead of fillet welds. This will eliminate tensile stresses and reduce chloride concentration that in turn will prevent SCC.

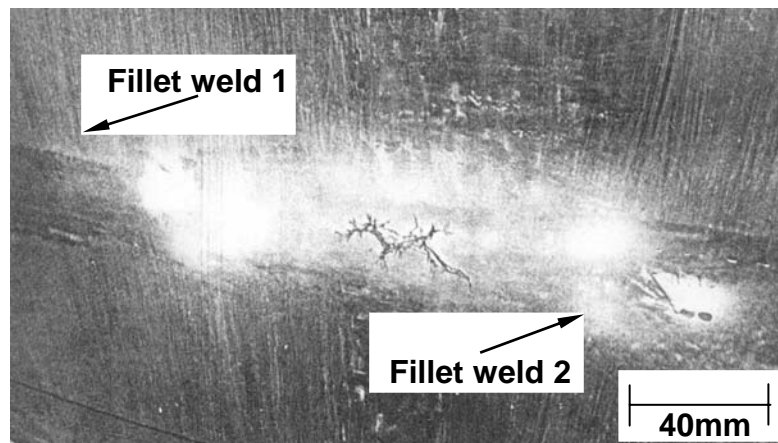
Visual and dye penetrant tests of the leaked zone, after removing both collar and rain water' collector disclosed branched cracks at the outer surface of tower shell (Figure 2). Cracks were confined only to the shell' zone that was covered with the collar. Cross sections from the failed tower' shell were cut out and prepared for chemical analysis, hardness measurements, optical and scanning electron microscopy examinations, and EDX micro-chemical analysis.

Figure 2. Close-up view of the outer surface of leaked shell' zone, after removing rain water' collector and its fixation collar showing branched type cracks confined between fillet welds of collar with shell.

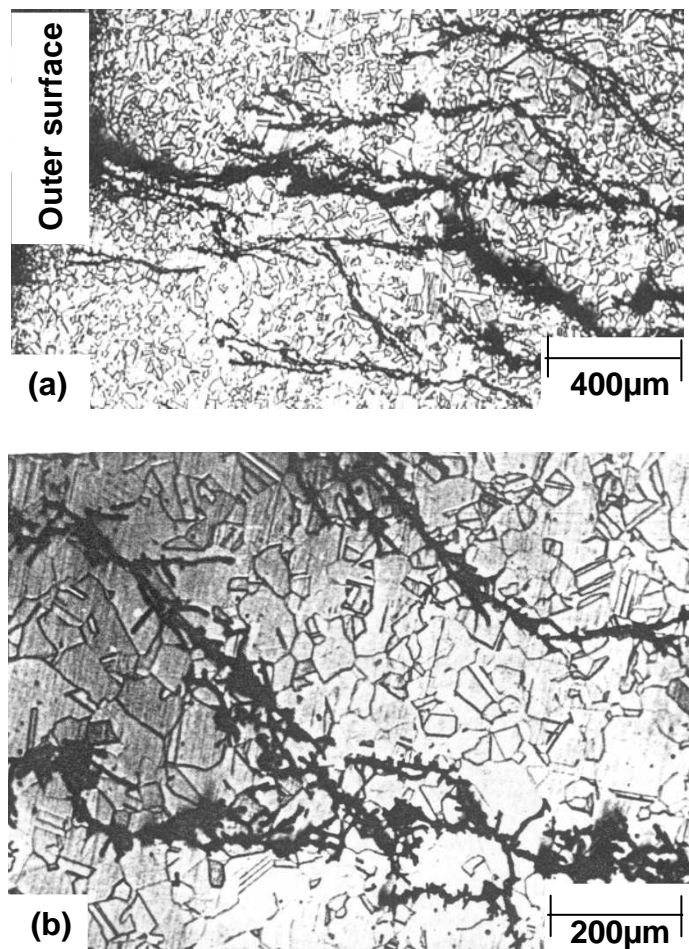
Figure 3-(a) shows optical micrograph of a cross section taken from the leaked zone. The most important notice is that cracks were initiated at the outer surface of the tower shell then, it propagated through thickness toward inner surface. The cracks exhibited branching as they propagated through shell wall thickness. Higher magnification indicated that paths of these branched cracks principally were on grain boundaries (intergranular) as shown in Figure 3-(b).

Figure 3-(a). Optical micrograph of a cross section taken from leaked zone showing branched cracks initiated at shell outer surface, (b) Higher magnification showing grain boundary crack propagation.

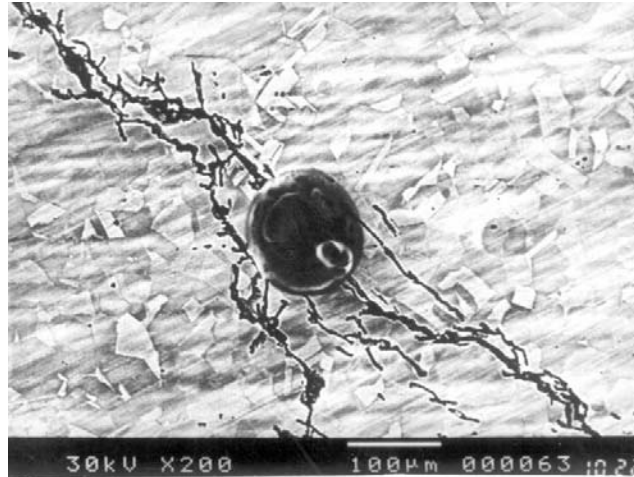
Scanning electron microscopic examination of the outer surface of a failed zone revealed branched cracks around a corrosion pit as shown in Figure 4. EDX microanalysis of this zone indicated chlorine at crack path. However, higher chlorine content was found at corrosion pits.

Figure 4. Scanning electron micrograph of outer surface of shell' leaked zone showing branched cracks around a corrosion pit.

Corrosion pits on the outer surface of the leaked zone accelerated the formation of SCC since it acts as stress raisers. Stress concentration increases tremendously as the radius of pit decreases. SEM examination disclosed branched cracks around a corrosion pit (Figure 4) that confirms initiation or starting of SCC at the base or root of corrosion pits. Once a crack has started, the tip of the advancing crack has a small radius and the attendant stress concentration is great. The conjoint action of stress and corrosion is a must for further crack propagation.
