FATIGUE OF OFF SHORE CONDENSATE RECYCLE LINE AT NATURAL GAS PRODUCTION FIELD

ABSTRACT

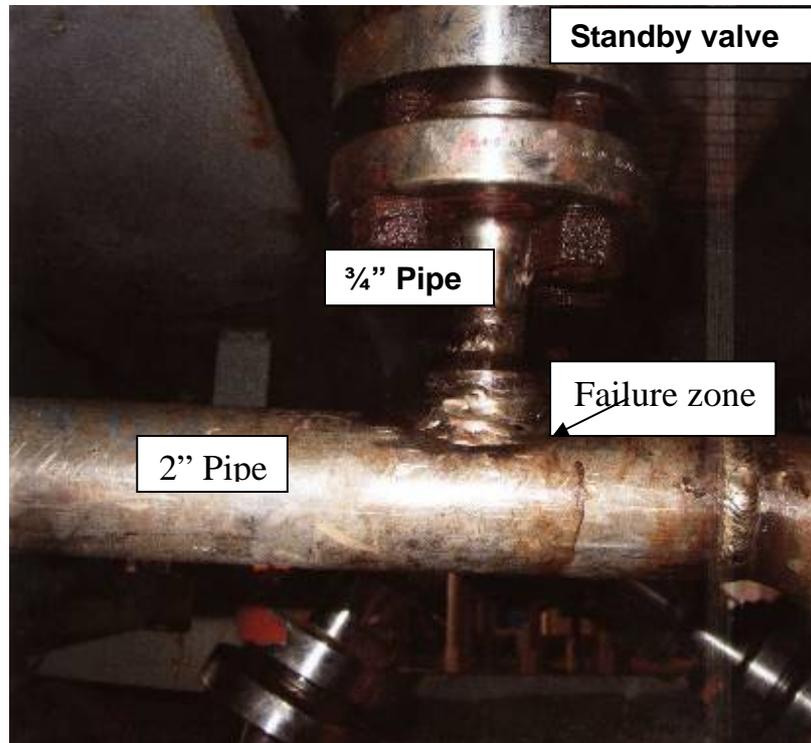
Recently, condensate recycle line has experienced leakage at its fillet welded joint with ¾" pipe branch. Detailed non destructive testing were carried out then, flanges of standby valve were disconnected and spool including ¾" pipe branch with about 230mm length of 2" main line around the leaked zone was removed for comprehensive investigation and clarifying failure cause.

Fig. 1. Part of condensate recycle line showing $\frac{3}{4}$ " pipe branch fillet welded to 2" main horizontal line where leakage has occurred.

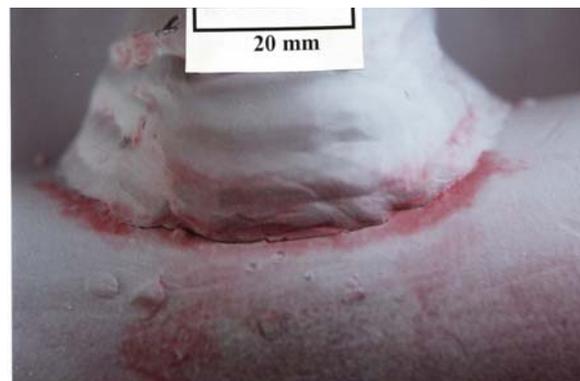
The leaked zone was subjected to different non-destructive tests including visual investigation, thickness measurement and dye penetrant investigation. The leaked zone was confined to fillet weld connecting ¾" pipe branch to 2" main line. Visual inspection showed that the outer surface of the leaked zone is clean and free from deposits or indications for corrosion. However, some welding prominent as a result of using hand grinder after welding were observed. It also indicated a remarkable irregularity in weld surface, particularly at weld base where there was sharp transition between fillet weld and 2" pipe as a result of undercut and overlap (Fig. 2). The leakage was confined to this zone where a crack with about 40mm length was observed (Fig. 2). Examination of crack using magnifying lens indicated that width of crack is varied along its total length, suggesting multi-initiation sites. Absence of crack on other side of fillet weld was confirmed by dye penetrant test. It is noticed that non-cracked fillet weld side has a smooth transition with 2" pipe.

Fig. 2. Outer surface of leaked zone after dye penetrant test showing crack at base of fillet weld where sharp transition is obvious.

Visual and macroscopic examinations showed that the leaked zone was confined only to the base of fillet weld joining $\frac{3}{4}$ " pipe branch to 2" pipe where stress concentration sites (undercuts and overlaps) were existed. It showed also brittle fracture with multi-initiation sites on outer surface.

In order to increase the lifetime of the subject condensate recycle line, cyclic stresses and/or stress concentration sites should be avoided. Since cyclic operation mode of the subject line can not be prevented, cyclic loads were minimized, by removing the standby valve. Besides, fillet weld geometry was improved so that smooth transition between fillet weld and 2" pipe was achieved that means reducing stress concentration at weld base. In other words, fillet weld free from undercut and overlap that works as stress concentration sites was made.

Periodic inspection was scheduled in order to check the existence of outer surface cracks at the concerned fillet weld then, necessary action, including repairing or replacing the defected zone, to be carried out in order to avoid sudden failure and unexpected shut down.

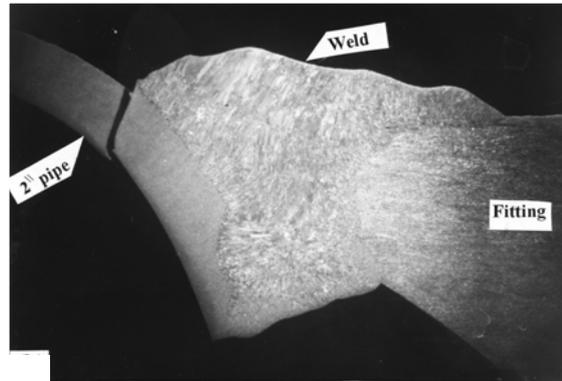
Low magnification stereoscopic examination of the observed crack indicated that crack width on outer surface was relatively wider than that on inner surface. This has been confirmed through investigating different cross sections of leaked zone. Macrograph of a cross section taken from leaked zone is shown in Fig. 3. It can be noticed that crack width at outer side is relatively wider than that at inner side and this increase the probability of crack initiation at outer surface. Crack was initiated at weld toe, just beside fusion

Fig. 3. A cross section of leaked zone showing through-thickness crack with wider width at weld toe.

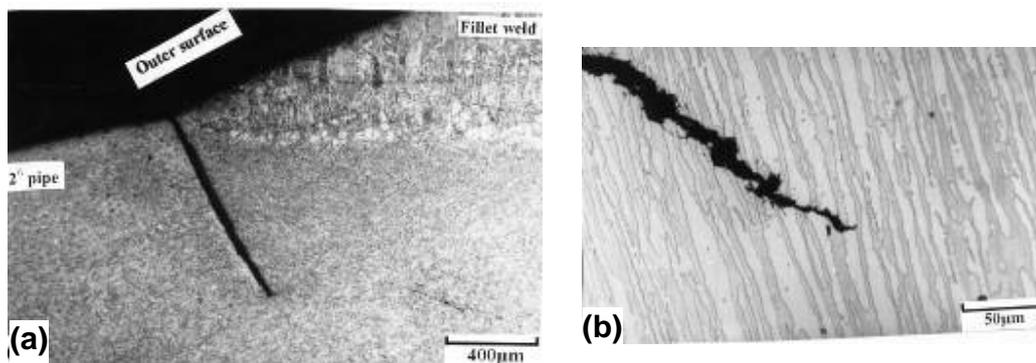
Optical micrographs of a cross section taken at 20 mm in front of the through-thickness crack' tip are shown in Fig. 4. It is noticed that single, non-branched crack was initiated on the outer surface just at weld toe, beside fusion line then it propagated through base metal toward inner surface (Fig. 4-a). Higher magnifications around crack' tip indicated transgranular crack type (Fig. 4-b). Analysis of crack tip using EDX technique showed that the main components are iron oxide and chloride.

Microstructure of weld metal and HAZ consists of large ferrite grains with continuous networks of austenite at the ferrite grain boundaries and intragranular austenite precipitates. The coarse grained HAZ region adjacent to fusion line could be resulted from nearly complete austenite dissolution on heating and subsequent ferrite grain growth. Widmanstatten austenite precipitated from the grain boundary austenite was observed in weld metal. Microstructure of base metal is duplex with approximately equal volumes of both ferrite and austenite phases. Since hot working of duplex stainless steel is normally performed in the austenite-ferrite, two-phase region, the resultant microstructure tends to be strongly oriented along the working direction (Fig. 4-b).

Fig. 4. Optical micrographs of a cross section taken at 20 mm in front of through-thickness crack' tip showing non-branched (a) and transgranular (b) crack initiated at weld toe.

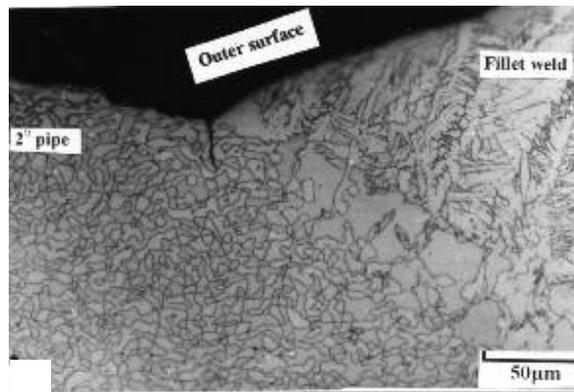
Optical micrograph of a specimen taken from non-leaked zone of 2" pipe is shown in Fig. 5. The most important notice is the initiation of a non-branched crack on the outer surface just at weld toe, beside fusion line then its propagation through base metal toward inner surface. Path of this crack was principally through grains (transgranular). Microstructure of base metal, HAZ and weld metal of non-leaked zone is similar to that of leaked zone.

Fig. 5. Optical micrographs of a cross section taken from non-leaked zone showing straight and transgranular crack initiated weld toe.

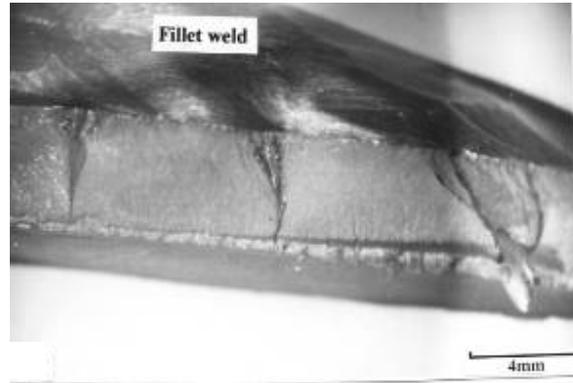
In order to help in identification of failure mechanism, through-thickness crack' surface was subjected to both stereoscopic and scanning electron microscopic examinations. Low magnification stereoscopic photograph of crack surface is shown in Fig. 6. Fracture features include a brittle appearance and multiple initiation sites. Multiple fracture initiation sites can be seen on outer surface beside weld boundary, just at weld bead conjunction where stress concentration sites (undercuts and overlaps) were existed. Generally, a

Fig. 6. Stereoscopic photograph of cracked surface showing brittle appearance and multiple initiation sites for fracture.

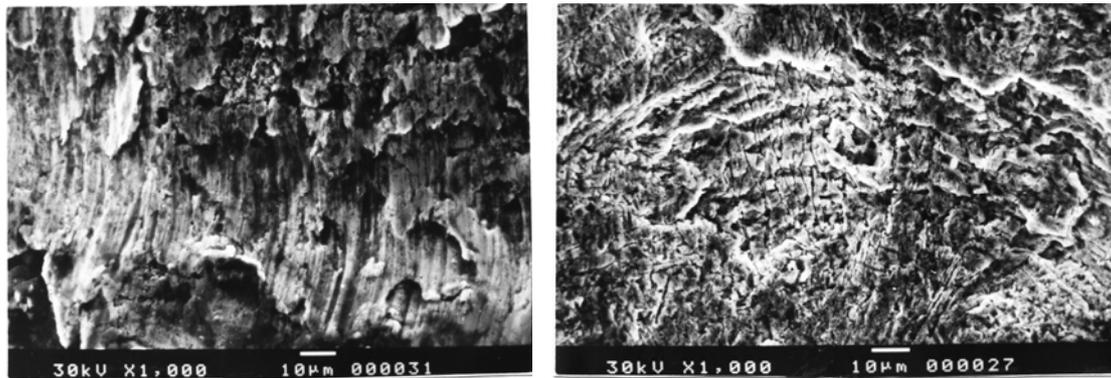
Scanning electron micrographs of the most probable crack initiation zones are shown in Fig. 7. The important notice is the transgranular crack propagation behavior within the grain and the unclear fatigue striations.

Fig. 7. Scanning electron micrographs of fracture initiation zones showing unclear fatigue striations.
