Characterization of Explanted Bileaflet Mechanical Heart Valves and Correlation with Patients' Clinical Data

M.F. Brunella¹, G. Bruschi², S. Farè³

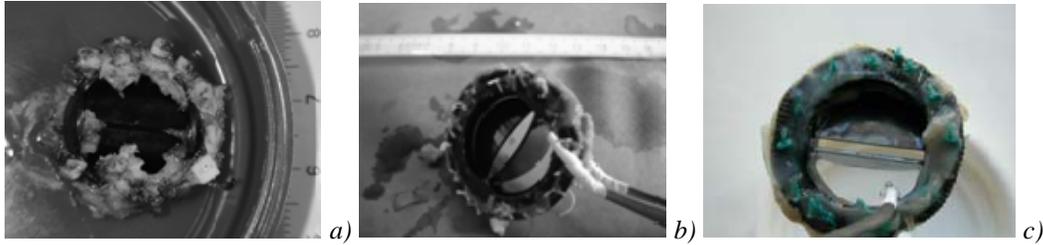
Figure 5 – Pannus on the suture ring, the correct motion of the two leaflets is obstructed: a) St Jude valve #23; b) Sorin Bicarbon #57; c) Carbomedics #36

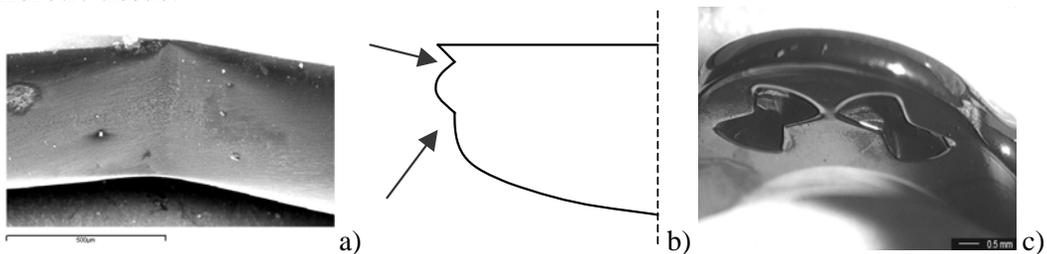
The St. Jude Mechanical Heart Valve was the first heart valve prosthesis that used two component coated by pyrolytic carbon (PyC) for the cinematic coupling with concentrate wear, as the one between hinges and pivots. The first studies performed in vitro demonstrated that wear of the PyC coated pivots did not cause malfunction or break [4]. In fact, the abrasive wear detected in all the 8 analyzed valves was not directly correlated to a clinical symptomatology. The effects of the abrasive wear are more evident in the zones of relative motion between the housing and the two leaflets (Figure 6a,b and figure 6c). In the St Jude prosthesis, the transvalvular pressure during the closure cause a maximum load on the leaflets and is sustained by the tips of the two leaflets [4]. High load and impact among the leaflets and the hinges can explain the presence of scratches on the pivots of the MHVs #2 and #25. Furthermore, high loads could give rise to the isles with a marked porosity, observed in the hinge of valves #15, #22 (Figure 7a). On the contrary the bright areas, characterized by a high porosity (figure 7b), observed on the leaflets and on the rim and the outer surface of the housing of valves #23 and #25 are most likely due to an imperfect surface finishing process rather than to mechanical damage, for their position out of the areas of high load and impact. The scratches on the pivots could have changed the cinematic coupling between the two leaflets and the housing, preventing the normal movement of the occluders, and promote the pannus growth (i.e. rough surface). Also the zone of the hinges with high porosity could have caused the growth of fibrotic tissue.

Figure 6 – a) Scratches on the leaflet near the pivots and b) their position; c) scratches inside the hinges

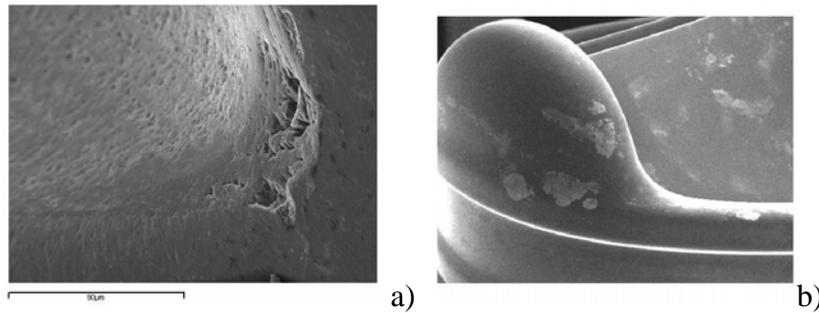
Figure 7 – Housing of valve #15 porous surface in the hinge (a); valve #23 porous areas on the outer surface of the housing and in the centre of the leaflets (b)

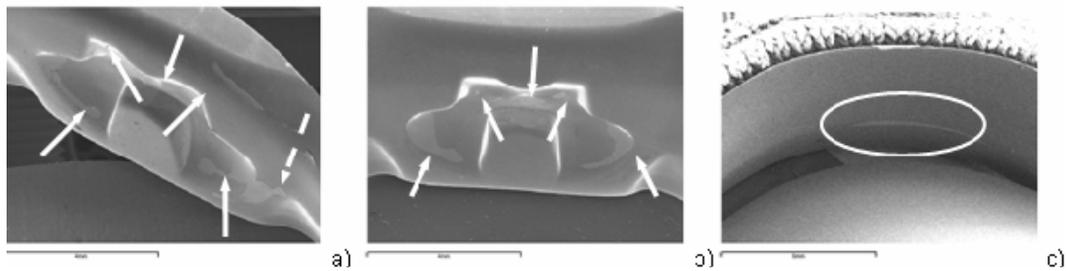
Figure 8 – Detachments of the PyC coating in the two hinges (in and out, a, b respectively) and in the housing (c).

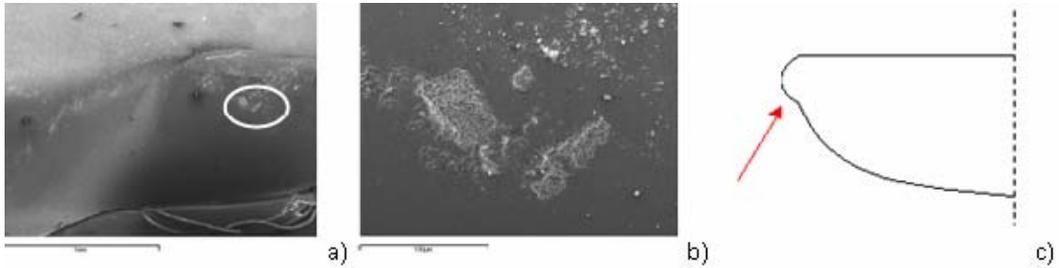
Figure 9 – Porosity of the pivots surface (a), same surface at higher magnification, the porosity is more evident (b), position on the leaflet (c).

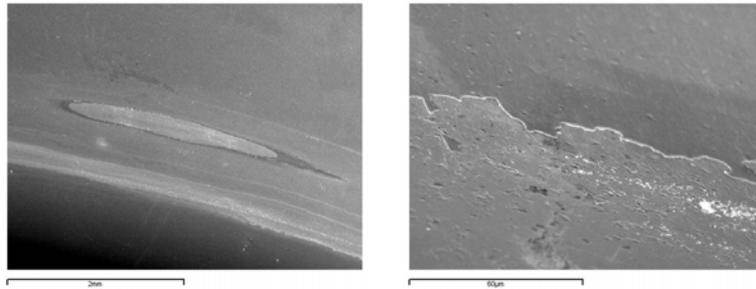
The Sorin valve prosthesis was designed to promote a low thrombogenicity caused by the improvement in fluid dynamics and an innovative mechanism for the cinematic coupling between the housing and the two leaflets. The design of leaflets and hinges allows to have only a rolling movement, decreasing wear and friction. *In vitro* fatigue tests demonstrated the absence of structural failure after 400 million of cycles (corresponding to 11 years *in vivo* functioning) and allowed to observe the distribution of worn surface in the hinges [9]. A study by Hasenkam et al. [10] demonstrated that the more evident wear marks are present on the surface of the pivots in the inlet side. The effects of wear on the housing were also analyzed, evidencing the presence of delamination of the PyC coating most of all in the inner zone of the hinges [10]. All the Sorin prosthesis considered in this work exhibited scratches due to abrasive and impact wear phenomena, in accordance with the *in vitro* and *in vivo* studies [9,10]. In particular, on valve #7, implanted for 8 years, wear scratches were observed (Figure 8, and Figure 9), accordingly with the ones found by Hasenkam et al. [10]. The other Sorin valves, implanted for 11-18 months, showed wear pattern less evident as demonstrated also by Grigioni et al. [9]. For valve #27 (implanted for 18 months) evident scratches due to wear phenomenon were detected, probably due to defects in the surface finishing process (Figure 10).

Figure 10 – Scratches and PyC coating detachment correlated to defects in the surface finishing process

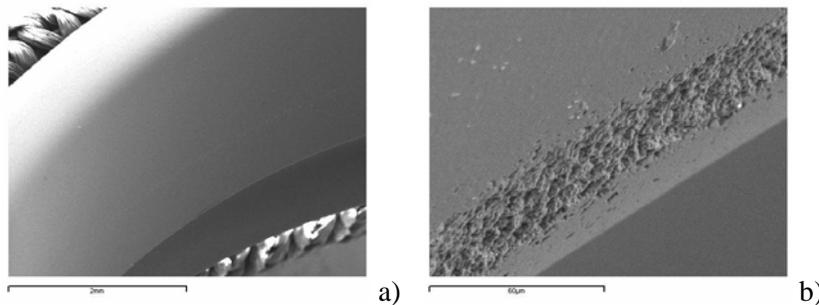
The analyzed valve, implanted for 15 years, showed a slight wear; the pivots, for example, did not exhibit any scratch. The only impact wear evidence is located in the groove that lock the leaflet during its closure (Figure 11). This cycle step is the one more critical for the material resistance; in fact the most worn zones in the inner part of the hinges are the ones in which the pivots hit when the valve is closed.

Figure 11 – Scratch due to impact wear in the housing (a), and porous surface of the scratch
