# DESIGN RELATED FAILURE OF THERMOWELLS IN FEED GAS SUPPLY DOWNSTREAM PIPELINE

*A. El-Batahgy<sup>1</sup>, G. Fathy<sup>2</sup>, M. Amin<sup>1</sup>*

*<sup>1</sup>Central Metallurgical R & D Institute, Cairo, Egypt; <sup>2</sup>Natural Gas Production Company, Cairo, Egypt*

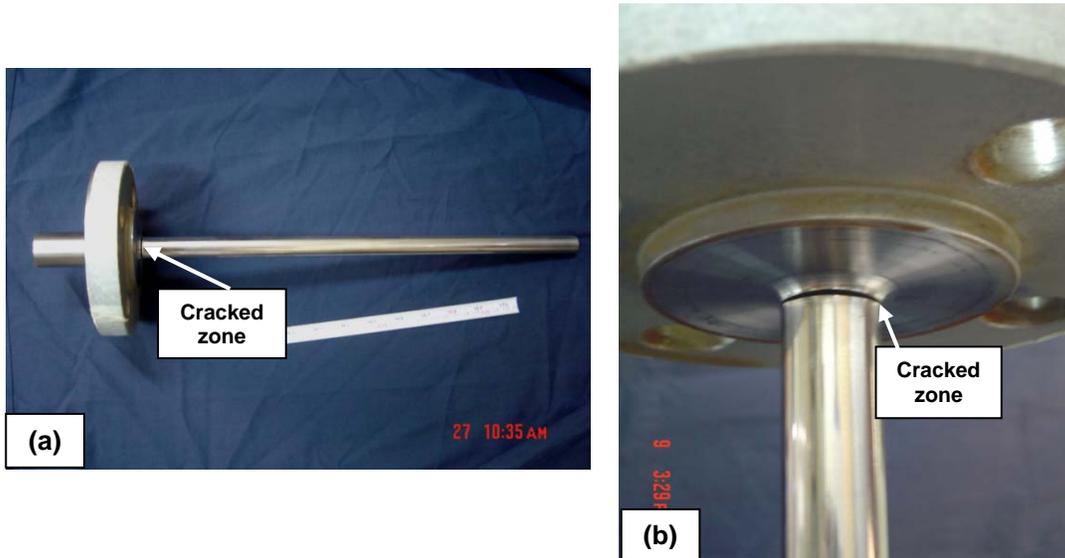
Failed thermowells were subjected to different non-destructive and destructive tests including visual investigation, dimensions measurement, liquid penetrant test, stereoscopic examination, chemical analysis, optical and scanning electron microscopic examinations, and hardness measurements. General and enlarged views of one of several failed thermowells are shown in Fig. 1. One important notice is that thermowell was circumferentially cracked at the neck of tube with flange. It can be noticed that the outer surface of the failed thermowell is clean and free from deposits or indications for corrosion. Dye penetrant inspection indicated no surface cracks either around or away from fractured zone of thermowells.

Fig. 1. General (a) and enlarged (b) views of one of several racked thermowells. Note that crack had occurred at the neck between flange and tube.

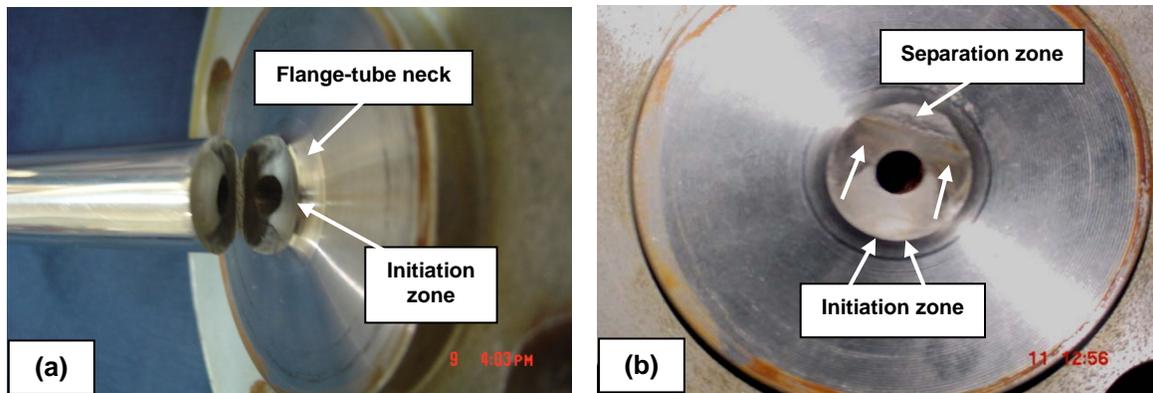
Enlarged views of cracked thermowell during and after separation of the remainder of its circumference are shown in Fig. 2. Crack initiation zone is highlighted with arrows. Visual examination showed that thermowell had cracked along neck between flange and tube. The crack extended more than half way around the circumference of the neck. The remainder of the circumference had been separated gradually with hand. It was not clear whether the crack originally extended more than half way around the circumference, or whether it had been shorter but part of it was extended by mishandling of thermowell during or after removing it from its location on pipeline. However, it is clear that crack was started at outer surface of thermowell neck which is considered as stress concentration zone.

Fig. 2. Enlarged views of cracked thermowell during (a) and after (b) separation of the remainder of its circumference. Crack initiation zone is highlighted with arrows.

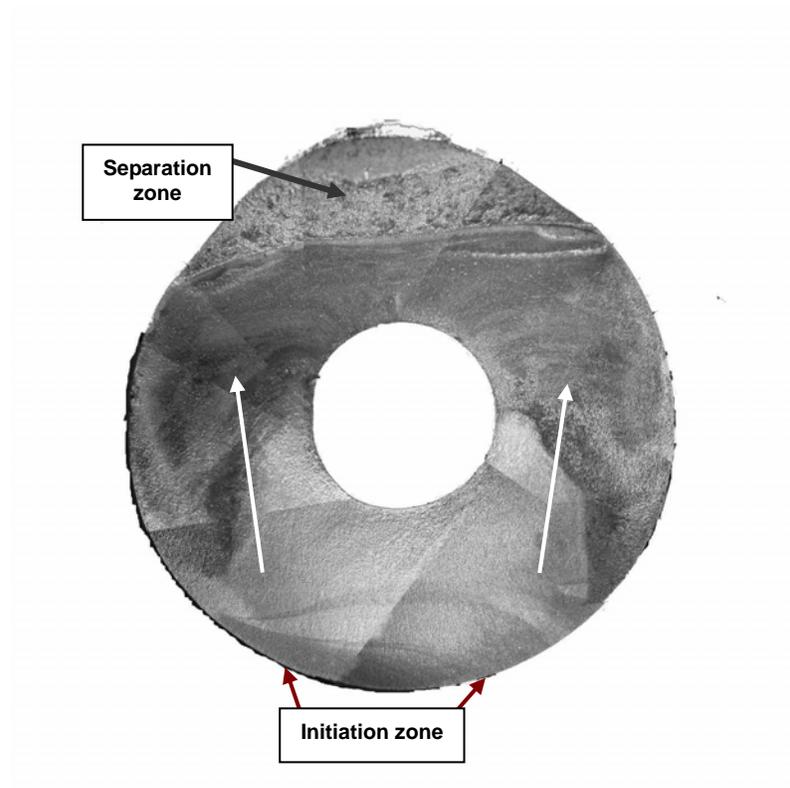
Stereoscopic photograph of fractured or cracked surface of thermowell is shown in Fig. 3. It is obvious that fracture was initiated at outer surface of thermowell tube' neck where smooth fracture surface can be seen. Approximately 80% of the fracture surface appeared relatively smooth and associated with beach marks of a propagating ductile crack. The remaining 20% of the surface had a rough texture associated with the final brittle fracture of the thermowell. Beach marks, crack initiation sites on outer surface and propagation directions are highlighted with arrows.

Whenever there is an interruption in the propagation of a fatigue fracture a unique feature of macroscopically visible marks or ridges may be found. These marks are described as “beachmarks” or “growth rings”. Figure 3 shows an example of beachmarks in the subject fatigue failure. Beachmarks must not be confused with striations, although they frequently are present on the same fracture surface; there may be many thousands of microscopic striations between each pair of macroscopic beachmarks. As the propagation of the fatigue crack continues, gradually reducing the cross-sectional area, it eventually weakens the material so greatly that final, complete fracture occurs [7, 8].

Fig. 3. Stereoscopic photograph of fractured or cracked surface of thermowell. Beach marks, crack initiation zone and fracture propagation direction are highlighted with arrows.

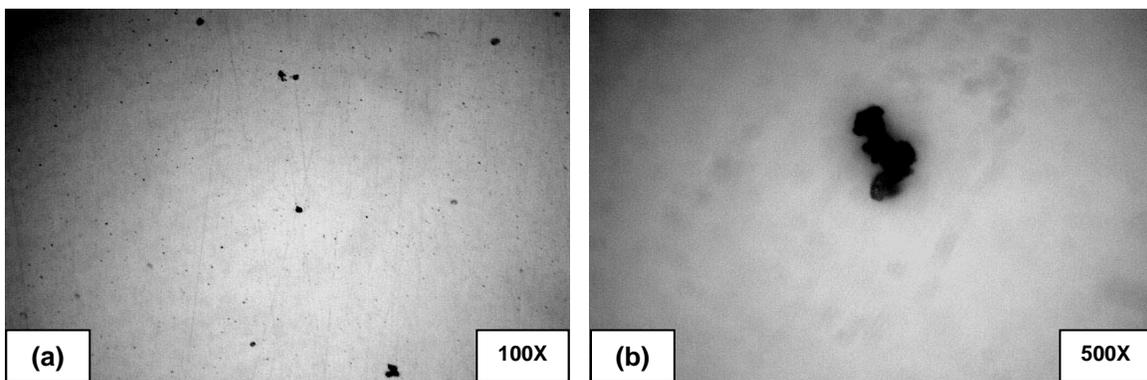
Optical micrographs with different magnifications of as-polished cross section taken from fractured zone (thermowell neck) are shown in Fig. 4 while those of as-polished cross section taken away from fractured zone are shown in Fig. 5. The most important notice is the existence of second phase in the austenitic matrix of failed thermowells.

Fig. 4. As-polished optical micrographs of a cross section from fractured zone (thermowell neck).

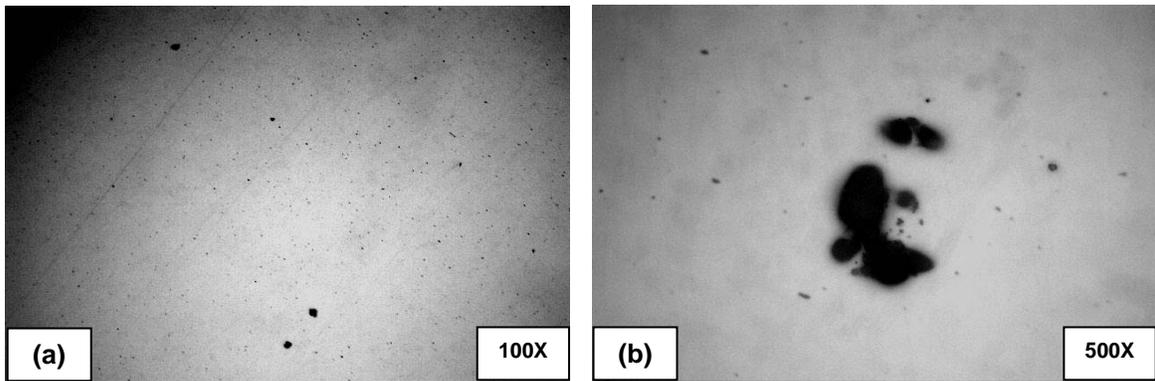
Fig. 5. As-polished optical micrographs of a cross section taken away from fractured zone.

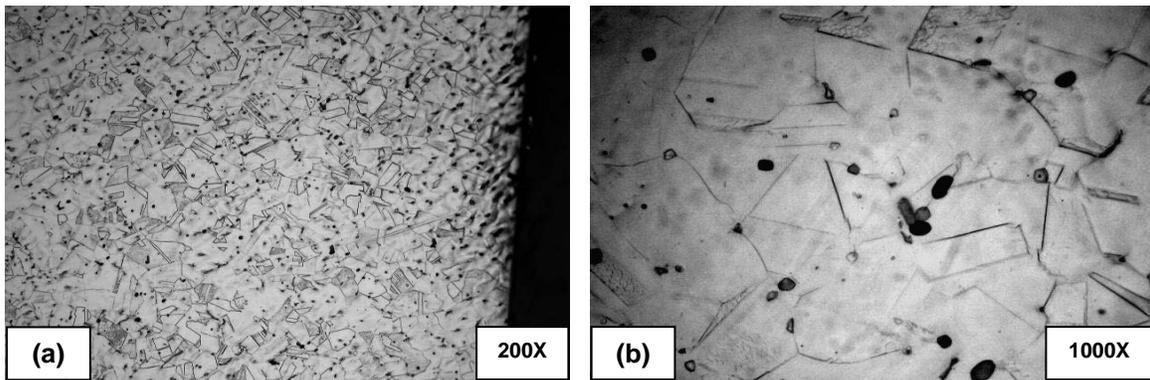
Optical micrographs of etched cross section, taken from fractured zone (thermowell neck) are shown in Fig. 6 while those of etched cross section taken away from fractured zone are shown in Fig. 7. For both cross sections, no microcracks were found. Similar microstructure was obtained for both specimens taken close to and away from fractured zone. No microstructural difference was obtained between outer surface, through thickness and inner surface of investigated specimens. All specimens showed austenitic microstructure with second phase precipitates within matrix.

Fig. 6. Etched optical micrographs of a cross section taken from fractured zone (thermowell neck).

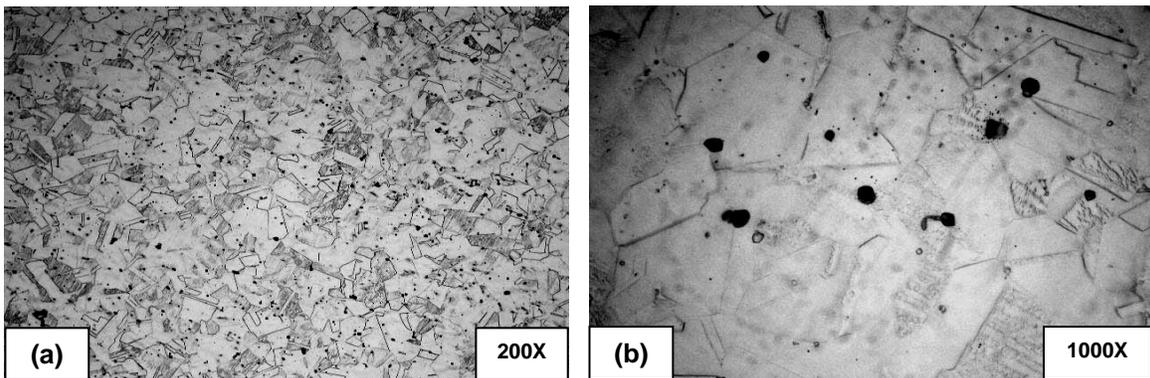
Fig. 7. Etched optical micrographs of a cross section taken away from fractured zone.

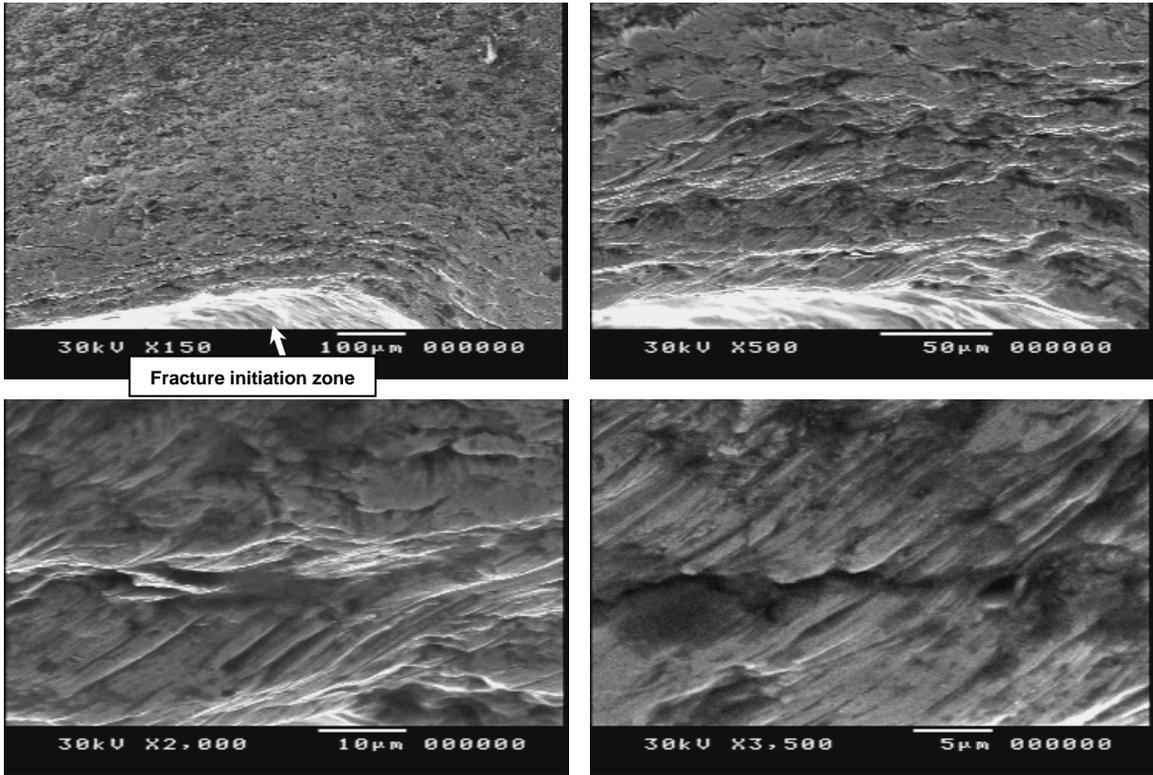
In order to help in identification of failure mechanism, cracked or fractured surface including suspected initiation zone was investigated using scanning electron microscope. It is confirmed that initiation sites are confined to thermowell tube outer surface just at thermowell neck where stress concentration sites were existed. Scanning electron micrographs with different magnifications of fracture suspected initiation sites at neck outer surface are shown in Fig. 8 while those of fracture surface away from initiation zone are shown in Fig. 9.

Crack initiation sites can be seen on outer surface of thermowell neck where a single macroscopic direction of crack propagation is impossible to be defined. This is because crack size is still in the microcrack zone, where multiple cracks form at the surface, initiating at different locations and with different orientations (Fig. 8). The important notice is the fatigue striations at fracture initiation zone on neck outer surface. On the other hand, brittle fracture was observed away from fracture initiation zone or neck inner surface as shown in Fig. 9.

Fig. 8. Scanning electron microscopic photographs of fracture suspected initiation zone at neck outer surface showing fatigue striations.

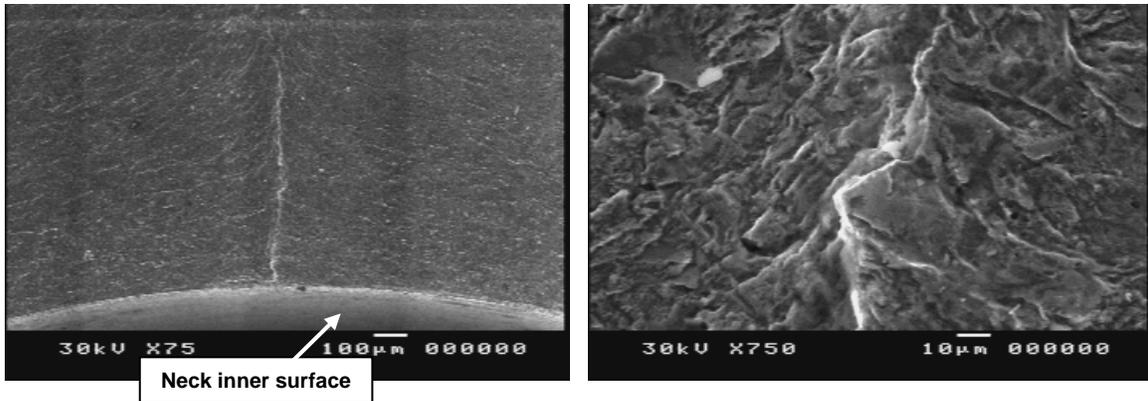
Fig. 9. Scanning electron microscopic photographs of fracture termination zone (neck inner surface), showing brittle fracture.
