Examination of Fatigue Crack Origins in Aircraft Turbine Blades Using Serial Sectioning Techniques

Sylvie Dionne¹, Tim Lang¹, Jian Li²

¹*Transportation Safety Board of Canada, Ottawa, Canada;* ²*CANMET-Materials Technology Laboratory, Ottawa, Canada*

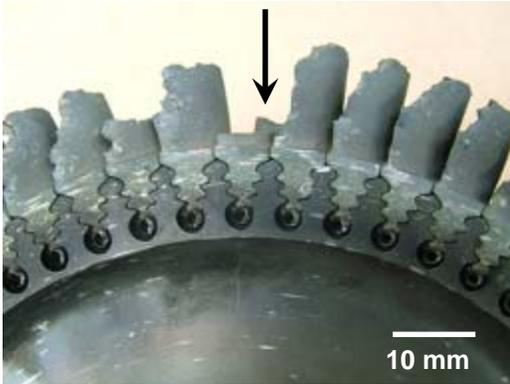
A compressor turbine (CT) failure was identified as the primary cause of the in-flight failure of an aircraft engine. Visual examination of the CT wheel determined that all of the blades had fractured in an instantaneous overstress mode of failure except for one blade which showed a progressive mode of failure. This CT blade had fractured close to the platform (Figure 1). The trailing portion of the subject blade fracture face exhibited a flat faceted topography consistent with fatigue failure (Figure 2) while coarse fibrous features consistent with overstress (Figure 3) were observed in the leading portion. The subject blade was examined in a scanning electron microscope (SEM) using a quadrant type semiconductor back scattered electron (BSE) detector operated in the topographical mode. Based on the orientation of fatigue beach marks observed on the BSE images, it was determined that fatigue cracking initiated near the trailing edge (Figure 2) and progressed towards the leading edge in a high cycle mode until the blade eventually separated by overstress extension of the high cycle fatigue cracking.

Figure 1: Photograph showing the subject CT blade in-situ (arrowed, trailing edge view).

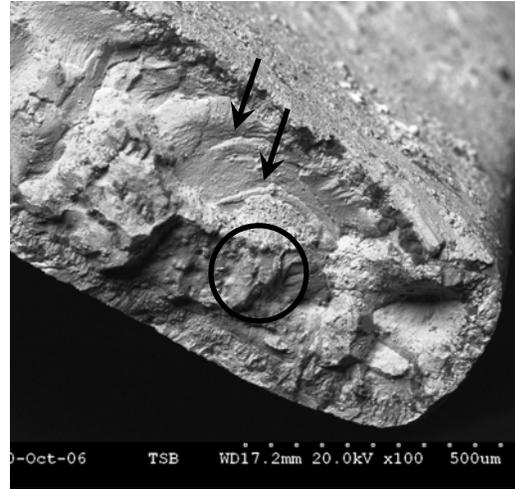
Figure 2: BSE image of the trailing portion of the CT blade fracture face showing beach marks (arrows) and the suspected fatigue crack origin (circled).

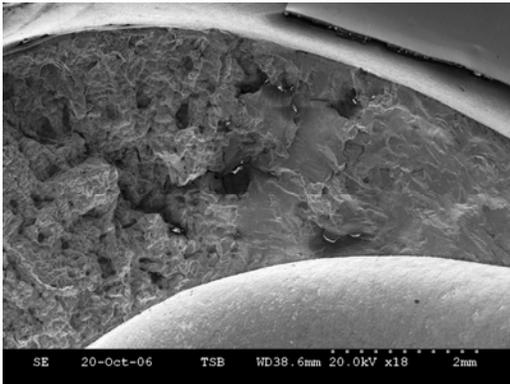
Figure 3: SEM image of the CT blade fracture face showing the transition from fatigue (left) to overstress (right) regions.

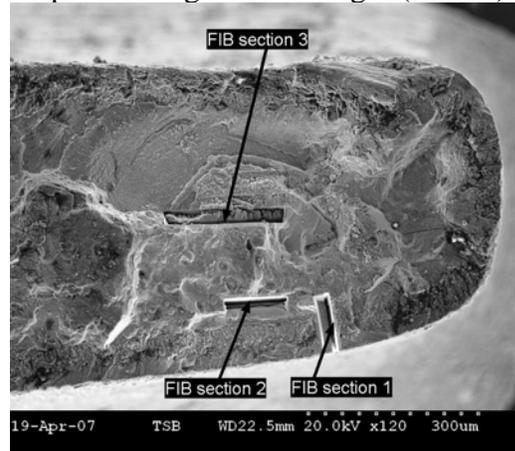
FIB cross-sections were prepared from the subject CT blade to determine if any metallurgical anomalies were associated with the suspected fatigue origin. Figure 4 shows the location of three FIB sections prepared in the trailing portion of the CT blade. The first FIB section was made to examine the bond between the coating and blade parent material on the pressure side of the blade near the trailing edge (Figure 5). The FIB section showed a few small pores at the interfaces between the aluminide layer, diffusion zone and blade parent material. These pores were considered to be typical of diffusion-processed coatings. No evidence of cracking or coating failure was observed. A narrow band of

Figure 4: SEM image of the trailing portion of the CT blade fracture face showing the three FIB sections.

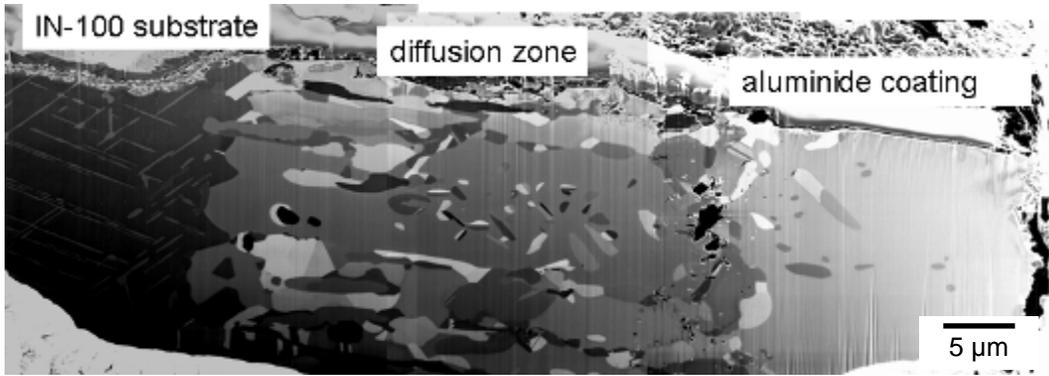
topologically closed-packed (TCP) phases was observed in the blade material adjacent to the diffusion zone. It was determined that the band of TCP phases was a normal feature of CT blades subjected to a similar time in service.

Figure 5: Montage of FIB images of FIB section 1 showing the coating, diffusion zone and blade material in the vicinity of the suspected fatigue crack origin.

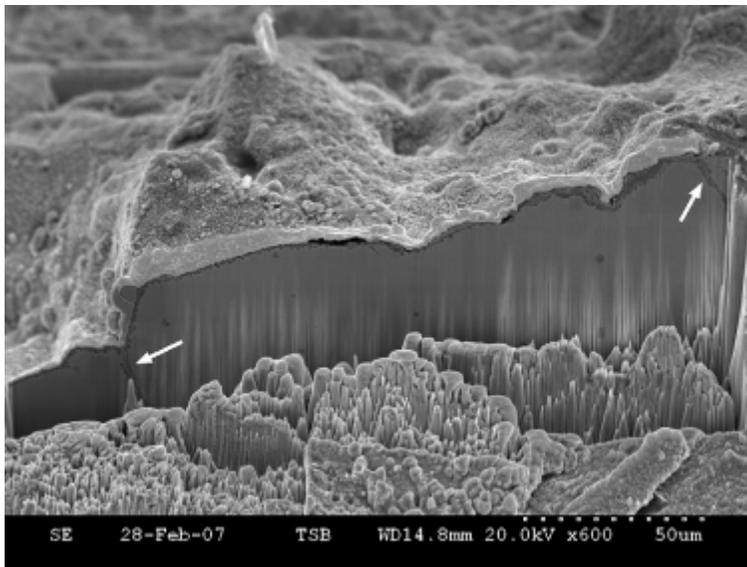
The second and third FIB sections were taken across a region with a rounded dendrite-like appearance on the fracture face (Figure 4). These FIB sections revealed the presence of seams extending into the blade material below the fracture face (Figure 6). The seams had a complex structure consisting of multiple layers and particles (Figure 7). Energy dispersive spectroscopy (EDS) analysis showed that the seams were oxygen-rich (Figure 8). These observations suggested that there was an anomaly with similar characteristics to those of an internal casting pore at the origin of the fatigue crack on the subject CT blade.

Figure 6: SEM image of FIB section 3 showing seams (arrowed).

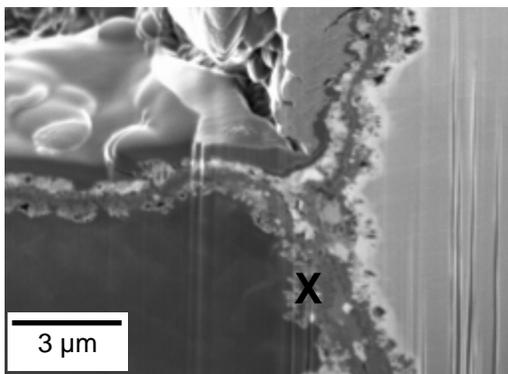
Figure 7: FIB image showing the left seam arrowed on Figure 6.

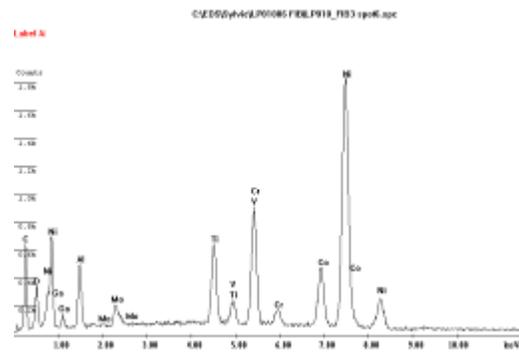
Figure 8: EDS spectrum obtained from the location marked on Figure 7.

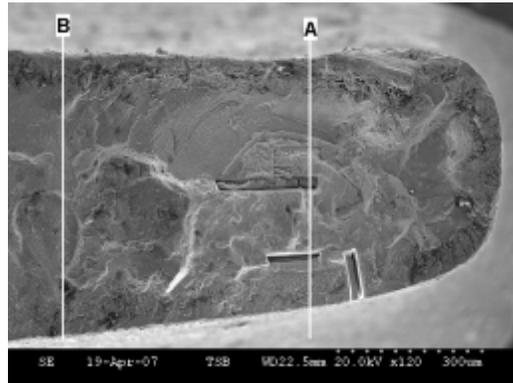
Conventional metallurgical sections were prepared from the subject blade to determine the size of the region affected by the seam defects. The blade was mounted in transparent cold setting epoxy and sectioned using a tool capable of controlled material removal in increments of 20 microns (Figure 9). Section polishing was accomplished using conventional metallographic preparation techniques. In total, twenty-five polishing steps were completed to document the microstructure in the trailing portion of the blade. The location of each plane of polish was determined using features on the fracture profile and the FIB sections as reference points. Figure 10 shows the position of the plane of polish after the 8th (line A, 400 μm from the blade trailing edge) and 23rd (line B, 910 μm from the blade trailing edge) polishing steps, respectively.

Figure 10: SEM image of the trailing portion of the subject CT blade showing the location of two metallurgical sections (lines A and B).

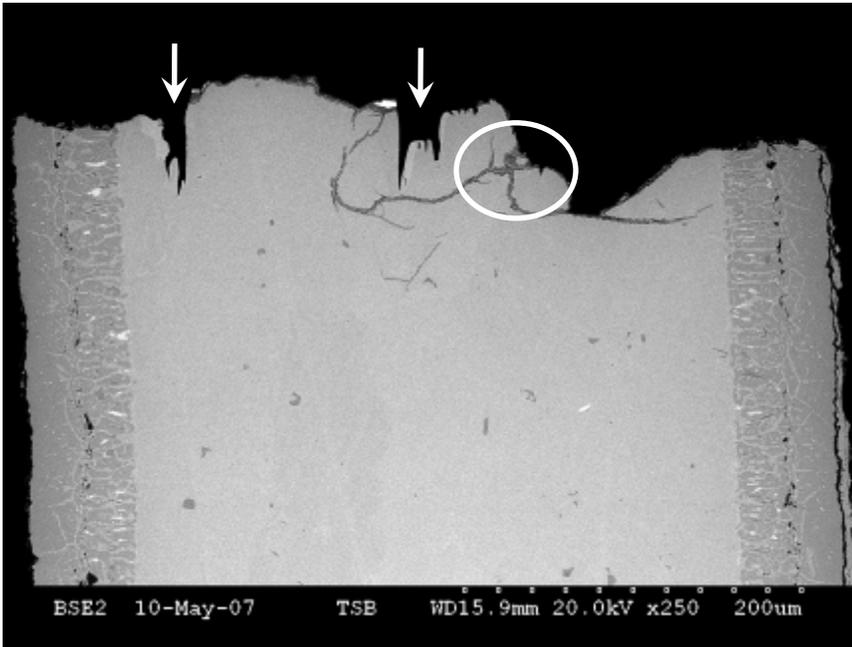
Polishing steps one through seven revealed a typical cast superalloy microstructure with a well defined gamma prime phase. The uniform distribution of the gamma prime phase indicated that the blade had not been exposed to excessively high temperatures. Semi-quantitative standard less EDS analysis showed that the blade material was in agreement with the compositional requirements for the major elements of the cast IN-100 alloy specified for the blade. At the 8th polishing step, a large cluster of seams was observed adjacent to the fracture face (Figure 11). EDS elemental mapping showed that the center of the seam defects was nickel-rich while the outer layers contained oxygen, aluminum, titanium and chromium (Figure 12). Polishing steps nine through twenty-four showed that the seams formed a continuous network. In several locations the fracture face was coincident with a seam, suggesting that the blade had separated at the seam. Secondary cracks and small pores associated with the seams were also observed (Figure 13). The seams had essentially disappeared by the 25th polishing step, corresponding to a location approximately 2 mm from the trailing edge. The size of the seam cluster was estimated at approximately 1 mm in overall length, coincident with the fatigue cracking origin observed on the fracture face.

Figure 11: SEM image of a cross-section of the subject CT blade after the 8th polishing step (refer to line A on Figure 10). Arrows point to the location of FIB sections 2 (left) and 3 (right).

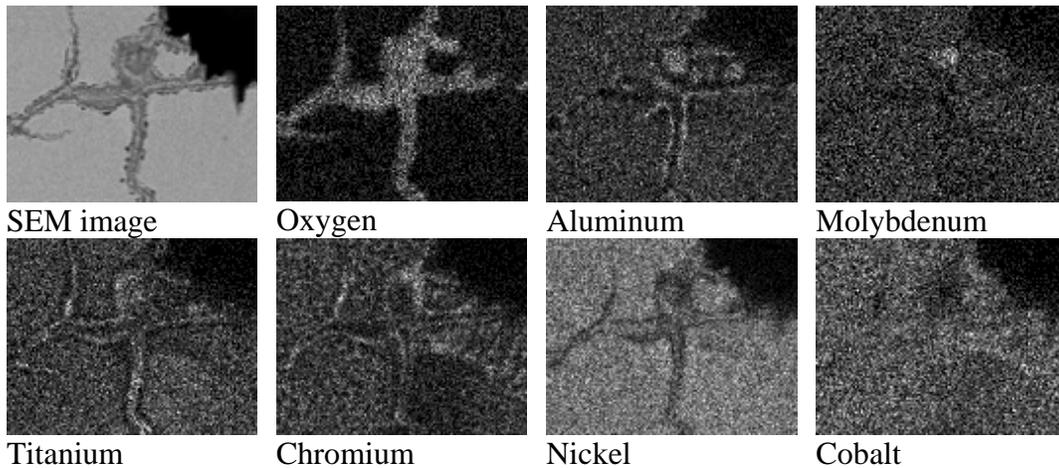
Figure 12: SEM image and associated EDS elemental maps showing the distribution of elements in a cluster of seam defects (refer to the area circled on Figure 11).

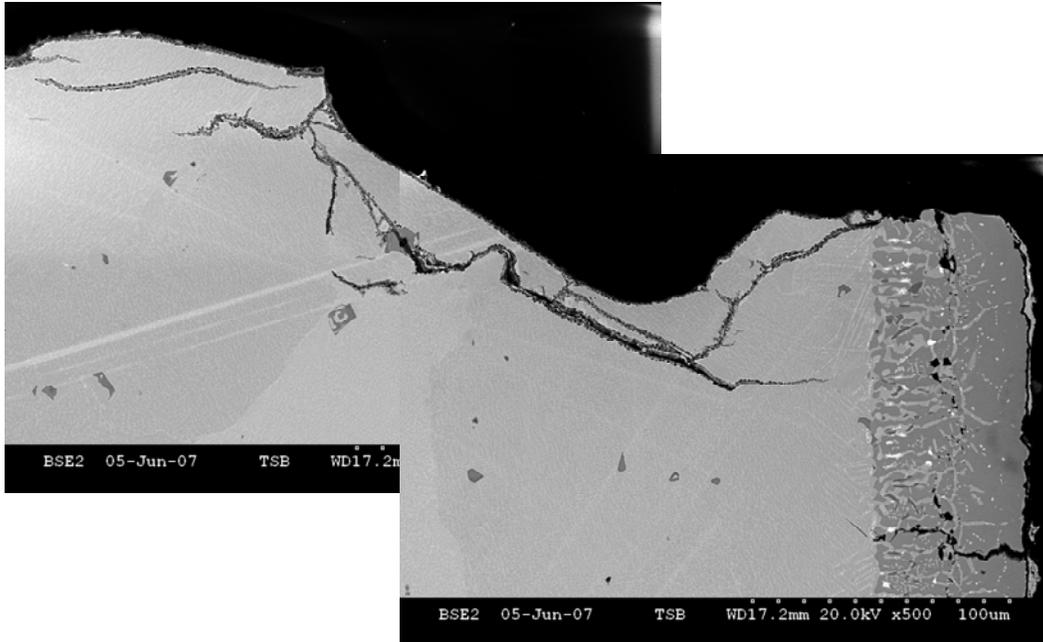
Figure 13: Montage of SEM images of a cross-section of the subject CT blade after the 23rd polishing step (refer to line B on Figure 10) showing seam defects associated with the fracture face and internal cracks.

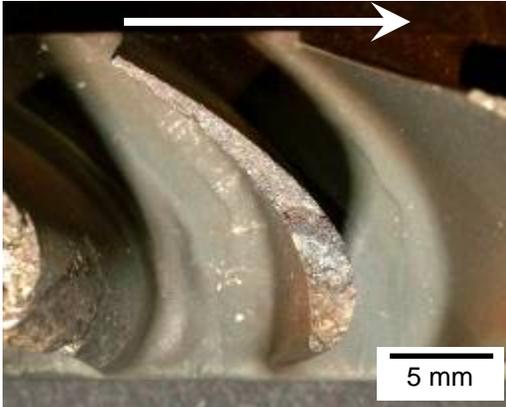
The examination of a helicopter engine that had sustained an in-flight loss of power showed that three blades had separated from the third stage turbine wheel. One blade had separated at mid-span and contained a region of flat faceted fracture consistent with a progressive mode of failure (Figure 14). The region of progressive failure was tarnished, indicating that the crack had been exposed to the environment for some time before blade separation. The two other blades had separated a few millimeters from the shroud and their fracture faces had a fibrous appearance typically associated with failure due to overstress. Rub damage was observed on the seal and shroud opposite the separated blades consistent with unbalanced operation of the wheel resulting from blade separation.

Figure 14: Photograph showing the subject third stage turbine blade. An arrow indicates the direction of rotation.

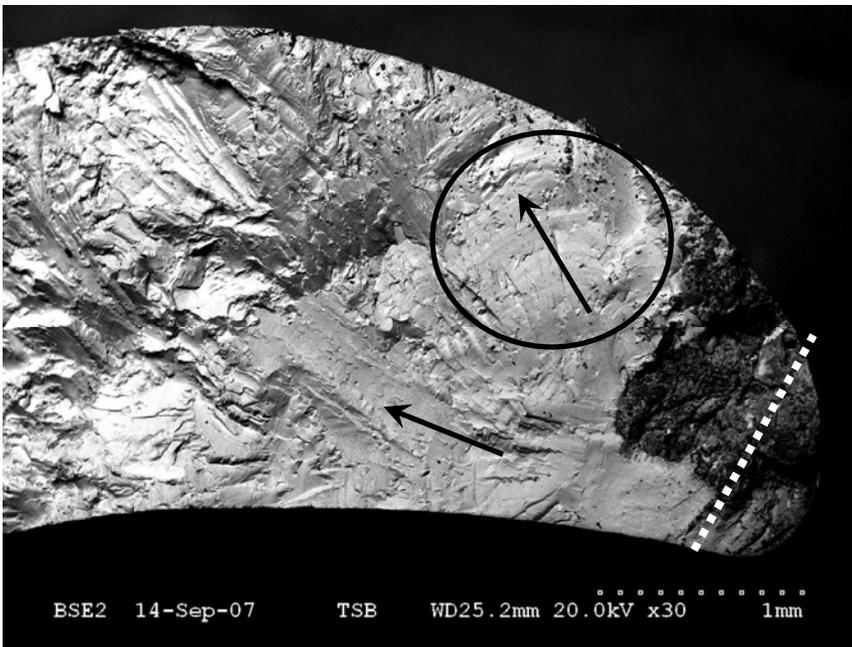
Figure 15 is a BSE image of the progressive failure region on the subject third stage turbine blade. Based on the direction of local crack propagation deduced from the orientation of the beach marks, the origin of the fatigue crack was a region with a dark contrast at the leading edge of the blade. Fatigue striations were faintly visible at higher magnification but oxidation of the fracture face precluded the determination of striation spacing. The suspected fatigue crack origin had a granular texture and contained several secondary cracks. EDS elemental mapping revealed the presence of oxygen, magnesium, aluminum and silicon enrichments in varying concentrations throughout the region of fatigue crack initiation.

Figure 15: BSE image of the progressive failure region on the subject third stage turbine blade. A region containing beach marks is circled.

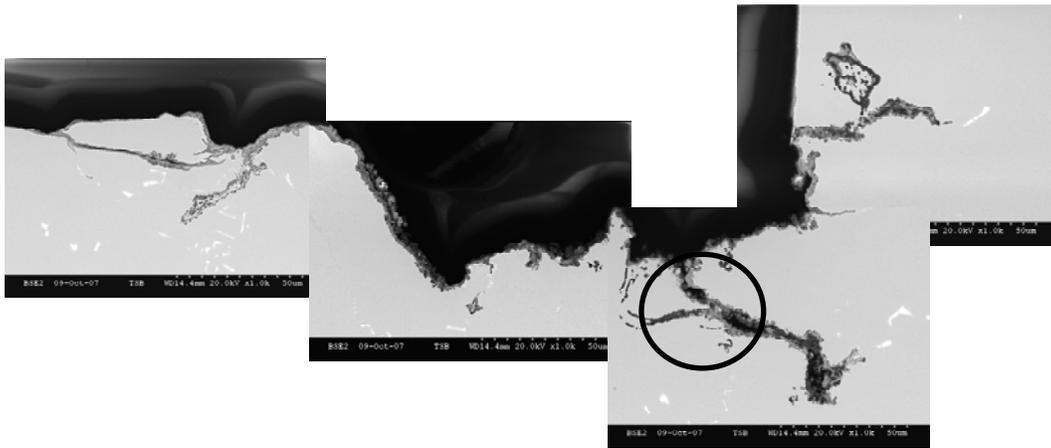
A metallographic cross-section was prepared from the subject third stage turbine blade using the serial sectioning technique described previously to determine the depth of the fatigue crack origin in the axial direction. The location of the plane of polish is indicated by a dashed line on Figure 15. Figure 16 is a montage of BSE images showing that the fatigue crack origin was composed of a network of small pores and seams with a darker contrast than the blade material. These seams were present at the fracture face and along secondary cracks. The secondary cracks and seams extended approximately 50 microns below the fracture face. The films adjacent to a secondary crack were enriched with oxygen, magnesium, aluminum, titanium and chromium in comparison with the blade parent material (Figure 17). Silicon and potassium were also detected in some particles within these films. Semi-quantitative EDS analysis showed that

The appearance and composition of the seams observed at the fatigue crack origin was consistent with a casting-related anomaly. This type of anomaly is observed when impurities (slag) from the top of the molten metal pool in the crucible are carried over into the mold during casting of the blade. Overall, the anomaly covered approximately 1 square millimeter of the fracture face at the leading edge. The microstructure of a comparison blade did not show any evidence of microstructure changes resulting from exposure to excessive temperature. No casting-related anomalies were detected in the comparison blade.

Figure 16: Montage of BSE images showing the central portion of the fracture profile on a metallographic cross-section through the leading portion of the third stage turbine blade (refer to the dashed line on Figure 15).

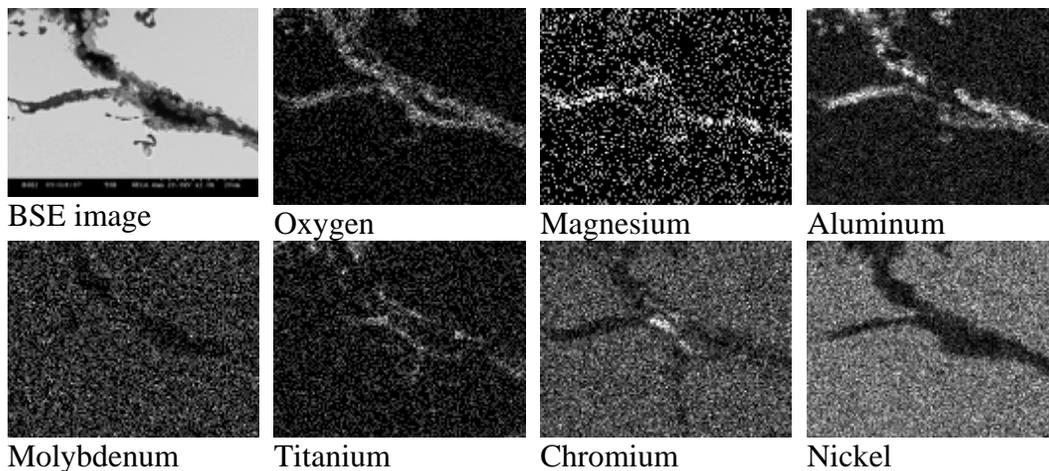
Figure 17: BSE image and associated EDS elemental maps showing the distribution of elements around a secondary crack in the subject third stage turbine blade (refer to the circled area on Figure 16).
