# Failure Investigations of Cracked Spherical Bearings in Aircraft

X.Wu, A.Bourgeois  
*Bombardier Inc., Montreal, Canada*

During aircraft overhaul, six spherical bearings were found cracked in bearing balls made of 440C stainless steel. The cracked bearings were used for different aircraft joints and came from different suppliers. Investigations revealed that all the cracks originated from the ball surface and extended in the axial direction of the bearing. Intergranular fracture was the common characteristic found in most of the cracked balls.

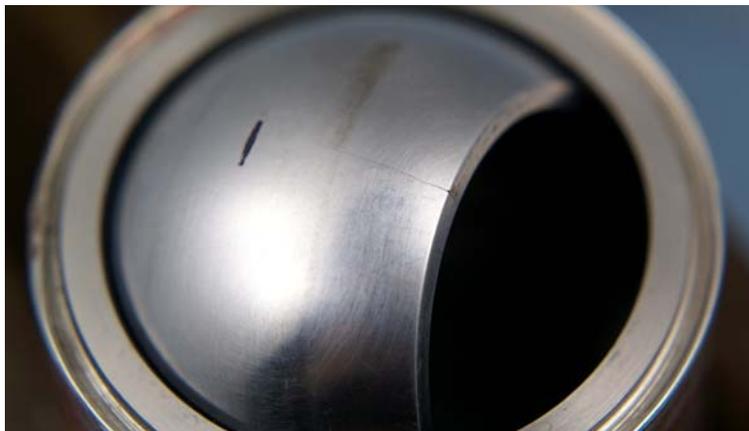
All six bearings were cracked through the ball thickness in the axial direction. The crack length varied from one quarter to nearly half of the ball width in cases of partial cracking (Fig. 2). Multiple cracks that appeared to be random on the side faces were found in the Ball E and the Ball F.

Fig. 2. The partially cracked Ball D

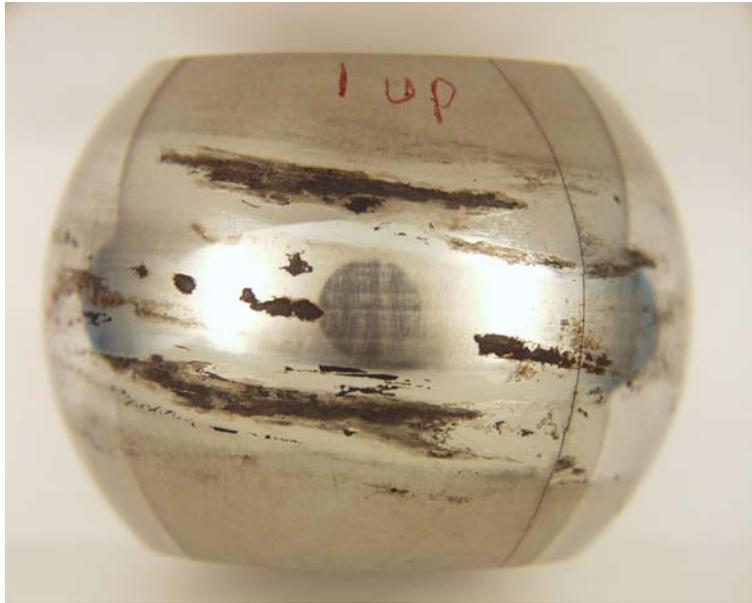
Some of the cracks on the flat faces could be easily located by unaided eyes, while others could only be found under microscope at magnifications above 10×. Cracking and chipping in Cr plating caused by the contact stress were observed on the side faces. The Ball A was lubricated by grease and was seized when the crack was discovered. After the ball was released from the race, two burnished bands with the patches of dried grease and surface degradations were revealed on the spherical surface (Fig. 3). These evidences suggested that the insufficient lubrication led to the seizure.

Fig. 3. The burnished bands with dried grease and surface degradation on Ball A

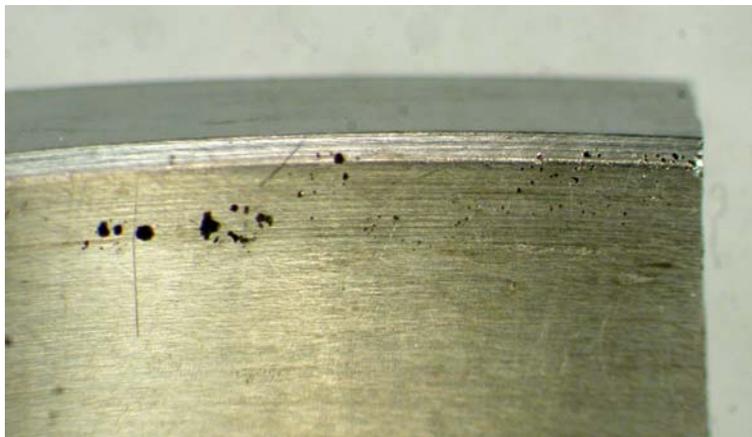
Fig. 4. The pitted area on the bore surface of the Ball B, next to the vertical crack

the Ball A also contained a frosted area with discernable pits next to the crack. In the Balls B and C, pits of different sizes appeared on the side faces, on the bore surface and on the inner chamfer (Fig. 4).

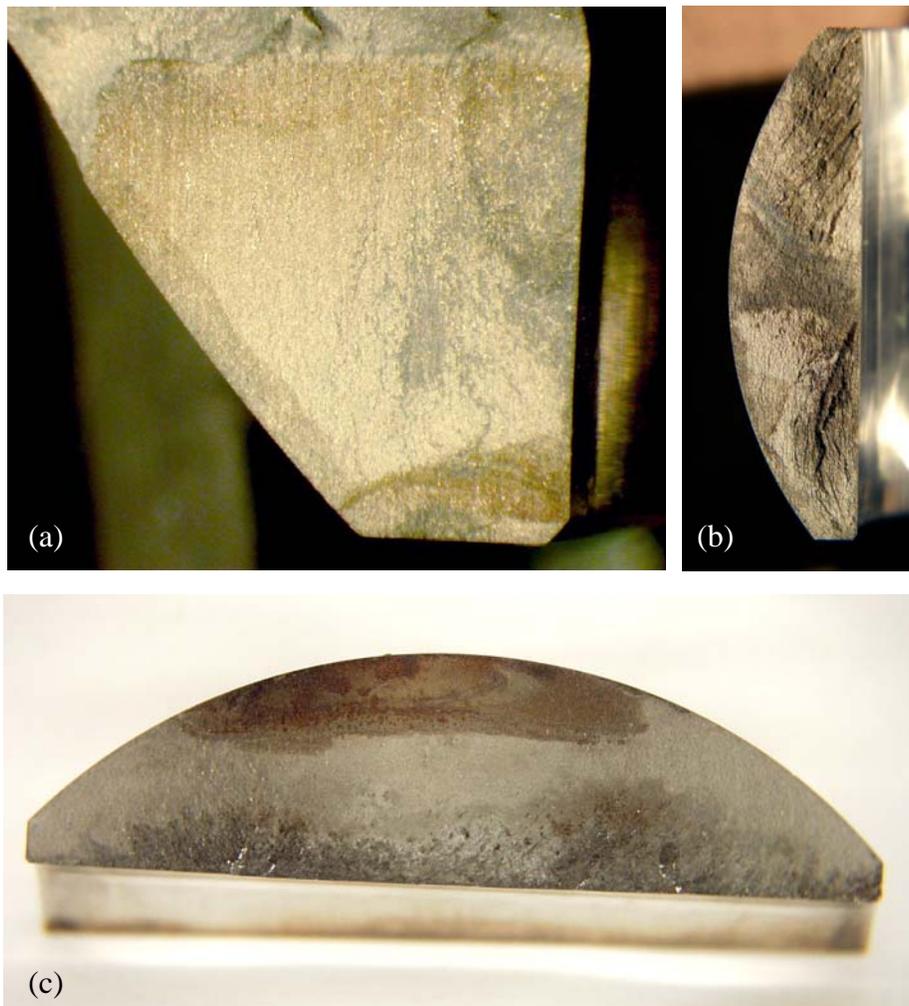
As shown in Fig. 5, several stains surrounding the initiation revealed curved intermittent crack fronts during propagation. This is the evidence that the crack propagation was time dependent. Energy dispersive spectroscopy (EDS) analysis later determined that the stains consisted of mainly wear debris entering the crack during the propagation.

Fig. 5. Three opened crack surfaces: (a) One of the cracks in the Ball E, (b) The crack surface of the Ball B, and (c) The crack surface of the Ball A

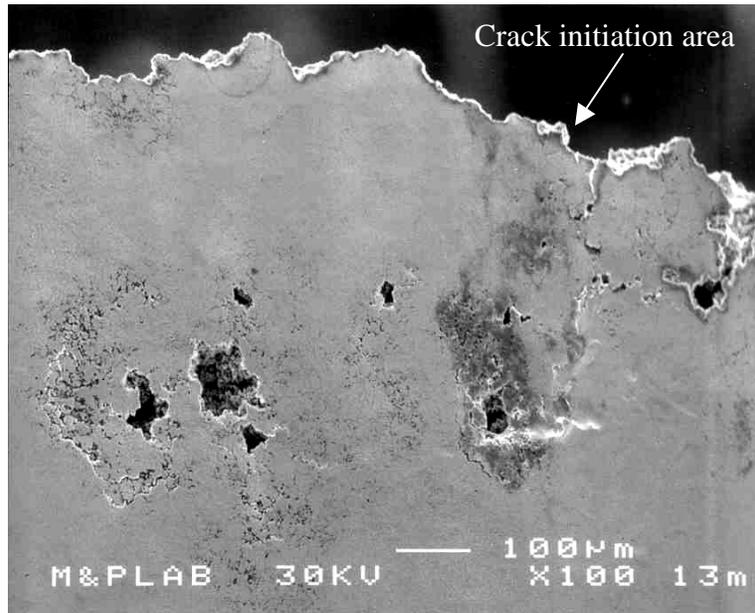
Phenomenon of pitting was found in the vicinity of the crack initiations in three balls. The frosted surface next to the crack initiation in the Ball A presented several pits below the serrated crack (Fig. 6). The formation of such pits was caused by local contact stress that exposed hard carbides and sunk the surface layer after a subsurface crack nucleated (Fig. 7). Two curved cracks had formed on the left side of the pits (Fig. 6) pointing towards the sliding direction of the ball, which is typical for cracks initiated by cyclic contact stress. In the Ball B and the Ball C, cracks initiated by contact fatigue pits were identified on the inner

Fig. 6. The pitted area on the spherical surface of the Ball A

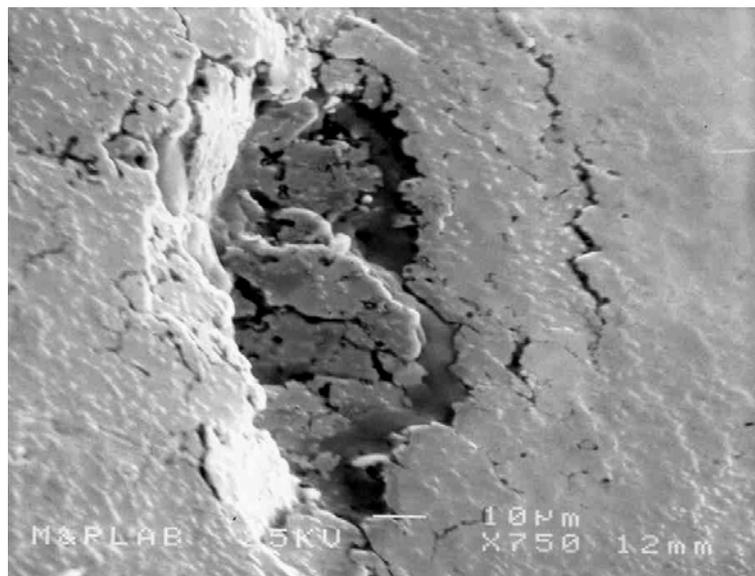
Fig. 7. A sunken pit on the spherical surface of the Ball A

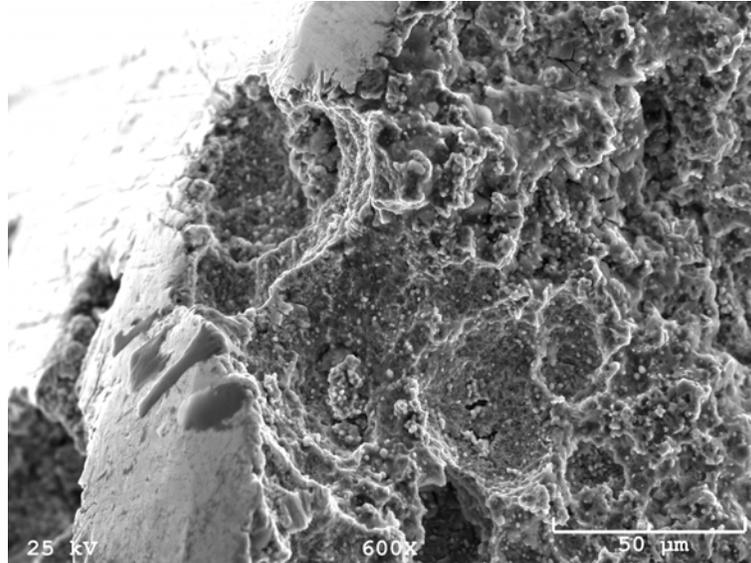
It is believed that the seizure resulted in the cyclic stress on the Ball A. The seized ball was stationary to the race except for small vibration that led to the pitting and finally cracking. The Ball B and the Ball C appear to be subject to axial deflection. This postulate is based on the facts that pitted areas (Fig. 4) were opposite to each other near the inner chamfer, and high cyclic stress introduced microstructural alternations on the inner chamfer opposite to the cracks.

Fig. 8. The crack in the Ball B initiated from several pits on the chamfer. The characteristics of contact fatigue propagation were found in the pits.

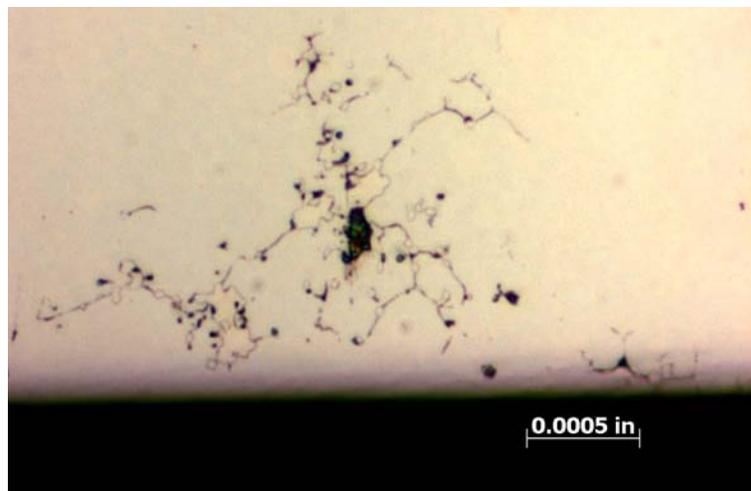
Metallographic samples were taken from areas where the surface degradations were obvious. The samples were prepared following conventional metallographic procedure with the polished surface perpendicular to the thickness of the ball. The polished cross sections revealed the pitting development under contact fatigue stress (Fig. 9). The subsurface cavities were created first at the stress raisers such

as the large carbides, then microcracks spread along small carbides possibly under the influence of the environment.

Figure 9. A subsurface cavity and microcracks along grain boundaries in Ball A

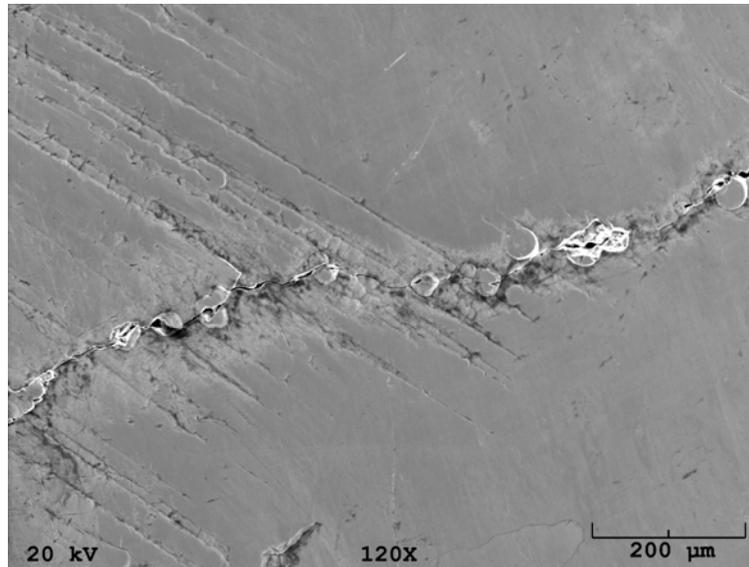
Plating defects were found on the Cr plated Balls D and F. In the Ball F, protruded Cr nodules and gas pits were observed on the unworn spherical surface. On the side faces the nodules were worn to flat and often cracked under stress due to the brittle nature of Cr plating. The microcracks in the nodules not only raised local stress but also broke the surface protection, permitting EAC to occur. That is why the randomly located cracks tended to follow the flattened Cr nodules on the side face (Fig. 10).

Fig. 10. One of the cracks on the side face of the Ball F

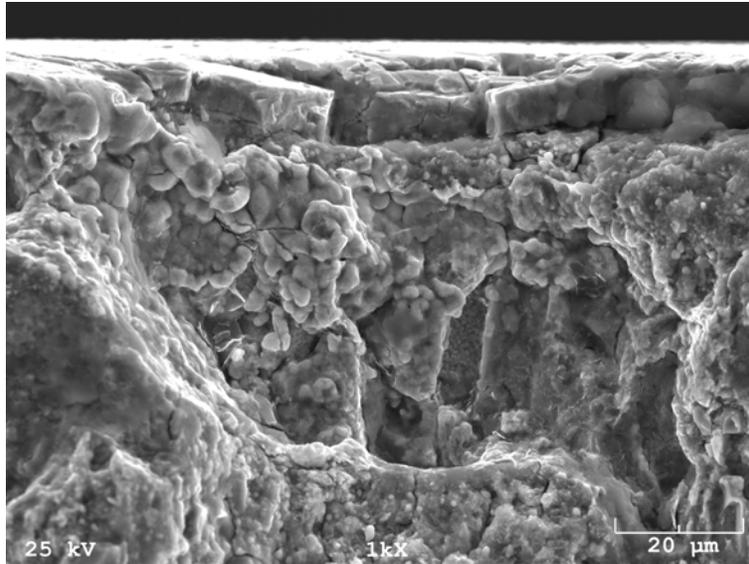
SEM examination of the crack surface on the Ball D revealed a globular feature in several isolated locations along the side face (Fig. 11). EDS analysis confirmed that this feature was part of the Cr plating penetrating much deeper than the thickness specified by the plating process. The globular appearance was the original Cr deposit growing in surface defects.

Fig. 11. The globular Cr deposit below broken Cr layer on the fracture of Ball D

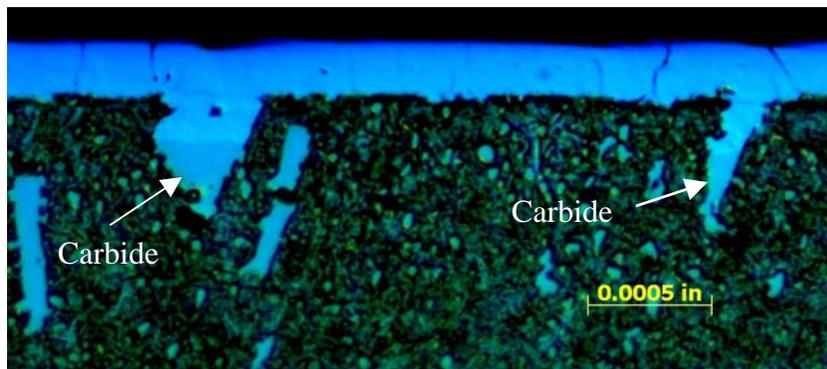
The polished metallographic sample also showed deep Cr penetration beyond the normal thickness in the Ball D. Further etching of this sample increased the colour contrast among different phases, revealing that many irregularities in Cr layer connecting to large carbides (Fig. 12). The Cr layer did not perfectly levelled above the carbides. This phenomenon was further investigated using x-ray mapping equipped in SEM. As shown in Fig. 13, the flat Cr layer hid the surface defect without fully filling up the cavity. Once the brittle Cr layer was broken, the plated cavities automatically became crack initiation sites as being observed.

Fig. 12. The Cr plating on the side face of Ball D  
Etchant: Kalling's No. 1 reagent

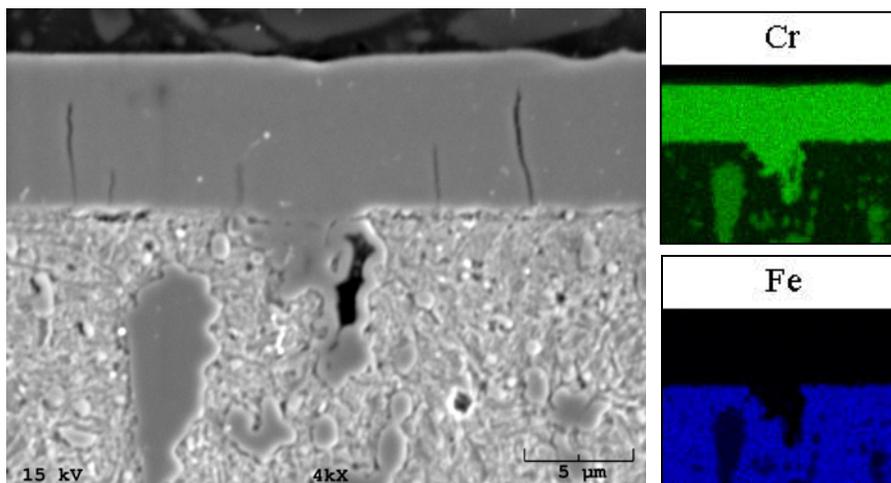
Fig. 13. X-ray mapping of a cavity hidden by Cr plating in the Ball D

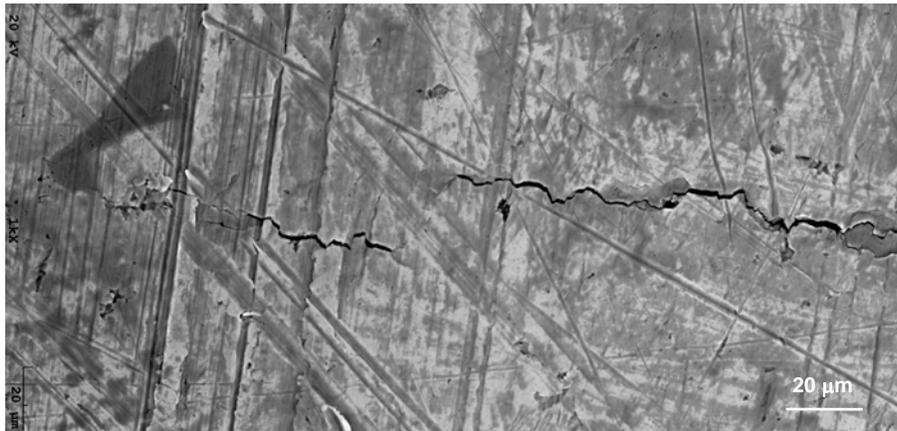
The passivated Ball E exhibited large amount of intergranular fracture and some crack branches during propagation. This ball also had three cracks on each side face. However, further examination of the side faces using SEM found more cracks in additional five locations. Some of the cracks appeared detached to each other (Fig. 14). The irregular traces matched with the nature of intergranular fracture. None of the cracks discovered by SEM were long enough to cross the width of the side face. The cracks often associated with superficial damages, such as denting and flaking caused by wear (Fig. 15). Surface cavities resembling to small corrosion pits were occasionally found on the side faces along with many dents from abrasive wear. Such pits in size of a few microns could also be found at the cracks (Fig. 14 and Fig. 15). Since the amount and the size of the pits found were insignificant compare to the surface damage caused by wear, it is believed that at least the wear played an important role along with pitting corrosion in creating microscopic initiations for EAC.

Fig. 14. Detached cracks found on the side face of the Ball E

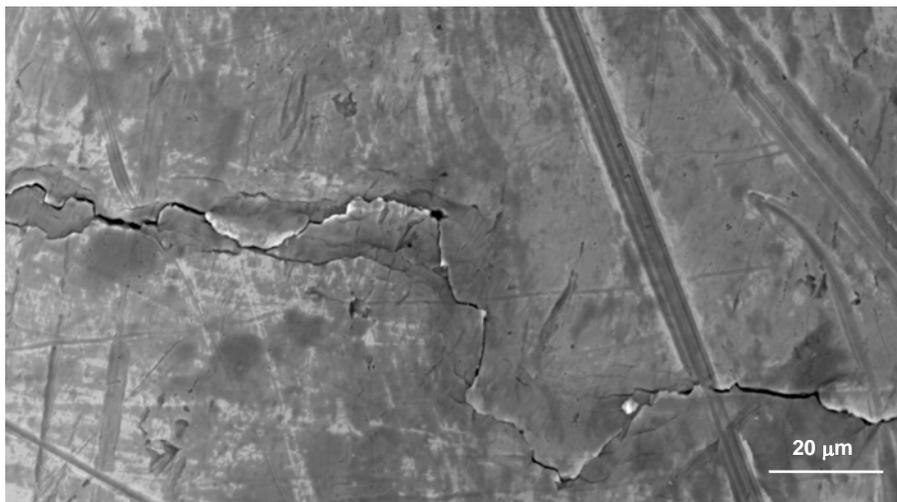
Fig. 15. Superficial damages and a few small pits near a crack in the Ball E
