Fractographic Analysis of the Effects of Combined Natural Weathering and Seawater on the Performance of GFRE Pipes

N. Merah^{1}, S. Nizamuddin¹, Z. Khan¹, F. Al-Sulaiman¹ and M. Mehd²*

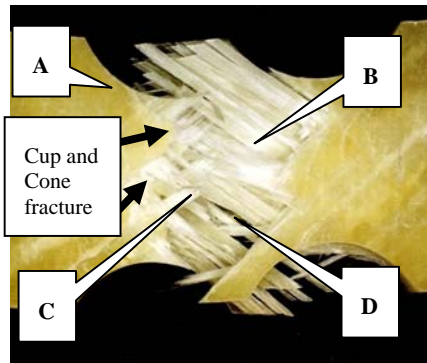
Fractographs of the tensile tested GFRE baseline sample can be seen in figures 2 to 4. Optical observation of the fractured specimen revealed that the fracture initiated at the inner surface of the ring specimen. This is due to the high hoop stresses developed at the internal surface. The fracture appears to initiate from the notch and propagate in a zigzag manner throughout the width of the sample. The cup and cone fractured zone in Fig 2 indicated different fracture mechanisms at the lateral edges and in the middle [9]. The fracture appeared to have initiated (Fig. 2) mainly due to fiber breakage (C) for the first 2-3 plies. This was followed by laminate splitting (B) and interfacial debonding (D) till the fracture reached the outer surface. The outer surface of the specimen displayed broom type failure that including matrix shear excessive longitudinal laminate splitting and interfacial debonding and fiber breakage on the outer 2 plies at the end of failure. Figure 8 is an SEM view of area C of Fig. 2. It clearly shows broken fibers adhered with resin matrix indicating good interfacial bonding. The presence of more amounts of broken fibers indicates application of higher loads prior to fracture [9]. The SEM of the outer surface of the specimen (Fig. 4) revealed the presence of a large

Figure 2. Optical picture of inner portion of the tensile tested virgin GFRE specimen.

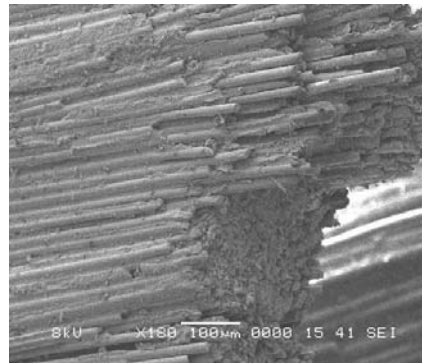
Figure 3: Broken fibers embedded in resin matrix at position C (Fig 2).

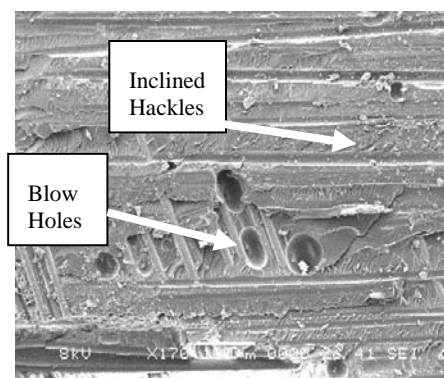
number of blow holes. These might have resulted from volatile gases trapped during the fabrication of composites [10]. The inclined hackles on the matrix are an indication that failure happened as a result of a combination of Mode I and Mode II fracture.

Figure 4. SEM view showing blow holes and inclined hackles

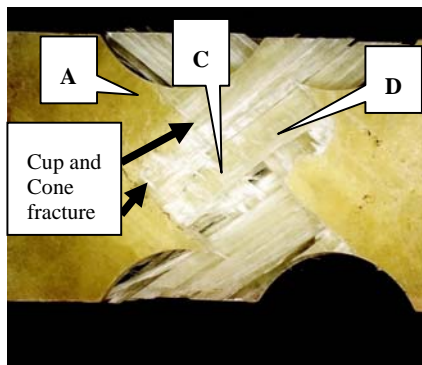
Figure 5 is an optical view of inner gage portion of the GFRE specimen conditioned to combined natural outdoor weather and seawater for 12 months. The fracture initiation from the inner surface and propagation was seen to be virtually identical to the failed GFRE baseline sample with the exception that more amount of fiber breakage and matrix shear along with less laminate splitting. The SEM picture (Fig. 6) taken at position C of Fig. 5 revealed neat broken fibers with minimum matrix adherence indicating weak interfacial bond strength. Since the inner portion of specimen was exposed to seawater, it is possible that the water molecules in seawater might have ingressed through the epoxy resin due to the presence of organic groups in the backbone of the epoxy resin [2]. The water molecules in contact with the glass fiber could have caused leaching out of water soluble alkaline components such as Na^+ and other elements present in glass fiber resulting in fiber level degradation [3].

Figure 5. Optical picture of inner portion of the tensile tested weathered GFRE specimen.

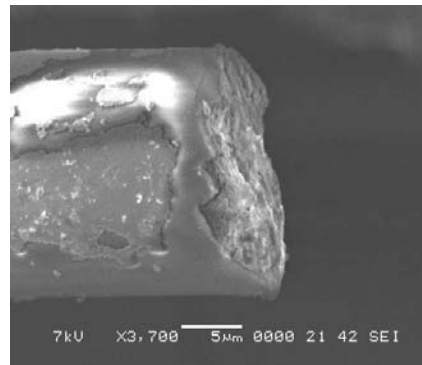
Figure 6: Fiber level damage at position C in Fig 5.

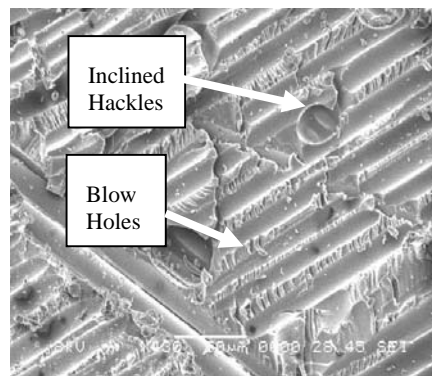
Figure 7 is the SEM view at the inner portion of the specimen (Fig 5-D) indicating groove marks on matrix along with inclined hackles, blow holes and transverse cracks. The presence of blow holes increases the porosity of epoxy matrix resulting in increased water ingress into the sample till the fiber level. The groove marks on the matrix are the result of pulled out fibers indicating weak interfacial bond strength after conditioning to seawater as a consequence of fluid attack on the fiber matrix interface. Again, the presence of inclined hackles indicates shearing of matrix and failure due to mixed mode.

Figure 7. SEM view showing blow holes and inclined hackles in area D (Fig. 5).

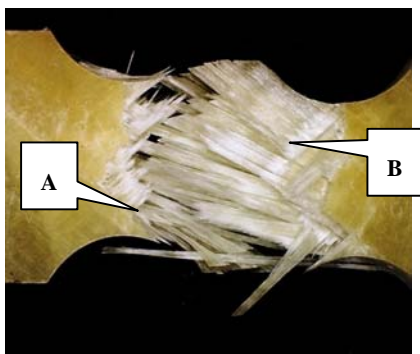
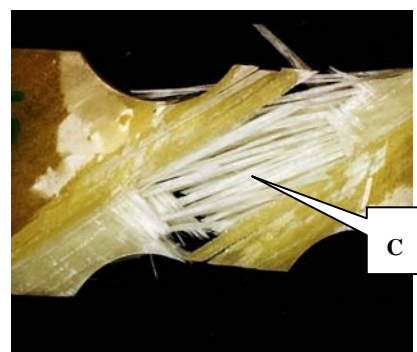
Figure 8. Optical pictures of the creep tested GFRE baseline sample (1X).

The average time to rupture at 70% of UTS for four GFRE baseline samples was found to be 35.5 hours. The fracture initiation and propagation mechanisms from inner surface (Fig 8 (a)) to outer surface (Fig 8 (b)) of GFRE baseline sample was found to be similar to that of the tensile tested GFRE baseline sample, in addition to more amount of fiber breakage.

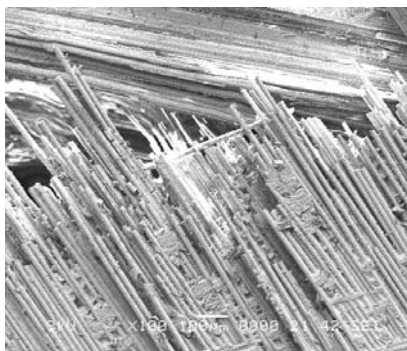
Figure 9 is the SEM view taken at position A on the inner surface revealing broken fibers partially buried in resin matrix. Thus, indicating good interfacial bond strength as noted before in the tensile tested GFRE baseline sample. The presence of blow holes in large number could be seen on the inner surface of specimen (Fig 8-B) as shown in Figure 10. The inclined hackles towards the fiber pullout direction depicts failure would have occurred due to combination of matrix shearing and also due to combination of mode I and mode II fracture mechanisms. The fracture propagation from inner to outer portion was seen to be mainly due to laminate splitting (Fig 8 (b)-C).

Figure 9. Broken fibers buried in matrix at position A in Fig 8 (a)

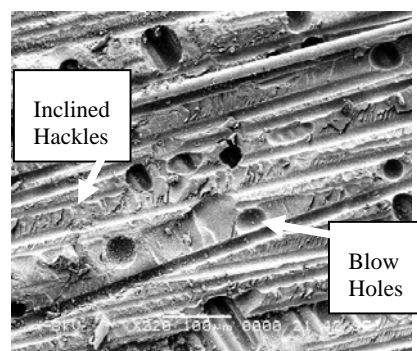
Figure 10: Blow holes and inclined hackles at position B in Fig 8 (a).

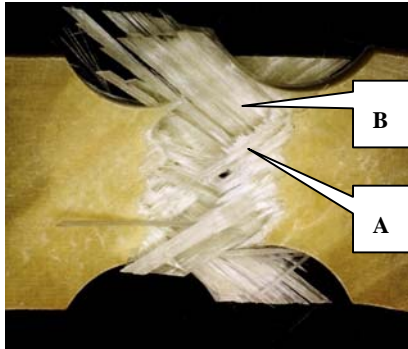
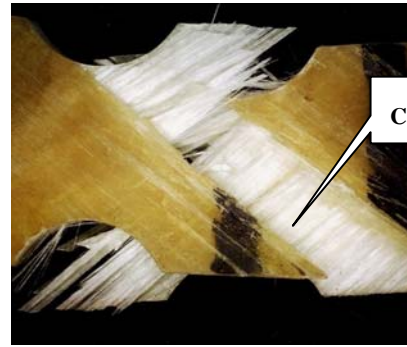
Figure 11. Optical pictures of the creep tested GFRE samples exposed to combined natural weather and seawater for 12 months (1X).

Figures 11 (a) and 11 (b) show optical views of inner and outer surfaces of stress-rupture tested GFRE sample after exposure to combined natural outdoor and seawater conditions for 12 months. The fracture initiation and propagation mechanisms are similar to those of the tensile tested samples. Figure 12 reveals the presence of blow holes on the inner surface of specimen (Fig 11 (a)-B), hence increasing the porosity of epoxy matrix and resulting in increased water ingress into the sample till the fiber level. The presence of hackles on the matrix would have resulted due to mixed mode failure. The outer surface of specimen (Fig 12 (b)-C) indicated that failure was mainly due to interfacial debonding. Neat fibers embedded in resin matrix could be seen in Figure 13 indicating reduced interfacial bond strength due to prolonged exposure to outdoor environment for 12 months.

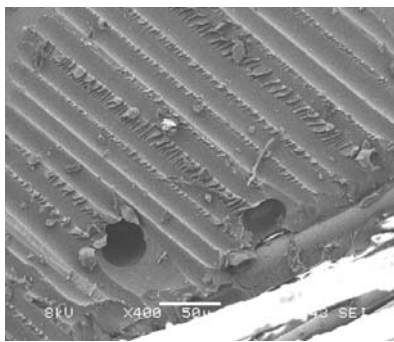
Figure 12. Blow holes along with inclined hackles at position B in Fig. 11(a).

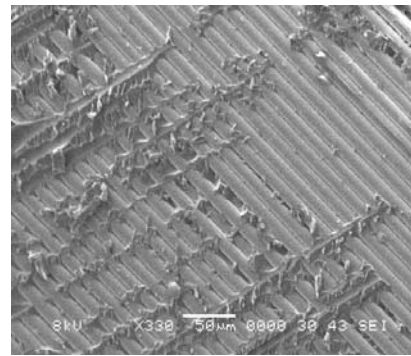
Figure 13. Neat fibers devoid of resin at position C in Fig.11(b)
