Fatigue Failure of Outlet Pipe Work of Flare System at Natural Gas Processing Plant

Abdel-Monem El-Batahgy^{1,*}, Martin Wheeler²

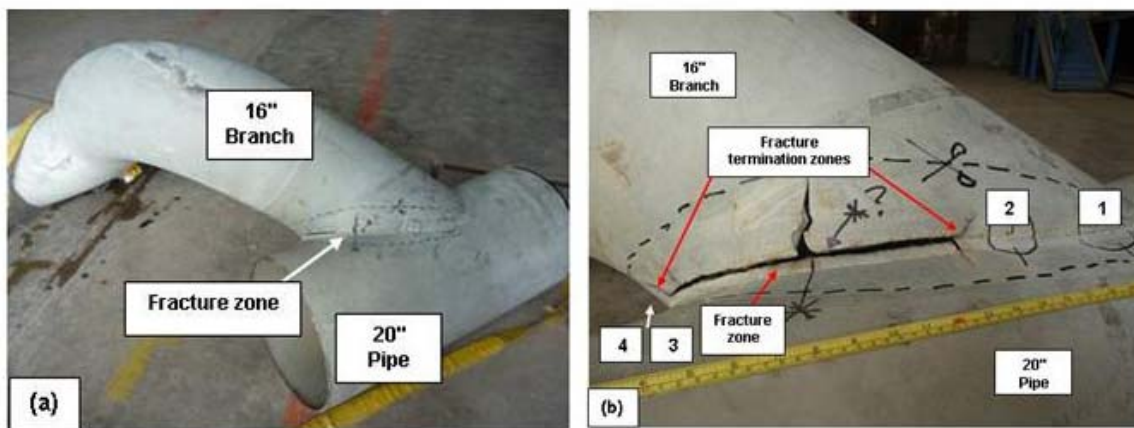
Figure 1. General (a) and enlarged (b) views of fracture zone of the spool. Note that fracture had occurred at sharp angle zone of 16" pipe/20" header assembly, just beside its circumferential weld.

Visual investigation of the internal surface of the failed spool showed damage at the inner surface of 16" pipe, which could be related to mechanical action. Except that, the internal surface of the spool showed smooth surface with no indications for internal corrosion. In other words, no thinning or variation in the wall thickness was observed, where almost uniform wall thickness (~6.0mm for 20" pipe and ~4mm for 16" branch) was obtained at both fractured and non-fractured zones. Macro- and microscopic investigations of a cross section taken from mechanically damaged zone showed internal localized reduction of about 0.6mm depth in the wall thickness of mechanically damaged zone. Optical microscopic investigation showed no indication for cracking at mechanically damaged zone.

Visual and dye penetrant examinations of the failed spool showed that the fracture zone was confined to the acute or sharp angle of 16" pipe/20" header assembly, just beside circumferential weld line. Such sharp angle is considered as stress concentration zone. The fracture was initiated at the outer surface and propagated through thickness in two opposite directions where it was extended less than half way around the circumference. No indications for corrosion attack were observed on spool outer or inner surface. Only, mechanically damaged zone was observed at the inner surface of 16" pipe and this could be occurred long time ago during construction or repair works. However, such mechanical damage played no role in the current failure. In general, non-destructive investigations showed less weld quality. Meanwhile, fracture was not directly related to welding defects since fracture had occurred in the base metal just beside weld line.

As a preventive measure, the other six connections of 16" pipe/20" header were subjected to visual and dye penetrant tests where absence of external surface cracks was confirmed. In order to minimize the possibility of such failure in future, the design of 16" pipe to 20" header connection was modified, where a compensation plate fitted was used to minimize stress concentration at this connection zone. Besides, circumferential welds were made with a better quality even it had no direct relation with the failure.

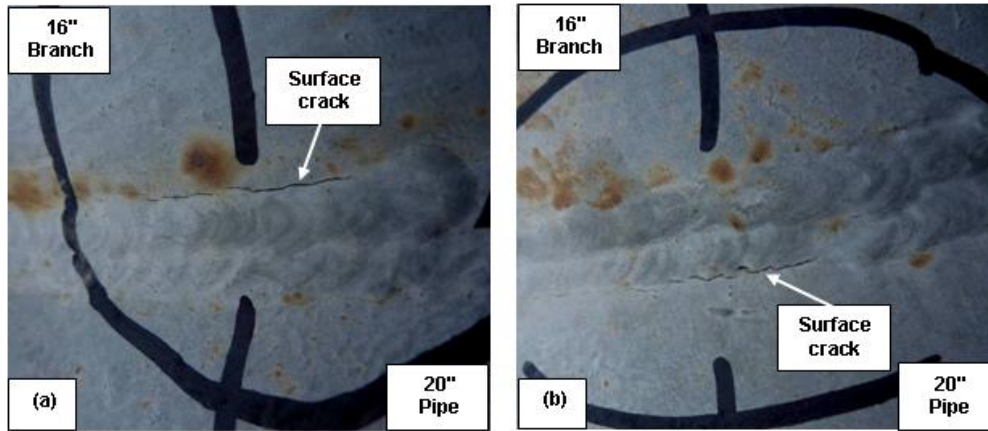
Surface cracks zones observed around the fracture termination zones (zones 1, 2, 3 & 4, in Fig. 1-b) were subjected to detailed investigation. Close-up views of zones 4 and 1 at front of the fracture termination zones are shown in Fig. 2-(a) and (b). It can be noticed that surface cracks are existed just beside

circumferential weld of 16" pipe/20" header. Visual and dye penetrant examinations of zones 3 and 4 showed similar results.

Figure 2. Close-up views of zones 4 and 1 at front of fracture termination zones of Fig. 1-b. Note surface cracks on both sides of circumferential weld of 16" pipe/20" header.

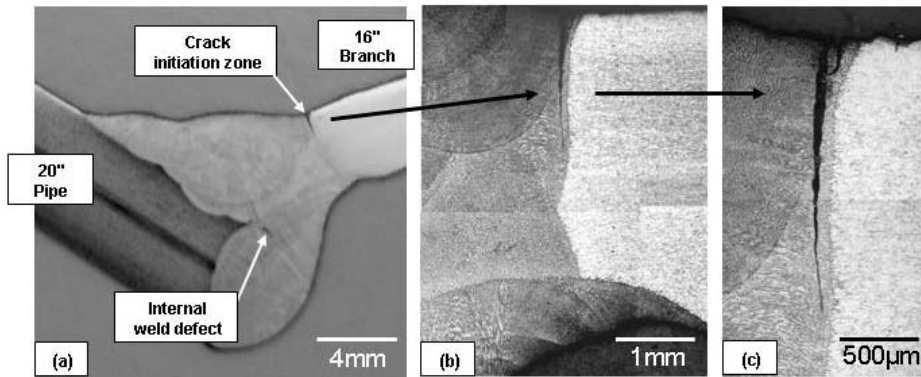
Cracked zones 1, 2, 3 and 4 in Fig. 1-(b) were cross sectioned where its cracking features were clarified. Macrographs of a cross section taken from cracked zone 2 are shown in Fig. 3. It is clear that the observed cracks are weld toe cracking type. Similar results were obtained for samples taken from zones 1, 3 and 4 in Fig. 1-b. Weld toe cracks of zones 2 and 3 (~18cm away from fracture termination zones) were propagated through thickness of 16" pipe. Weld toe cracks of zones 1 and 4 in Fig. 1-b (~35cm away from fracture termination zones) were propagated through thickness of 20" header. It is obvious that cracks were initiated at weld toe on outer surface then, propagated through thickness. Optical micrographs with high magnification of cross sections taken from zones 1 and 4 in Fig. 1-b are shown in Fig. 4. It can be noticed that normal austenitic microstructures for both base metal, HAZ and weld metal were obtained and cracks were propagated through grain boundaries. Survey of the hardness measurements indicated

Figure 3 Macrographs of a cross section taken from zone 2 in Figure 1-b showing toe cracks propagated through thickness of 16" pipe.

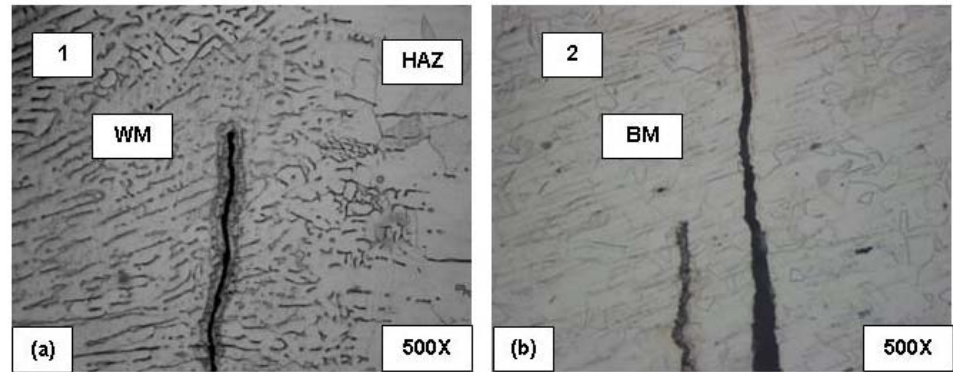
Figure 4 Optical micrographs with high magnification of cross sections taken from zones 1 and 4 in Figure 1-b. Note normal austenitic microstructures for base metal, HAZ and weld metal. Cracks were propagated through grain boundaries.

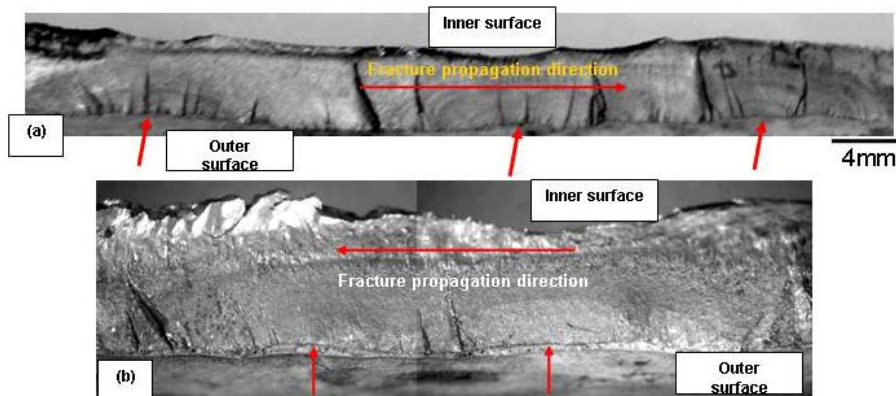
In order to help in identification of failure mechanism, fracture surface was carefully examined using stereoscope and scanning electron microscope. Low magnification photographs of fracture surface of 16" pipe side of the spool are shown in Fig. 5. Crack initiation zones and fracture propagation directions are highlighted with arrows. It is obvious that multi-cracks were initiated at the outer surface, where smooth fracture surface can be seen, then propagated toward inner surface. In other words, crack suspected initiation zones at the outer surface appeared relatively smooth and associated with beach marks and a propagating ductile crack. Crack termination zones at the inner surface had a rough texture associated with the final fracture.

Figure 5. Low magnification photographs of fracture surface of 16" pipe side of spool. Crack initiation zones and fracture propagation directions are highlighted with arrows. Note beach marks at crack suspected initiation zones.

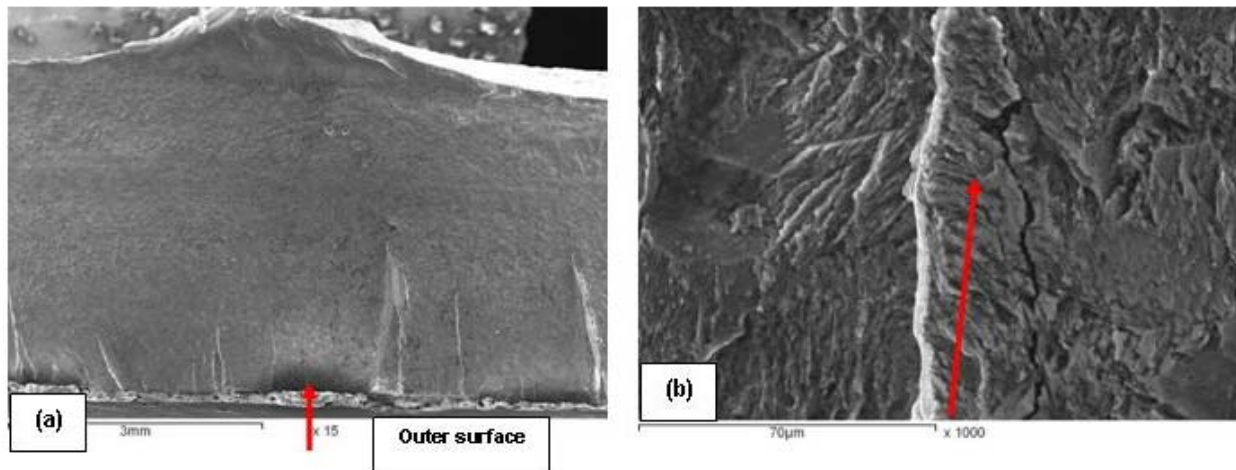
Scanning electron microscopic photographs with different magnifications of fracture surface including suspected initiation zones are shown in Fig. 6. Crack initiation sites can be seen on the outer surface, where a single macroscopic direction of crack propagation is impossible to be defined. This is because crack size is still in the microcrack zone, where multiple cracks form at the surface, initiating at different locations and with different orientations. The important notice is the unclear fatigue striations at the fracture initiation zones.

Figure 6. Scanning electron microscopic photographs of fracture suspected initiation zones at outer surface showing unclear fatigue striations.
