## Damage investigation of Zn-Al alloy coatings on steel wires

**ABSTRACT.** Generally speaking the rockfall protection net wires are Zinc or Zn-Al coated. This provides to the net a durable protection against corrosion. Due to their function, the rockfall protection nets can be damaged over time, and must be replaced. The aim of this work is to investigate the damage that the wire undergoes when subjected to “U” bending, in order to obtain a significant stress. Furthermore it has been analyzed the behavior of a Zn-high Al coating in comparison with the coatings normally used.

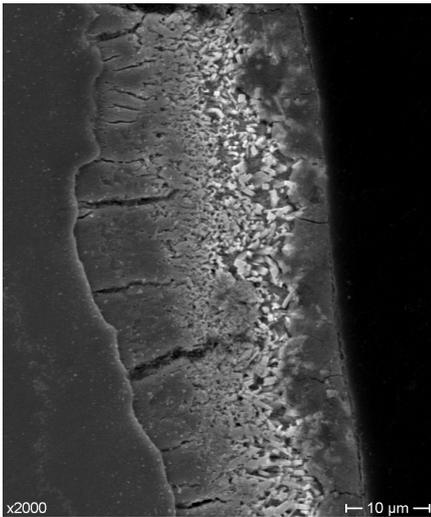
Figure 1: Pure zinc coating

Fig. 1 shows the pure zinc coating. It has an average thickness of about 20  $\mu\text{m}$ .

It highlights the morphology of the coating, that consists of the classical  $\Gamma$  (23.5-28% Fe),  $\delta$  (7-11.5% Fe),  $\zeta$  (5-6% Fe) phases, with a little  $\eta$  (almost pure zinc) on the outside part [6]. The presence of the phases has been confirmed by several EDS analysis.

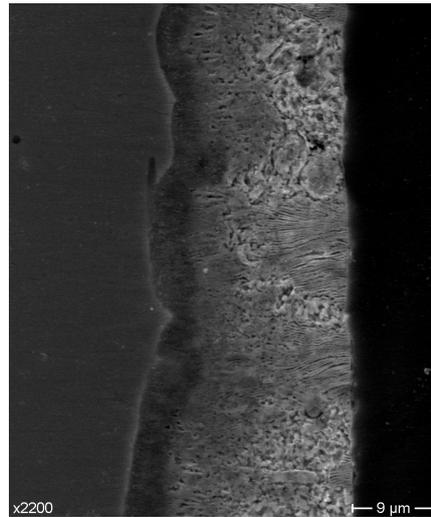
Figure 2: ZnAl5 coating

In Fig. 2, the coating ZnAl5 shows a first phase near the substrate composed by Zn-Fe-Al intermetallic (40 wt% Al, 25wt% Fe, and Zn 35wt%), with rising Zn and decreasing of Fe and Al going towards the outside.

The outer part of the coating shows the typical slats of an eutectic composition. The coating has a thickness of about 25  $\mu\text{m}$ .

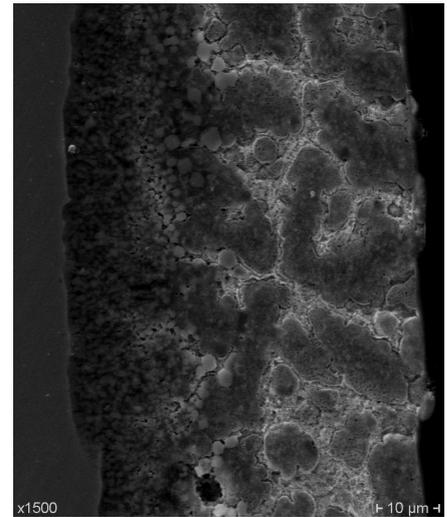
Figure 3: ZnAl22Si0.4 coating

Fig. 3 shows a coating obtained with the ZnAl22Si0.4 alloy, and it has an average thickness of 30  $\mu\text{m}$ .

The phase at the interface is composed of Zn-Al-Fe-Si intermetallics, the outer part has an average composition 40wt% Al and 60wt% Zn with traces of Fe.

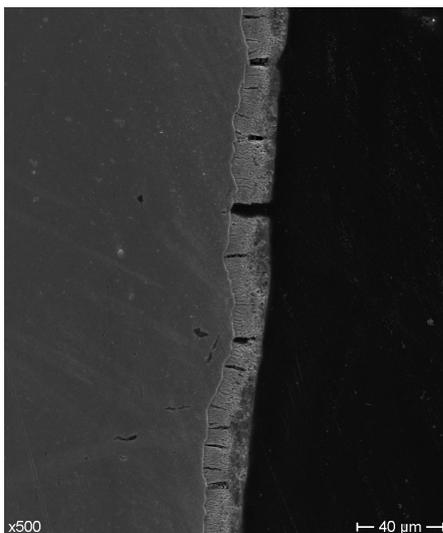
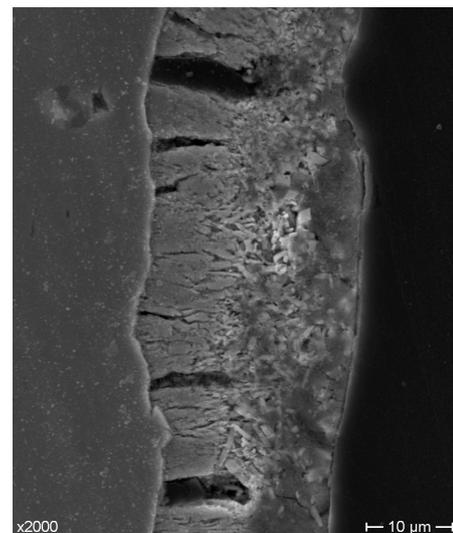
Figure 4: Apex of the bending of the zinc coating (stretched area)

Figure 5: Top of the bending of the zinc coating (stretched area)

Fig. 4 and 5 show the classical zinc coating. The top of the bending is visibly damaged in the stretched area. The cracks take origin in  $\Gamma$  phase and they propagate in  $\delta$  phase, that features a columnar morphology [6]. These cracks are partially arrested in  $\zeta$  phase, characterized by a good ductility [7].

The three coatings tested showed all a sufficient adhesion to the substrate. However, the classic zinc galvanized has, at the apex of the curvature, radial cracks that nucleate in the  $\Gamma$  phase, propagate in  $\delta$  and stop in  $\zeta$ .

The presence of such damage, induced by the intrinsic fragility of the phases involved, can limit and compromising the corrosion resistance.

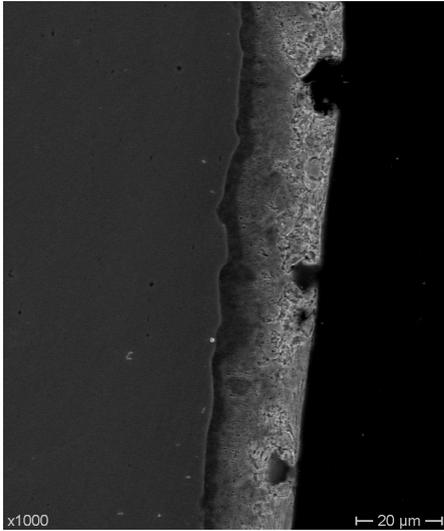
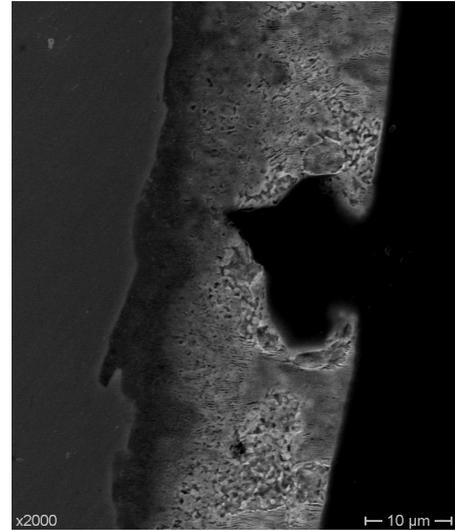
Figure 6: Apex of the bending of the ZnAl5 coating (stretched area)

Figure 7: Top of the bending of the ZnAl5 coating (stretched area)

Fig. 6 and 7 show the ZnAl5 coating. This undergoes a stretching near the bend, and the damage is evident only through some tears on the surface of the coating. However Galfan® shows also good adhesion to the substrate.

The Galfan® coating shows some superficial tears, induced by the tensile stress that can compromise the thickness and therefore its resistance to corrosion.

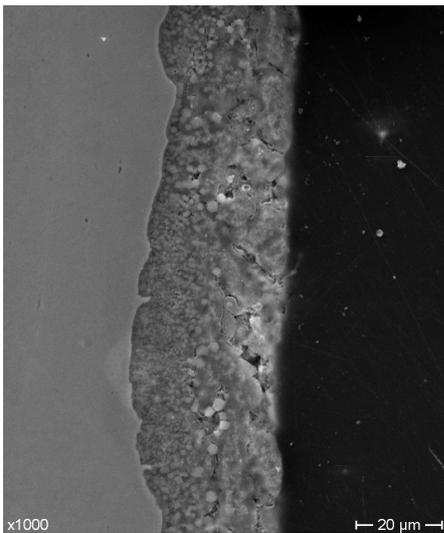
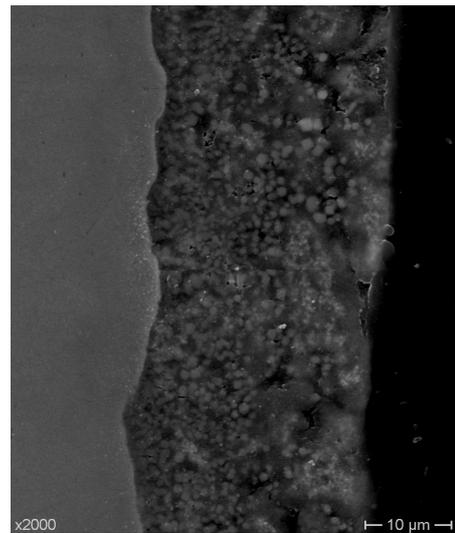
Figure 8: Apex of the bending of the ZnAl22Si0.4 coating (stretched area)

Figure 9: Top of the bending of the ZnAl22Si0.4 coating (stretched area)

Fig. 8 and 9 show the ZnAl22Si0.4 coating. It is the only coating that has not suffered damage. In correspondence with the apex it has only a slight thinning of the coating, which remains perfectly adherent to the substrate, proving to be able to follow completely the plastic deformation of the wire.

The coating obtained with the ZnAl22Si0.4 alloy, as well as showing the adequate adhesion, exhibits no cracking both internal (near the substrate), both external and is therefore the one that offers the best guarantees of reliability.
