## Hydrogen embrittlement of a torsion bar in a military aircraft

**ABSTRACT.** The torsion bar of the emergency braking system of a military aircraft, a forged block of a maraging low-carbon steel, was found fractured during an in-service inspection. Visual examination of the bar showed several defects associated to the missing and blistering of finishing on both external and internal walls. Further examinations using a Field Emission Scanning Electron Microscopy (FESEM) as well as the X-ray Energy Dispersive Spectroscopy (X-EDS) and metallographic microscope showed pits in the protective finish from which started inter-granular corrosion. FESEM observation also revealed grains disbonding, in according to a hydrogen embrittlement phenomenon. Finite Element Analysis (FEA) also performed to evaluate stress distribution pointed out the orthogonality between the main stresses direction and the helical fracture.

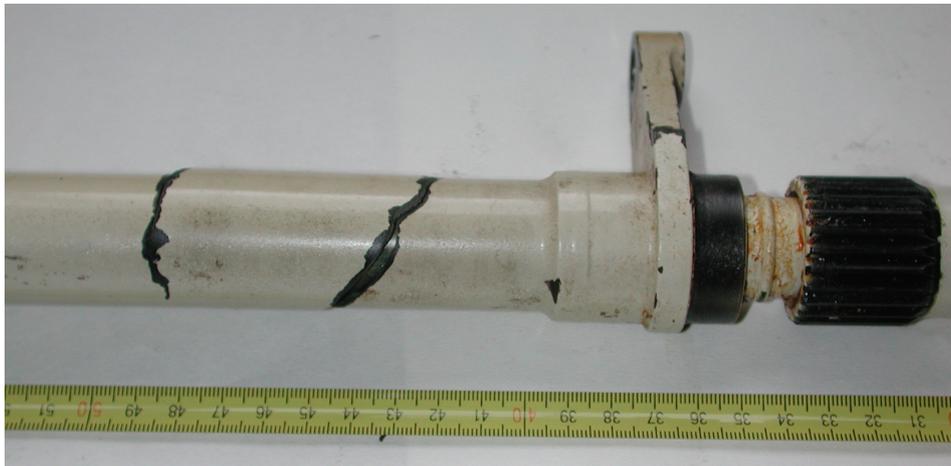
Figure 3: Helical fracture.

Visual examination revealed the presence of an helical fracture on the external tube ending with the lug bolt (see Fig. 3). The fracture is positioned about in the middle of tube length and covers almost 30% of its extension. In addition, spots where the finishing is removed or blistered were observed (see Fig. 4).

It is possible to notice three different planes of fracture: the central one is parallel to the radius and fine-grained, other two are oriented at  $\pm 45^\circ$  respect the radius and appears smooth and shining probably generated by a ductile overcharge fail. The central surface represents just the 5% of whole fracture surface and the external surface are perfectly symmetrical.

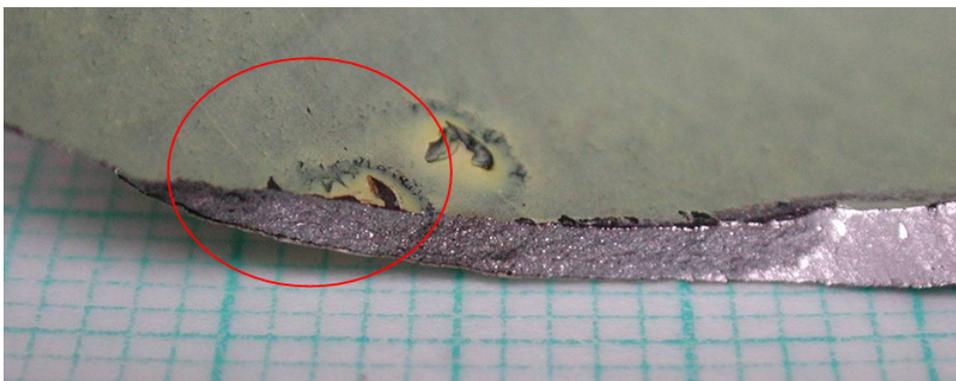
Figure 4: Blistering.

The investigation evidenced a hydrogen embrittlement failure of the torsion bar which was promoted by a corrosion pit on the external surface. Other similar pits were found on the bar surface, probably generated by a inadequate washing and drying after the phosphatation operation.

Following this investigation, it was recommended to check all the torsion bars installed and eventually remove all those having finishing defects of the external wall. It was also suggested to reduce the scheduled inspection intervals in order to verify the integrity of the finishing.

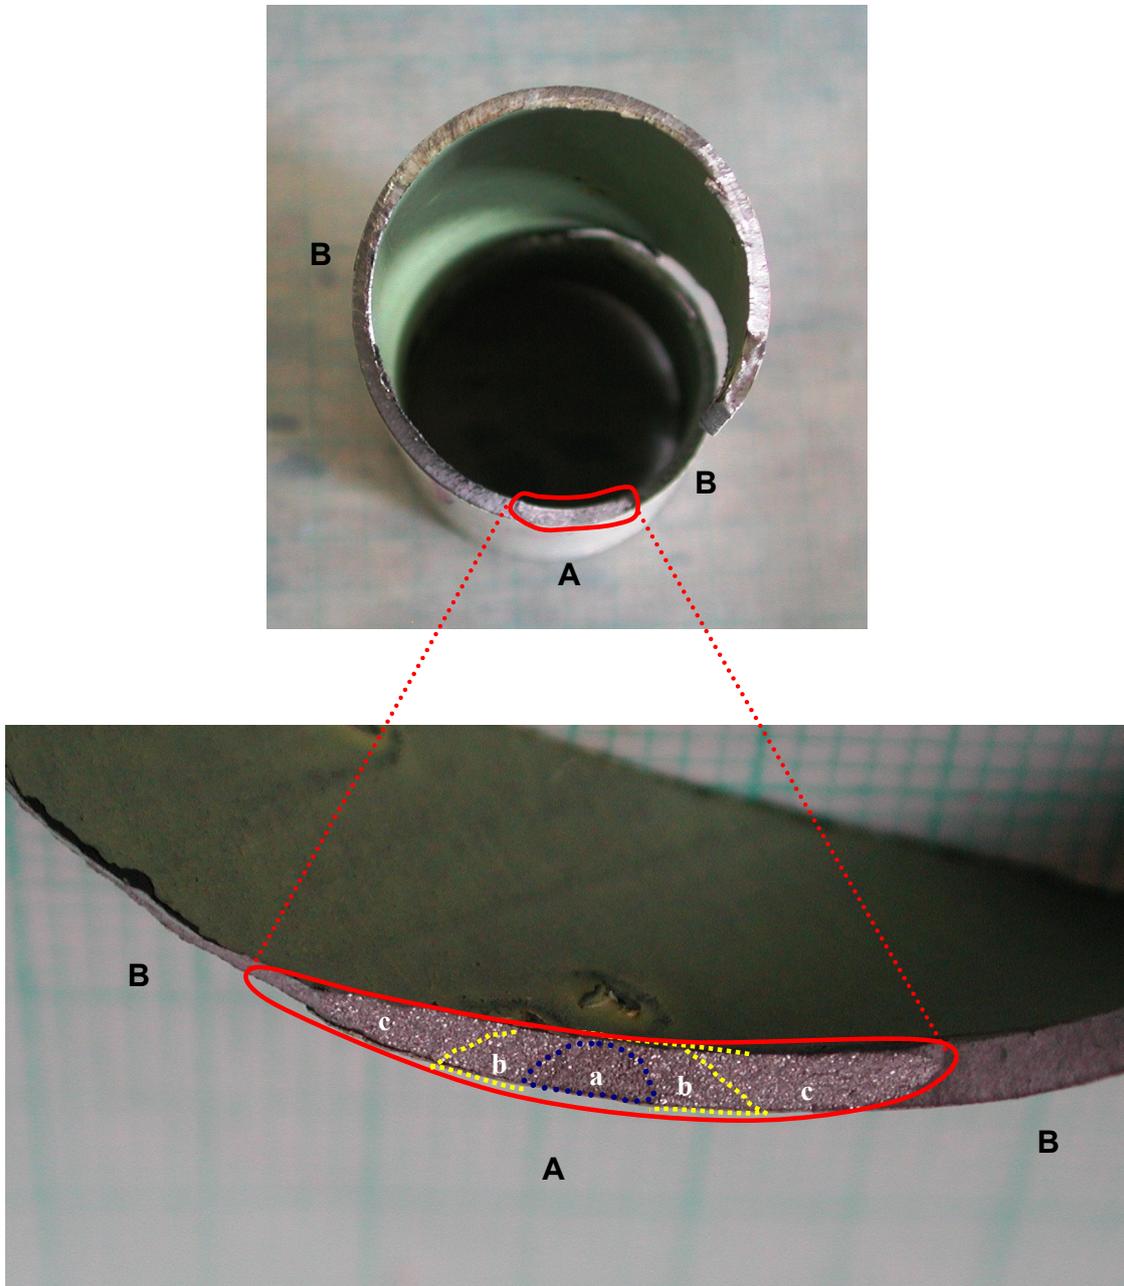
Figure 5: Morphologic zones.

FESEM examination of the central fracture surface was carried out in order to determinate the failure mechanism. It is possible to identify three morphologic zones (A, B and C, see Fig. 5).

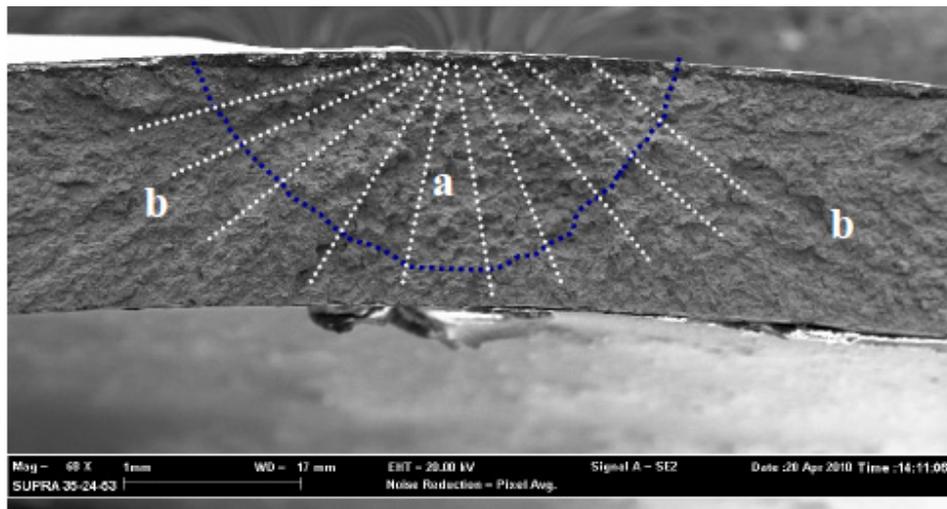
Figure 6: "A" zone.

The “A” zone is half elliptic shaped with the major axis about 3 mm long and the minor one extending for about 1 mm (Fig. 6).

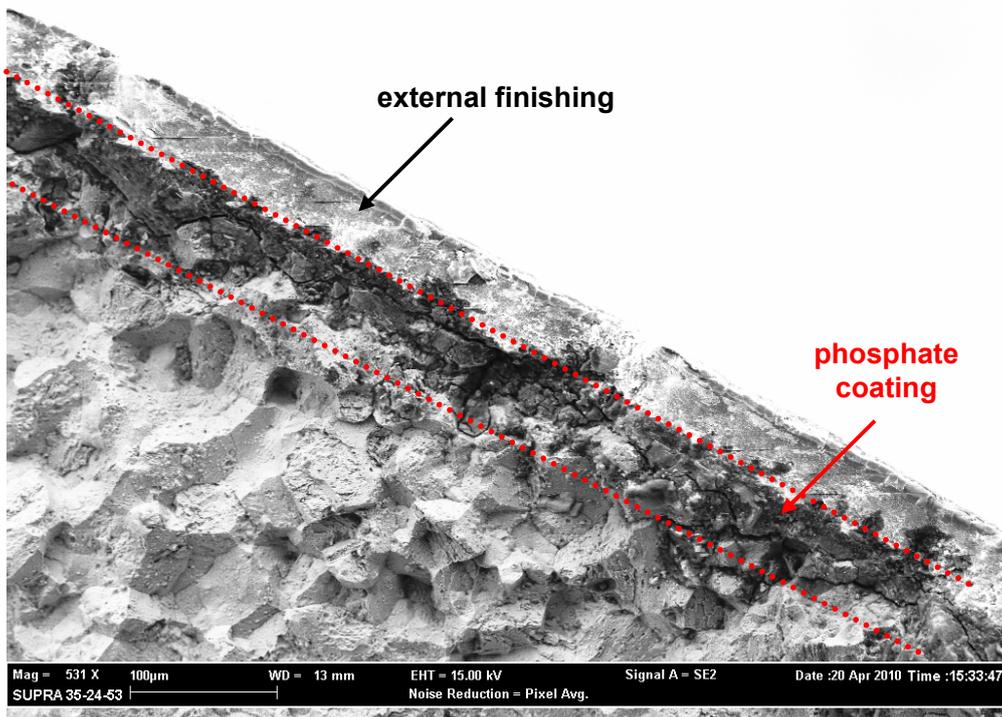
Figure 7: Morphologic zones.

Next to the external finishing can be observed a phosphate coating about 30  $\mu\text{m}$  deep; in addition on finishing were found several pits from 50 to 300  $\mu\text{m}$  wide (Fig. 7).

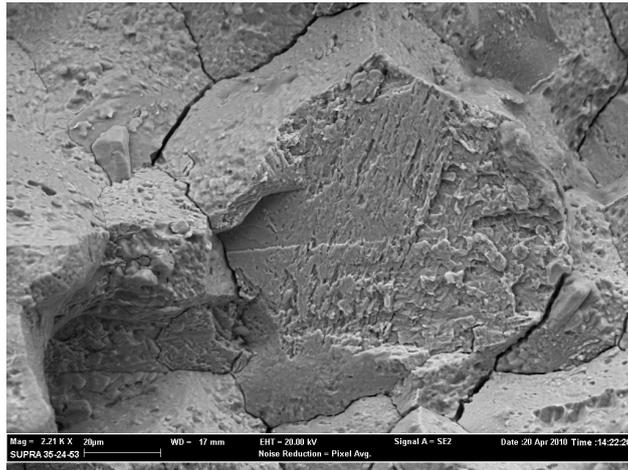
Figure 8: Grains disbanding.

Increased magnifications confirm the intergranularity of fracture. Grains result like disbonded with "hair lines" (see Fig 8), as high hydrogen inclusion fracture appears. Corrosion products were not found.

All evidence lead to ascribe the failure to a hydrogen embrittlement phenomenon. FESEM analysis showed intergranular fracture together to grain disbonding and hair lines, characteristic evidences of a brittle fracture. The microstructure as well as the hardness measurements tests were found satisfactory and in agreement with the original requirements. Metallographic exam revealed several finishing defects and corrosion pits, the biggest one located on the brittle fracture surface; moreover was detected a phosphate coating on the bar surface. FEA pointed out low stress values and orthogonality between main stresses direction and helical fracture.

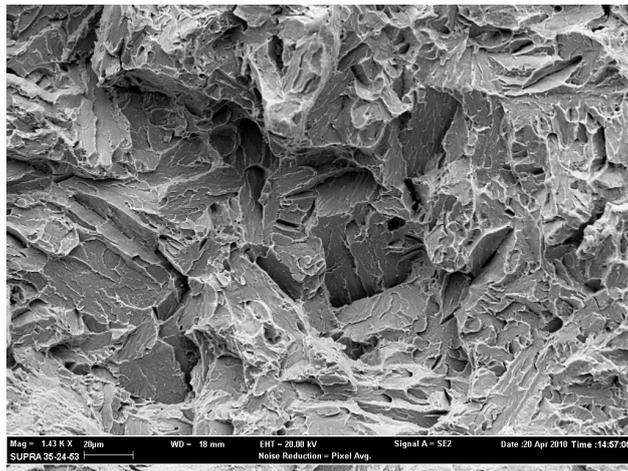
Figure 9: Cleavage.

“B” zone is 6 mm extended and is characterized by cleavage planes what means that a fragile fracture has occurred (see Fig. 9).

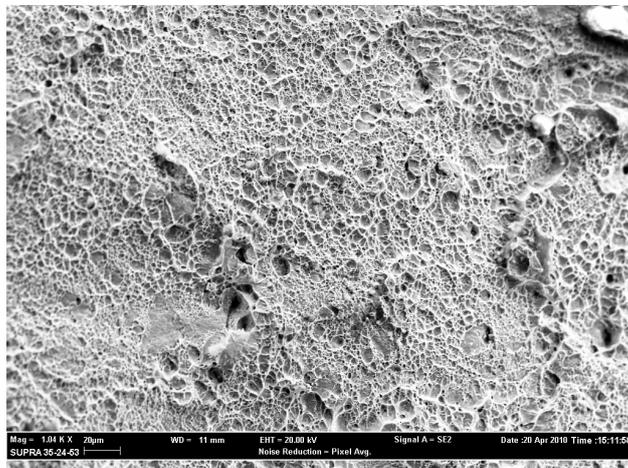
Figure 10: Dimples.

The remaining part of fracture surface, named as “C” zone, presents dimples due to a ductile overcharge fail (see Fig. 10).

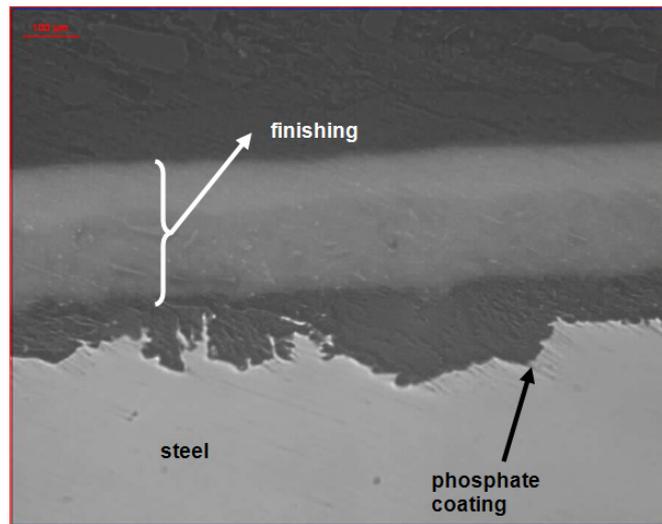
Figure 12: Finishing and phosphate coating

The core shows a typical low carbon maraging steel microstructure (see Fig. 11). A 75  $\mu\text{m}$  finishing, which consists of three different layers, is applied on a 30  $\mu\text{m}$  phosphate coating (see Fig. 12). Both, phosphate coating and finishing, are defective or absent in several spots.

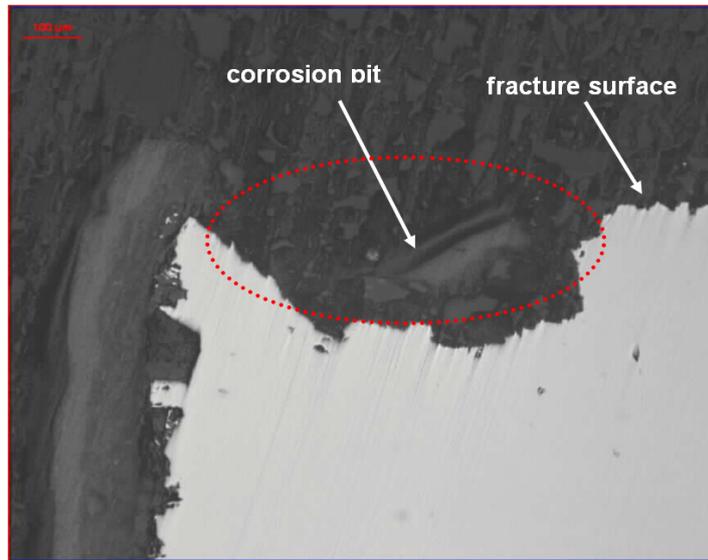
Figure 13: Corrosion pit.

Operating a progressive ablation, once reached the initiation point it was possible to reveal a 270  $\mu\text{m}$  wide corrosion pit just below the external finishing (see Fig. 13). No secondary cracks were found.

A hydrogen embrittlement phenomenon acted on the torsion bar, but low stress value was not enough to lead to a failure. The 300  $\mu\text{m}$  corrosion pit found on the fracture surface worked as a stress raiser originating a brittle fracture surface, orthogonal to the main stress direction, on the external tube. Due to the reduced section, the fracture propagated as ductile.

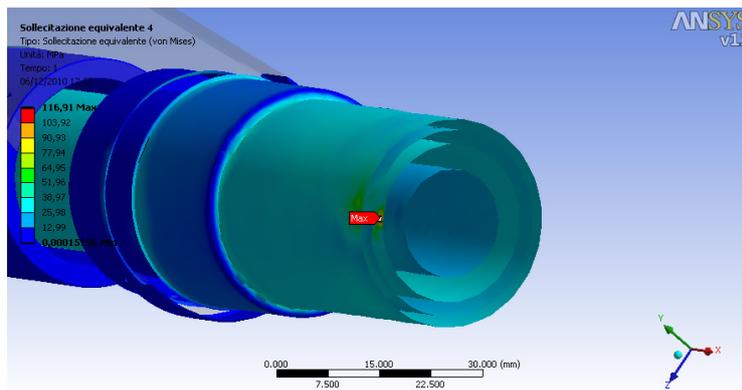
Figure 16: Von Mises stresses.

A Von Mises stresses increase was revealed near the fracture zone on both tubes (Fig. 16), in particular the maximum was located on the internal one.

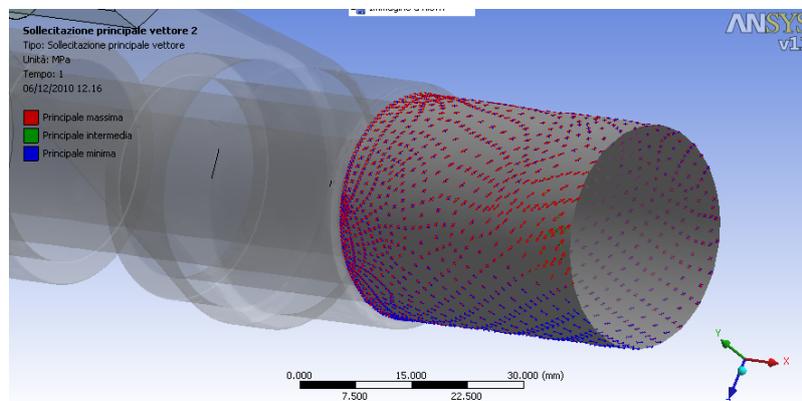
Figure 17: Main stresses vectors.

The stress values are not very high, much lower than the yield point (MPa), as largely expected with an applied displacement of 1 mm. It was pointed out the orthogonality between the main stresses direction and the helical fracture (Fig. 17).
