# Crack paths in a superalloy in aged condition

F. Kuhn<sup>1</sup>, F. Zeismann<sup>1</sup>, A. Brückner-Foit<sup>1</sup>, K. Kadau<sup>2</sup>, P. Gravett<sup>3</sup>

**ABSTRACT.** *The crack paths are analysed of fatigue cracks in aged IN 738 taken from removed turbine blades. Both artificial cracks initiated from notches and service cracks found in removed blades are taken into consideration. Transgranular crack growth is most common in the virgin material, but can still be found in aged material and in service cracks. Under operating conditions, transgranular crack growth is related to recrystallization of the material along the crack faces. It is suggested that the local plastic deformation plays an important role in this recrystallization process.*

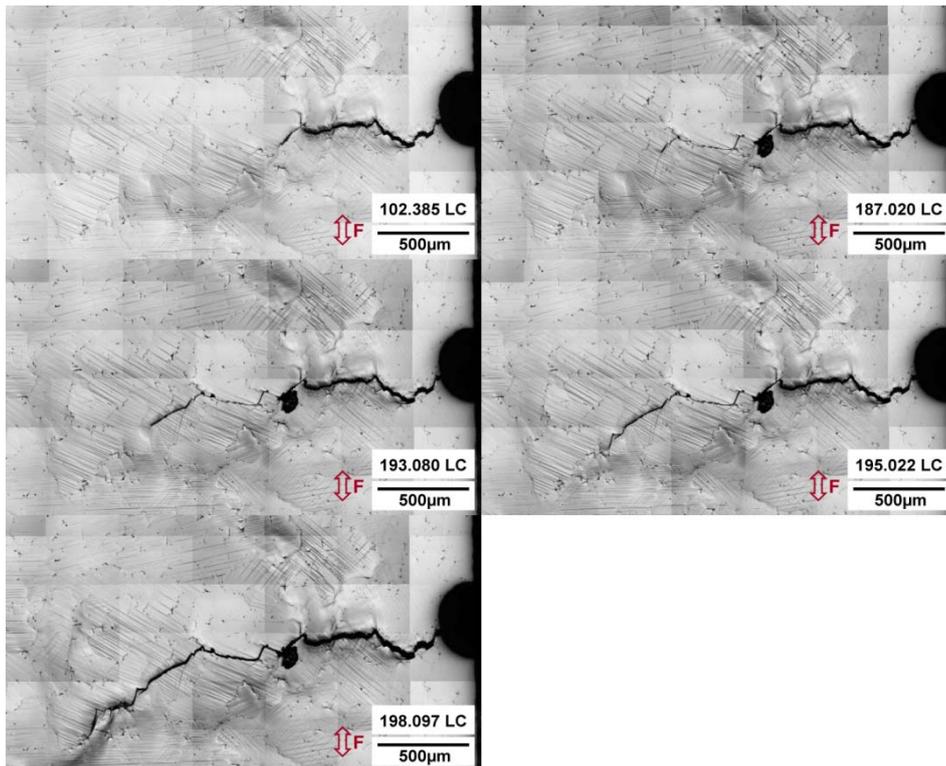
Figure 2 illustrates how a typical crack develops in the aged material (peak load blade). The crack path is partly transgranular, partly intergranular with numerous deflection points and crack branching. Interaction with microstructure is very strong, and shear controlled transgranular crack extension is possible at any stage due to the very coarse grains.

Figure 2: Development of fatigue crack from notch root; peak load blade

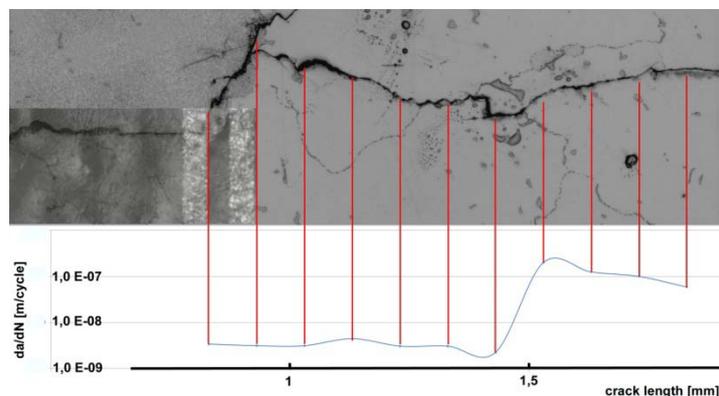
Figure 3: Crack growth rates along crack path; peak load blade

Figure 3 illustrates that the amount of scatter observed in the crack growth rates is directly related to the interaction between the crack and the microstructure. At the beginning observation, the crack possesses an intergranular crack path, and growth rate (measured by increase of crack length on the surface in this case) remains constant for more than 1mm crack extension. Then the crack tip passes through some smaller microstructural features and continues in a transgranular mode with an increase in crack growth rate by two orders of magnitude.

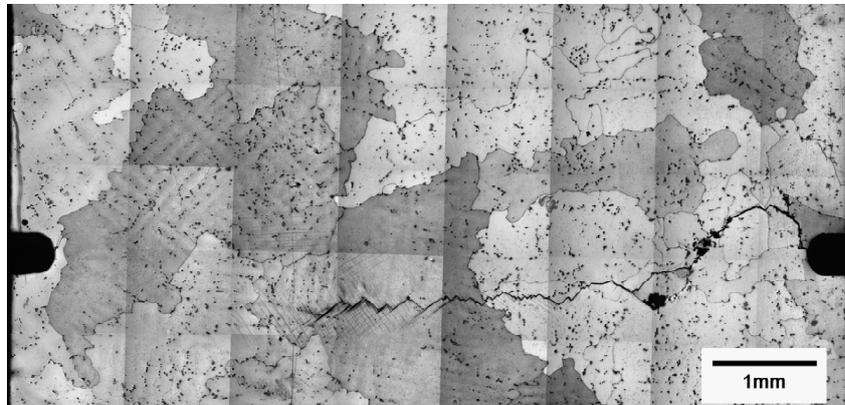
The crack paths found in the peak load material are very similar to those of the base load material. A typical example is given in Fig. 4 which also illustrates the transition between microstructure dominated crack growth with partly transcrystalline, partly intercrystalline crack path, and mode I crack growth with contributions of several activated slip systems. This transition occurs much earlier in the virgin material leading to comparatively straight crack paths and predominantly transcrystalline crack extension.

Figure 4: Crack path in base load aged material with transition to mode-I long crack growth

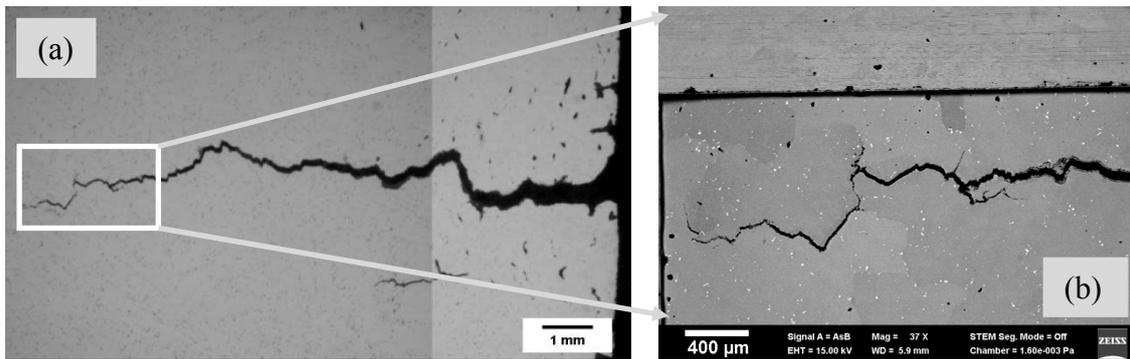
Service cracks have an even more tortuous crack path than artificial cracks in aged material, see e.g. Fig.5. A close-up of the microstructure in the vicinity of the crack tip shows that even though the intercrystalline extension mode is dominant there are also some parts of the crack path which seem to be transcrystalline (on the right hand side in Fig. 5b). Crack branching occurs frequently and sometimes gives rise to “backward” crack propagation.

Figure 5: Crack path of a service crack in a base load blade; (a) overview with optical microscope, (b) SEM micrograph BSE

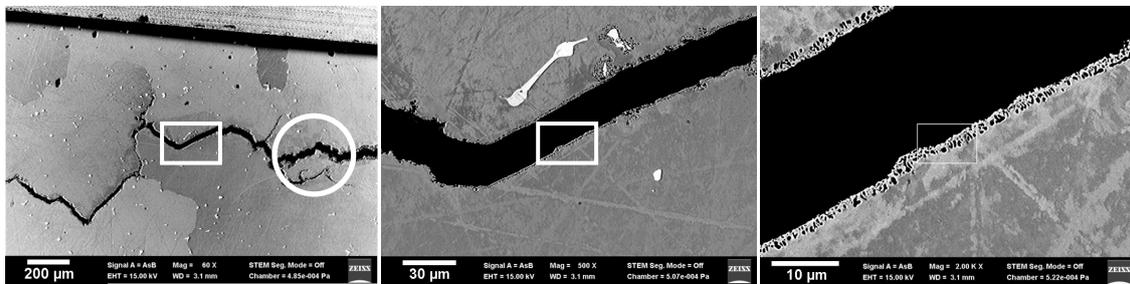
A closer inspection of the crack faces show that there are some structural changes at the edges (see Fig. 6). First of all there is a zone of very porous material at the very edge. This is very likely material which had been partly molten under operating condition. If the crack is open, there is no protection against the hot combustion gases and the local temperatures are apparently well above design level. This zone of porous material has a width of about  $1\mu\text{m}$  in the straight section of the crack shown in Fig. 6, but may become much wider (up to  $50\mu\text{m}$ ) at bends and turns. It is not clear yet whether there is an inhomogeneous temperature distribution along the crack path or whether this observation is related to the oblique in-depth extension of the crack at kinks.

Figure 6: Zone of local remelting at crack face; SEM-BSE micrograph BSE

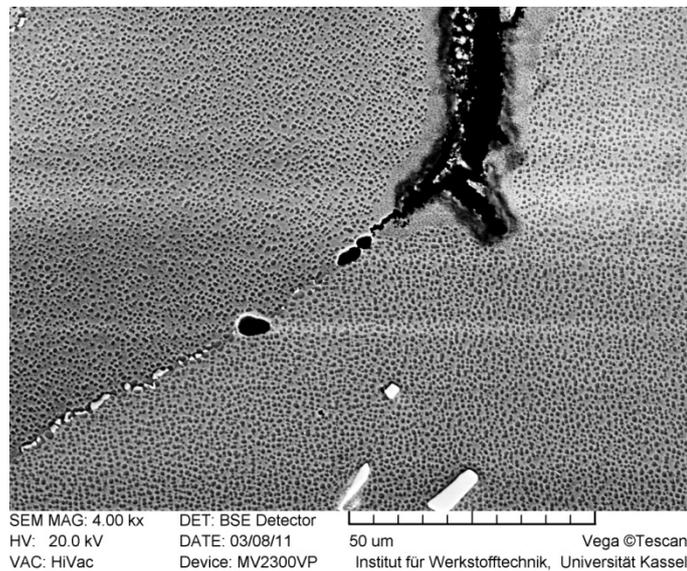
Figure 7: BSE image of crack tip showing zone without  $\gamma'$ -precipitates

In addition to the zone of porous material there is a band of material parallel to the crack faces where the visible  $\gamma'$ -precipitates have disappeared. This band can only be found in specific sections of the crack path; for the service crack shown in Fig. 5 this band exists in the vicinity of the crack tip (see Fig. 7) and in some parts along the crack. An EDX analysis was performed with the purpose of getting more detailed information about the distribution of  $\gamma'$ - precipitates along the crack faces. Fig. 8 shows the result for a crack face in the vicinity of the crack tip, and proves that there indeed no  $\gamma'$ -precipitates in this band.

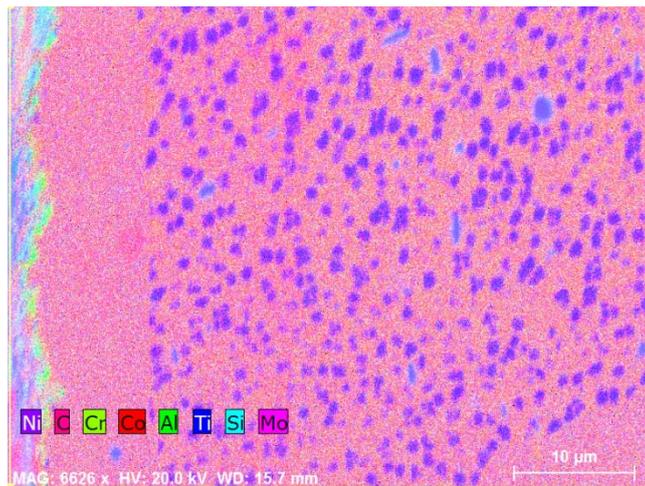
Figure 8: EDX-analysis of a crack face in the vicinity of the crack tip shown in Fig. 7

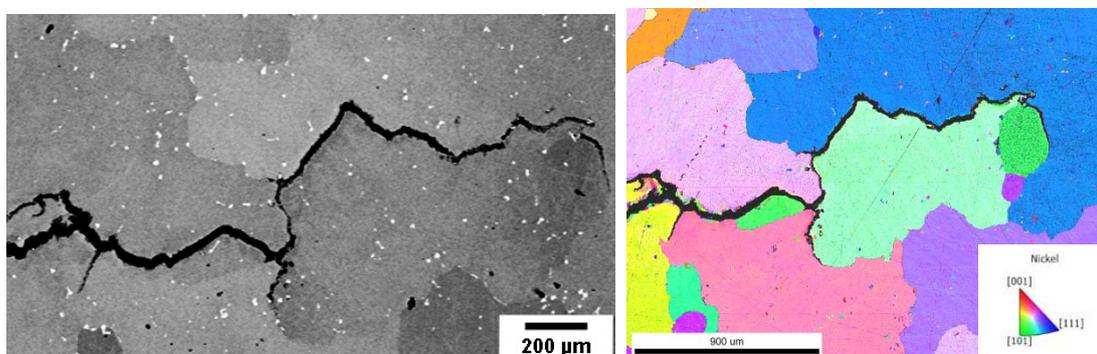
In the next step, an EBSD analysis was performed in order to find out whether this  $\gamma'$ -free bands can be related to other features of the microstructure. Figure 9 shows that the crack path was predominantly intergranular with some transgranular parts at the left hand side in the vicinity of the branching point. There are some finer features visible in the EBSD map which are present along the transgranular crack path and between the two grains which are coloured in similar shades of pink and hence have very little orientation difference.

Figure 9: Section around the crack tip of the crack shown in Fig. 5 (rotated by 180°); comparison of micrograph (SEM BSE) and EBSD analysis

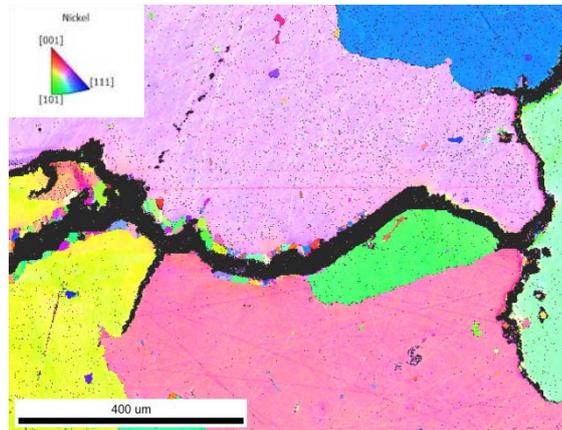
Figure 10 shows these features on a larger scale. Apparently there was some re-crystallization along the crack faces. This re-crystallization takes place whenever the crack passes in a transcrystalline extension mode through a grain or when it grows along a low angle grain boundary. A one-to-one match was found when comparing the zones of re-crystallization with the  $\gamma'$ -free bands.

Figure 10: Re-crystallization along crack path

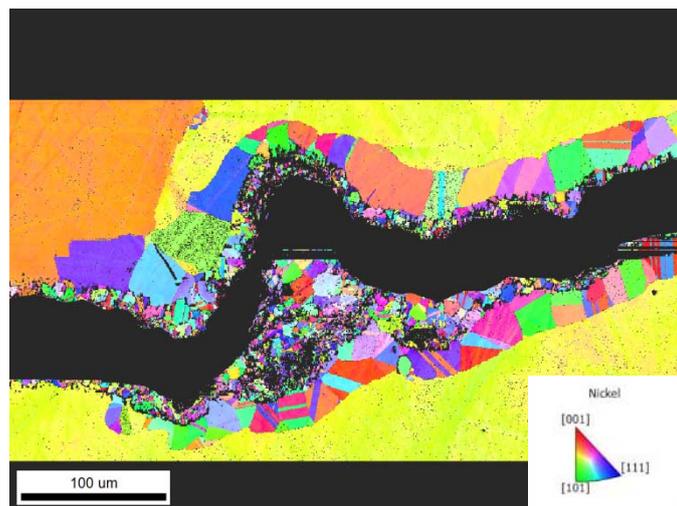
The largest zone of recrystallization was found in the area highlighted by the white circle in Fig. 6. The zone of high temperature damage (partial melting) is particularly large at the kink of the crack, and there is a substantial amount of re-crystallization around it (see Fig. 11). The edges of the crack are decorated by very finely grained layers. A mono-layer of crystals of constant width (about 50  $\mu\text{m}$ ) followed. These crystals contain numerous twin boundaries.

Figure 11: Re-crystallization zone containing twins

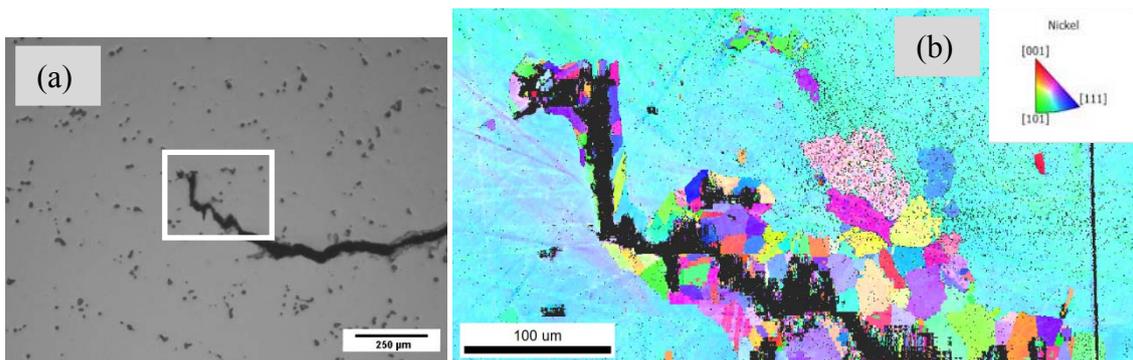
The crack discussed in Figs.5-11 was found in a base-load blade which typically experienced long hold times at high temperature. Further micro-analyses were performed with cracks in peak load blades in order to find out whether similar effects can be found there. Figure 12 indicates that this is indeed the case. Hence the re-crystallization process is closely related to the thermomechanical cycling during operation and is not a pure high temperature phenomenon which comes about at long hold times. Additional investigations with hardness indentations suggest that local plastic deformation is also an important influence factor.

Figure 12: Re-crystallization zone around crack tip of service crack in peak load blade (a) optical microscopy (b) EBSD-analysis (IPF)
