# Failure of Ti Plates for Oral and Maxillo-facial Surgery

A. P. Silva, G. Spera and C. Azevedo.

Instituto de Pesquisas Tecnológicas do Estado de São Paulo, Brazil

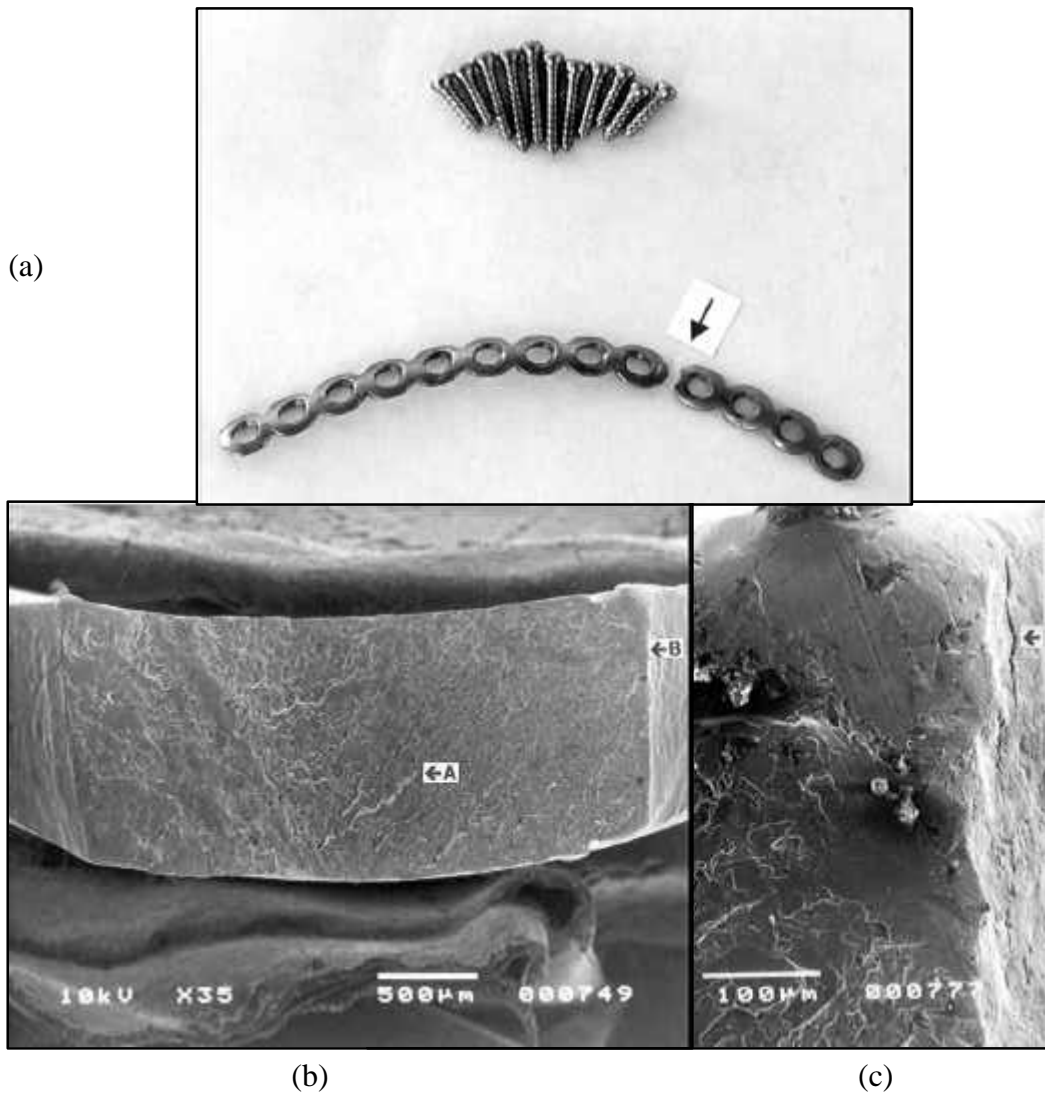
**Figure 1 :** a) Failed oral maxillo-facial plate for jaw reconstruction (see arrow); b) General view of the fracture surface showing radial lines (see arrow A) converging to the fracture origin (see arrow B)<sup>1</sup>; c) Detail of the fracture origin, lateral plate surface, revealing the presence of cracking (see arrow).

<sup>1</sup> Miniplate concave face lies in contact with the bone.

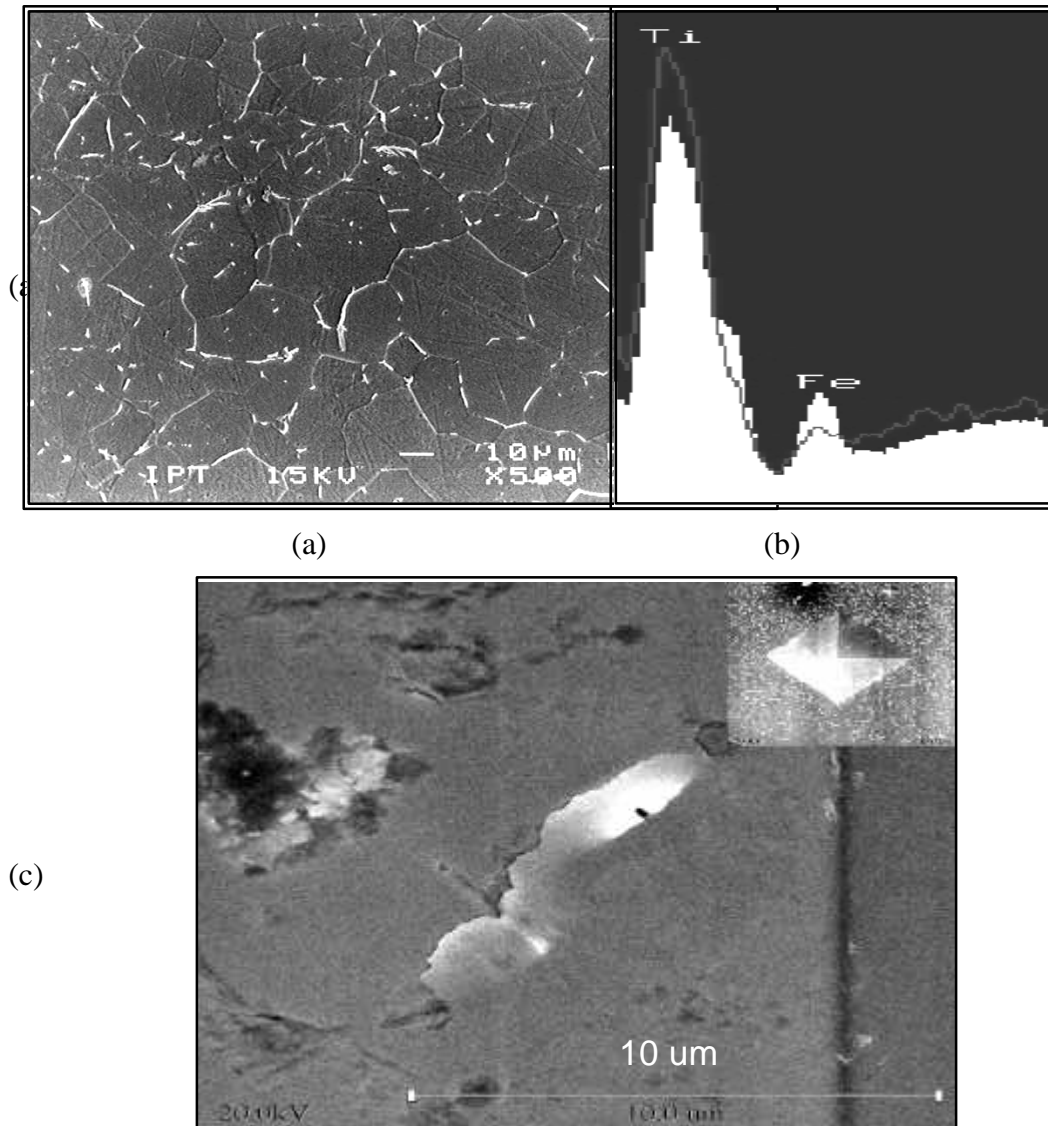
X-ray diffractometry (Cr K $\alpha$ , 40.0 KV, step mode,  $\Delta 2\theta=0.0020^\circ$ , t=40s) did not show the presence of TiH<sub>2</sub> or TiH phases, which may be responsible for the embrittlement of C.P. titanium [10-14]. The precipitation morphology suggests the presence of retained  $\beta$ -platelets instead [12-16]. The XRD results indicated the presence of 5 peaks of  $\alpha$  phase - d= 2.555Å,(100) $_{\alpha}$ ; d= 2.3414Å, (002) $_{\alpha}$ ; 2.2431Å,(101) $_{\alpha}$ , and 1.7269Å,(102) $_{\alpha}$  - and a possible peak of residual- $\beta$  phase - d=1.6553Å,(200) $_{\beta}$ . EDS microanalysis indicated that the platelets were richer in Fe ( $\beta$ -stabiliser element) than the matrix, see Figure 2c. Additionally, metallographic observation of Vickers hardness indentations (10 Kgf) showed the plastic deformation of platelets (see Figure 2b). These results suggested that

the intergranular precipitates are  $\beta$ -phase (not the brittle hydride phase) [17-20], which is typical in C.P. Ti due to the iron partitioning [21-22].

**Figure 2** : a) Detail of the microstructure showing equiaxed  $\alpha$  grains and intergranular platelets; b) EDS analysis showing matrix (line spectra) and Fe-rich precipitate (solid spectra), Ti-L $\alpha$  and Fe-L $\alpha$  peaks; c) Detail of the precipitate deformation inside the Vickers indentation zone (see top-right).

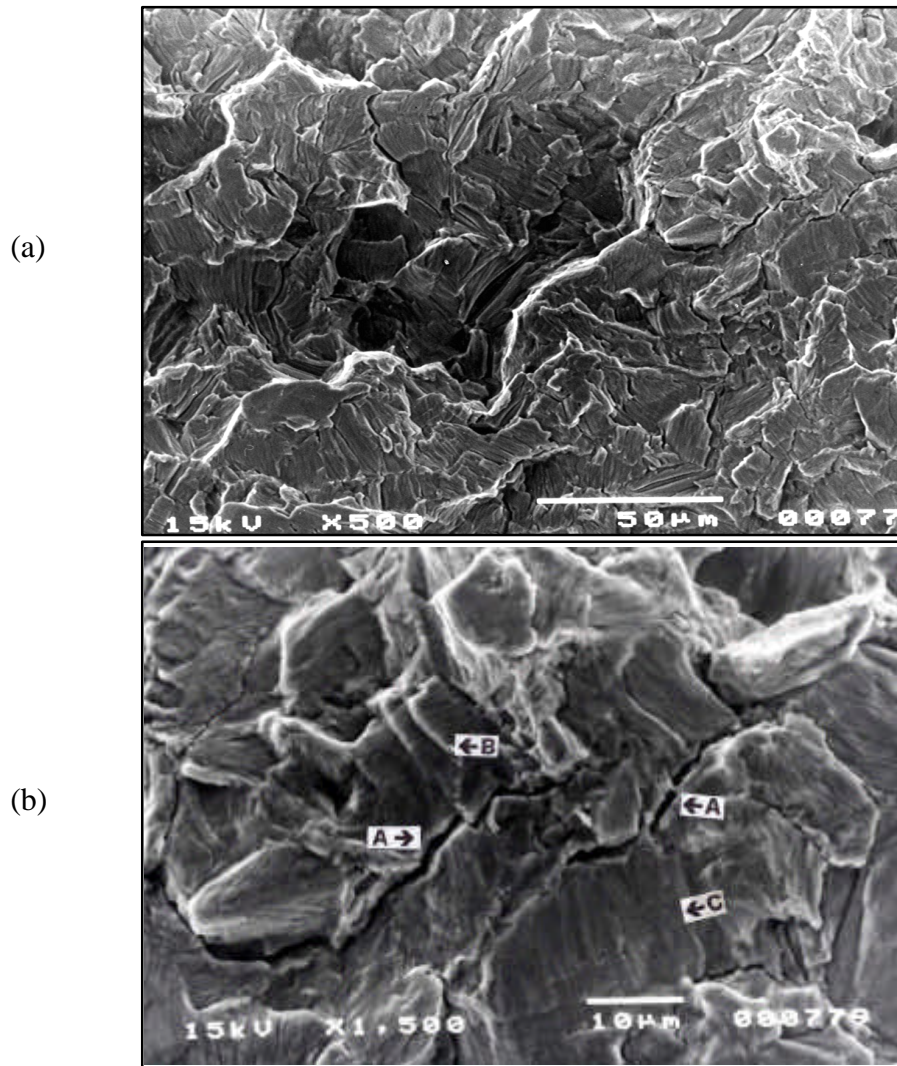
Fractographic investigation revealed the presence transgranular cleavage facets associated with secondary intergranular cracking (see Figure 3a). Detail of the fracture surface (see Figure 3b) showed intergranular cracking (arrow A); cleavage steps (arrow B) and "striation" marks (arrow C), indicating that the failure occurred by a brittle mechanism. High hydrogen content in the bulk metal (during dynamic load) or microvolumes (during sustained loading or fatigue cycling) may cause the embrittlement of Ti and Ti alloys [23]. The presence a fine discontinuous precipitation of  $\beta$ -phase may cause the embrittlement of near- $\alpha$  Ti alloys during dynamic [21] and sustained loading [22] as it acts as a hydrogen diffusion path. Microstructures containing thick continuous  $\beta$  platelets, however, are immune to embrittlement as  $\beta$ -phase tolerates hydrogen level close to its solubility limit without a significant loss in ductility [22, 23]. The presence of striation-like markings (see Figures 4a and 4b) were previously associated with cracking-arrest markings produced by discontinuous crack propagation (repeated formation and rupture of the brittle stress-induced hydride phase) [17-19]. William [24] explained that these markings are the intersections of intense slip bands with the fracture surface.

**Figure 3** : a) Detail of the fracture surface near the fracture origin revealing transgranular cleavage associated to secondary intergranular cracking (brittle fracture); b) detail of the brittle fracture surface showing intergranular cracking (arrow A); cleavage steps (arrow B) and slip traces (arrow C).

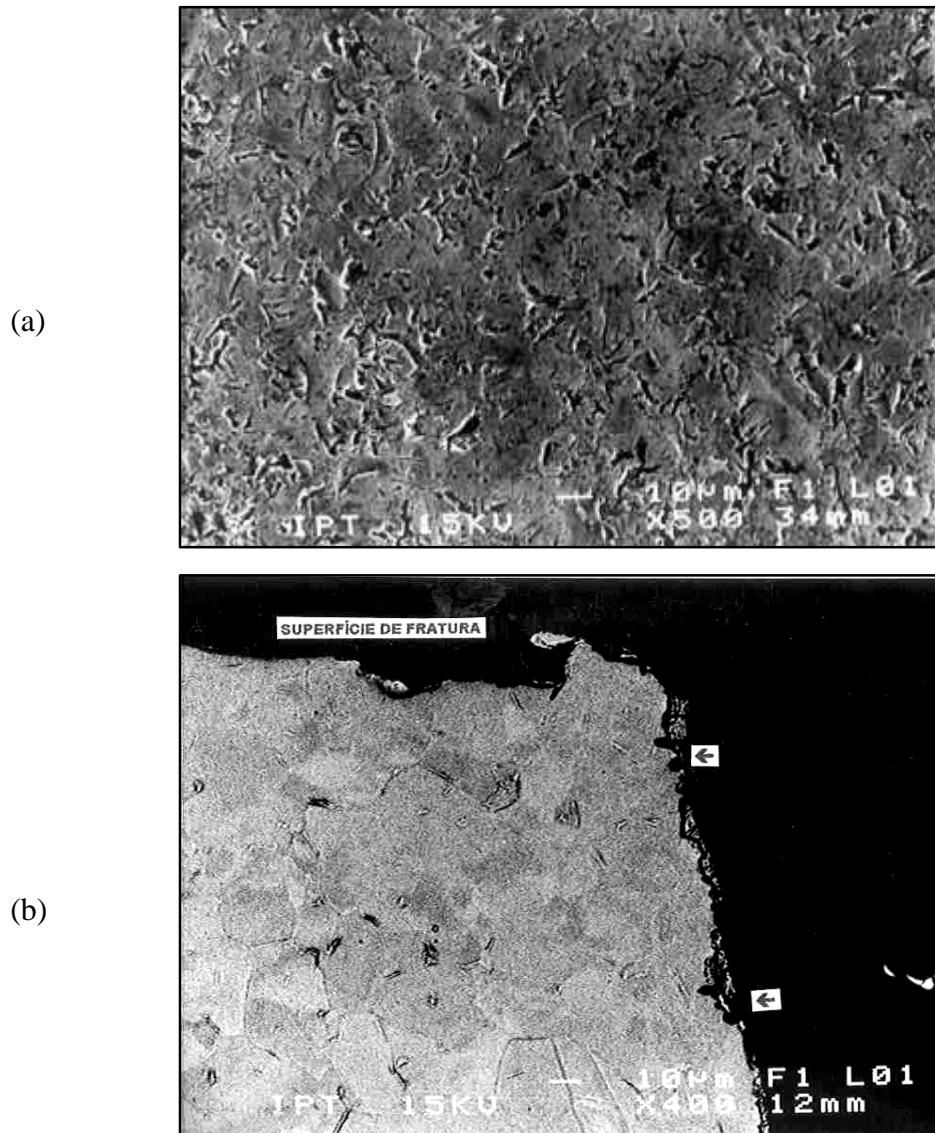
Figures 4a and 4b show the aspect of lateral and convex surfaces of the miniplate, indicating the occurrence of preferential attack and resembling microbiologically influenced corrosion, which may have acted as hydrogen source [25]. Finally, Koch [20] stated that the fracture produced by stress corrosion cracking (SCC) and slow-strain rate hydrogen embrittlement are indistinguishable in near- $\alpha$  alloys. They consist of cleavage-like facets within each  $\alpha$ -plate, each facet presenting surface steps and parallel secondary cracking. The fracture occurs occur through the  $\alpha$ -phase due to the formation of brittle stress- hydride phase. High quality pure titanium implants should present a special anodised surface finish that increases the thickness of the protective oxide film and, therefore, the corrosion resistance [26]

**Figure 4 :** Detail of the miniplate convex face: a) top view showing localised etching found on the miniplate convex face and lateral surfaces; b) longitudinal cross section showing the depth of the hydriding layer and the presence of localised etching on the convex surface (see arrows).
