# Aging aircraft transparencies: a case history from Italian Air Force Fleet.

Lt.Col. Manuele Bernabei, Lt. Daniele Caucci, Capt. Lorenzo Aiello\*  
Italian Air Force Flight Test Center  
Airport M. de Bernardi  
rc.gms@tiscali.it

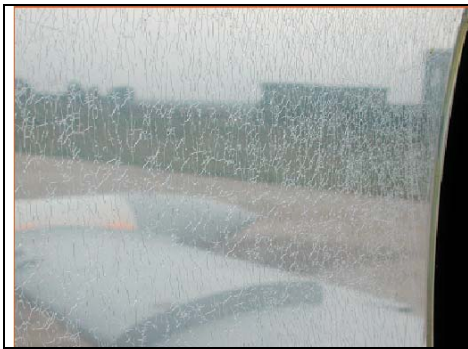
Figure 2.

Trainee ultrasonic aircraft fleet has been renewed in last five years and it is operating on an Air Force Base in the south of Italy. In this period ESC phenomena on transparencies of many vehicles has been observed. It has been necessary to replace parts well before of their required service life because of flight visibility lack, fig. 2, causing money waste and delay in flying readiness.

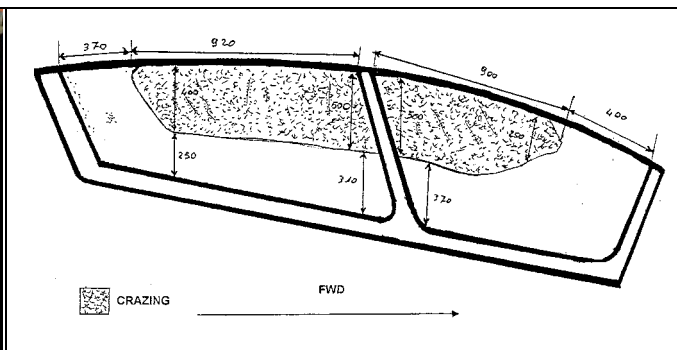
Figure 3. ESC localization

All damages were placed only on cockpit double transparencies, saving the windshield, and they were localized on central/right area, fig. 3.

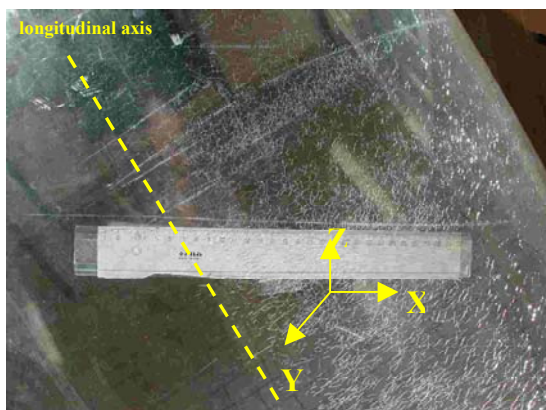
Figure 4.

Back transparency shows on left side superficial damages as scrapes but they did not act as initiation for ESC phenomena, fig. 4. Instead, on the right side, scrapes are stress concentration factors causing dense crazes, although there are many crazes even without initiation, far away from scrapes; a large part of damaged surface shows network of cracks with typical morphology of flat mug, fig. 5.

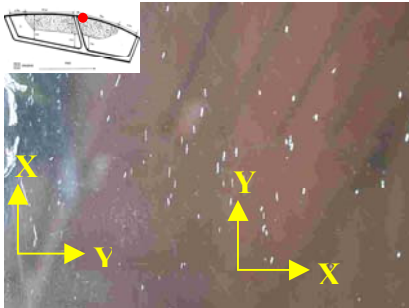
Figure 6.

Simple crazes are present on central area of the front transparency: each of them is perpendicular to longitudinal axis, fig. 6. The remaining damaged area it is not featured by a preferential direction of craze propagation, fig. 7; only a little zone shows a morphology of degradation which is typical of accidental contact with an aggressive liquid, fig. 8.

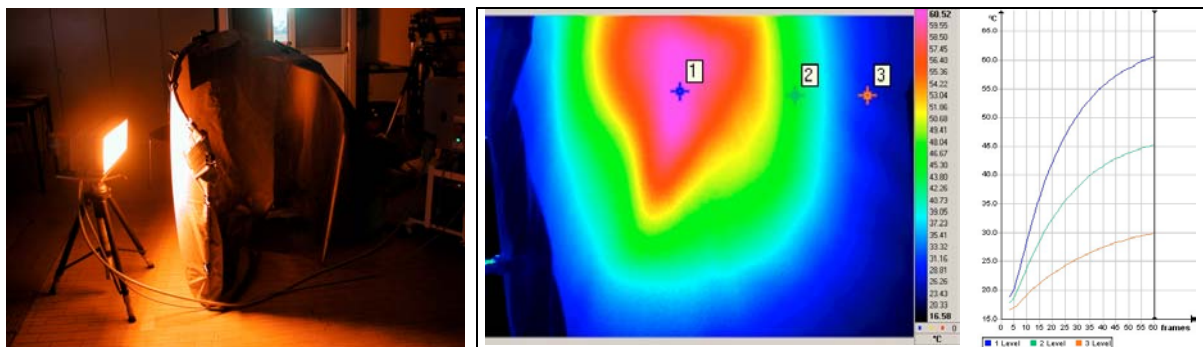
Figure 9.

Thermographic analysis have been carried out to measure the effect of sun irradiation and to evaluate transparencies behaviour while staying under covers used on aircraft. Heat transfer has been carried out by means of a 4000 W lamp at 25 cm, and temperatures have been measured on internal and external surfaces until constant values, figure 9. Low thermal diffusion of acrylic materials seems to be a critical aspect: a sharp temperature gradient is observed out of heat incidence, with loss of 30 °C in less than 20 cm.

FEM of a thermo-mechanical analysis has been produced to assess surface stress related to temperature gradient: after a 30 minutes heating, the highest value of principal stress was about 14 MPa, about 20 % of ultimate tensile strength value measured on aged acrylics specimen in undamaged area.

The observed deterioration can be defined as Multi Site Environmental Stress Cracking, and it might be avoided by using an under-transparency cover, or by means of shelters, or adopting a sun infrared irradiation reflective cover, or – at last – creating an air chamber between cover and transparencies.
