BRITTLE AND DUCTILE FRACTURES IN SERVICE OF PRESSURE VESSELS

ABSTRACT

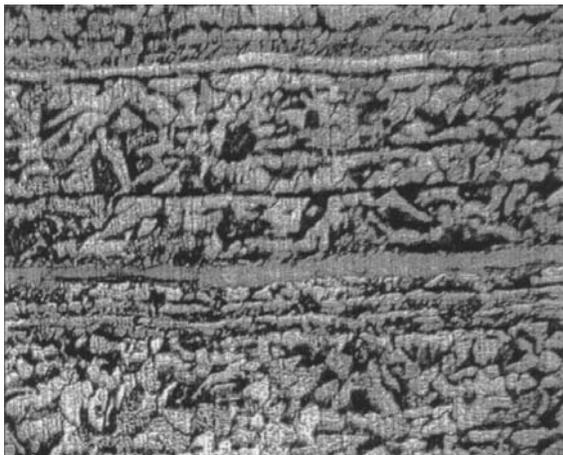
The 8 mm thick vessel mantle in Case I was produced from structural steel S355J2G3 according to EN 10025, with the chemical composition given in Table 1, and mechanical properties presented in Table 2. The microstructure exhibited expressed banding and non-uniform distribution of pearlite, with secondary linear structure, sulfide inclusions and segregation. The ferrite grain size was 9 -10, according to JUS C.A3.004 (Fig. 1a).

a. S355J2G3 steel (Case I)

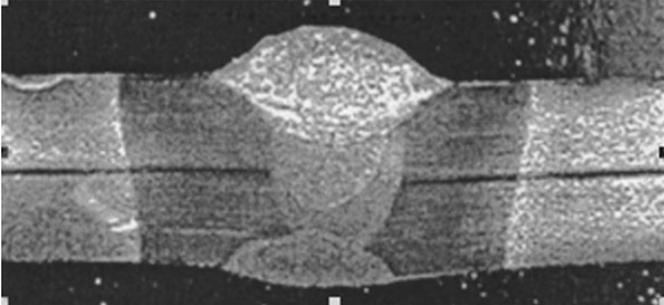
The microstructure of the base metal is not homogeneous due to laminated pearlite, as it is visible on the macrograph of the welded joint, Fig. 2. The HAZ microstructure is coarse grain bainite with acicular ferrite inside austenite grains and proeutectoid ferrite in net forms on austenite grain boundaries, Fig 3. Inclusions and coarse austenite grains in the HAZ favoured the occurrence of acicular ferrite. The proeutectoid ferrite in the austenite grain boundary is very coarse and brittle, and is therefore prone to brittle fracture.

Figure 2. Macrograph of the welded joint - S355J2G3 steel

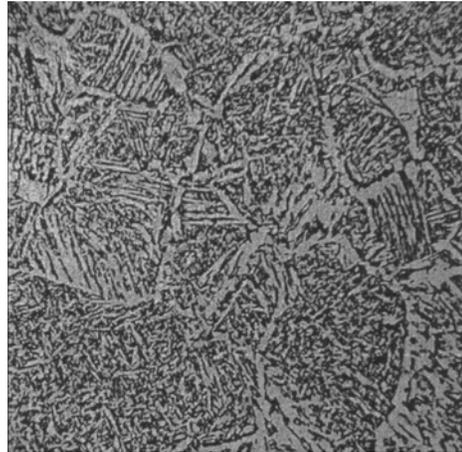
Figure 3. Coarse grain zone in HAZ (Case I).

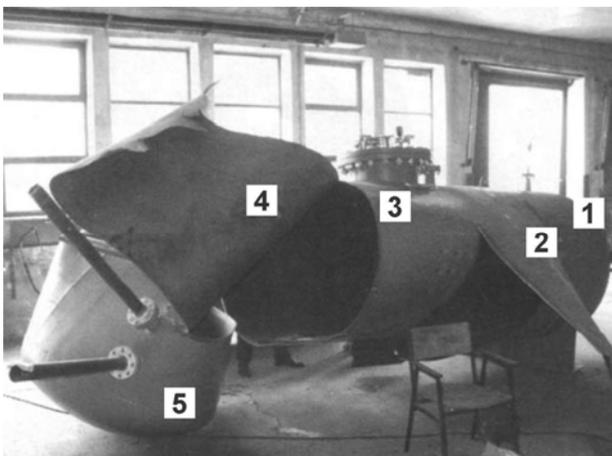
The view of the underground storage tank for liquified natural gas after brittle fracture is presented in Fig. 4. The plastic collapse of the mobile storage tank for ammonia transportation, with visible bulging, is presented in Fig. 5. In both tanks, the crack initiated in the heat-affected-zone (HAZ) of the vessel mantle. In the Case I, after initiation crack propagated in the longitudinal vessel direction, perpendicular to the circumferential welded joints. In Case II crack propagated following the circumferential welded joint.

Figure 4. Brittle fracture of the underground storage tank for liquified natural gas (Case I)

In Case I of the underground storage tank, according to the procedure, during proof pressure testing with gases from a higher pressure source, the material of the vessel should not be cooled below the nil ductility temperature (-20 °C in this case), and in order to be in accordance with the procedure, should be 25°C above it. It is supposed that during the proof pressure test, the underground storage tank had been exposed to the temperature lower than the nil ductility transition temperature, and the initiation of the brittle crack in plane strain situation can be attributed to this testing condition. The point of initiation in the lower part of the storage tank is expected, because that part is exposed to the lower temperature than the upper part of the tank. Crack propagation is parallel with the vessel longitudinal axis, according to the direction of maximum hoop stress. After some time, because of reduced temperature, the mantle temperature increases, and next propagation of the crack was ductile, with shear fracture surfaces at an angle of 45°, corresponding to maximum shear stress and plane stress condition.

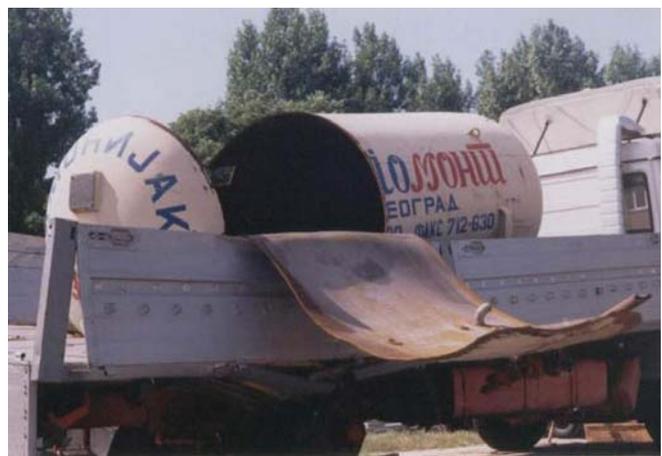
Figure 5. Ductile fracture of the mobile storage tank for ammonia transportation (Case II)

In the mobile storage tank for ammonia transportation (Case II), the crack initiated in the HAZ of the fillet weld between the mantle and the support reinforcement, firstly propagated longitudinally, in the direction of the vessel axis, and finally in the direction perpendicular to the axis of the vessel (Fig. 5). The point of initiation was located in the region where plastic deformation was constrained, Fig.12, which corresponds to plane strain condition. On the fracture surface 1 mm deep undercut can be seen, at the beginning of the fillet weld. The crack then propagated in the base metal in the highest hoop stress direction, Fig. 13. Propagation of the crack was through the circumferential weld by shear mechanisms.

In Case II, mobile storage tank for ammonia transportation fractured in fully ductile manner. Wall thickness reduction was from 8 mm to 5.3 mm at the point of crack initiation. The measured hardness of the HAZ on the mantle plate was from 310-321HV5, which is acceptable according to standard EN288-3, but having in mind the working medium (ammonia), due stress corrosion the recommended maximum value of hardness was 250HV. Because of the high value of toughness of the base metal, and the coarse grain of HAZ, the crack was propagating through the HAZ.

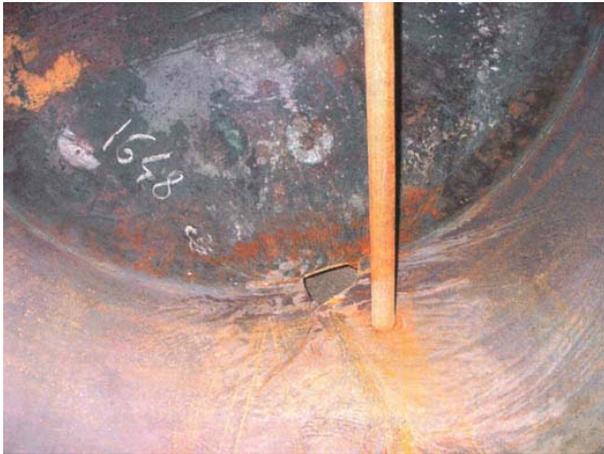
In Case I, the crack occurred in the lower part of the vessel mantle. From the lower part, one small piece of material was punched out, Fig. 6. The crack initiated in the HAZ of the circumferential welded joint, Fig. 7, in the coarse microstructure of the final bead (Fig. 3), then on one side partly propagated perpendicular to the longitudinal vessel axis, along the HAZ of circumferential welded joint located in position 2 of pressure vessel (Fig. 8). Reaching the region of higher toughness in welded joint, crack deviated into the base metal, in which it was finally arrested. On the other side crack propagated longitudinally through the base metal. In position 3 of the vessel (Fig. 9), after initiation in HAZ, crack did not follow HAZ, but propagated through the base perpendicularly to the weld, and where it was again arrested.

Figure 6. Fracture on the lower part of the underground storage tank

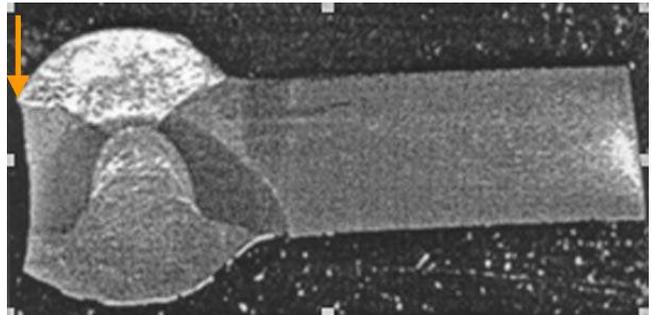
Figure 7. Crack initiated and developed through the HAZ of underground storage tank

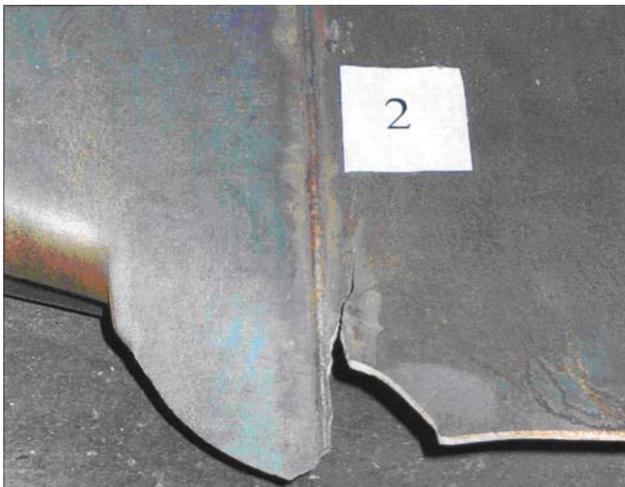
Figure 8. Crack deviated from the HAZ to the base metal

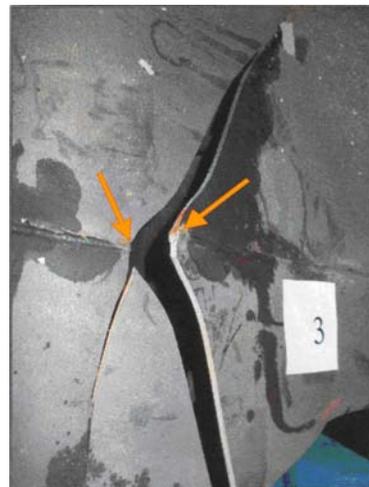
Figure 9. Crack deviated from the HAZ to the base metal

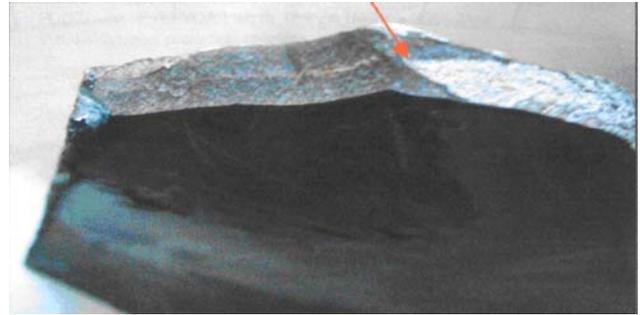
Analysis of the fracture surface on both the left and right sides of the point of initiation, along the heat affected zone, revealed that the fracture surface is perpendicular to the surface of the vessel, and flat, which is typical for the brittle fracture, without plastic deformation, (Fig. 10). The chevron patterns, which can be easily recognized in Fig. 10, could followed back eventually indicate the position of crack initiation, After normal flat fracture surface, corresponding to brittle fracture, the separation process had been finished by shear mechanisms in plane stress condition, in the slant direction of maximum shear stress acting in 45° direction, as it is shown in Fig. 10 for vessel position 2, and more clear in Fig. 11 for position 3, with typical brittle to ductile transition of fracture, with shear leaps.

Figure 11. Chevron patterns

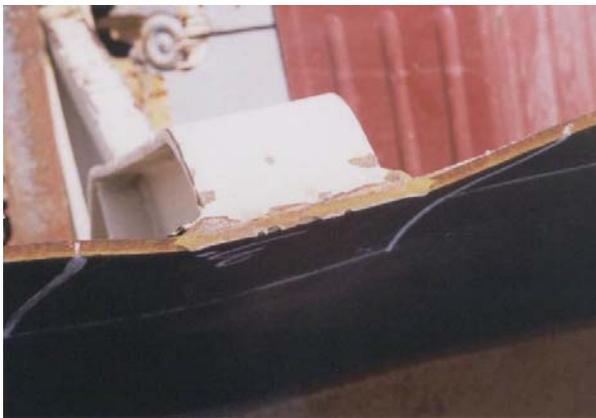
Figure 12. Location of crack initiation with indicated crack development path

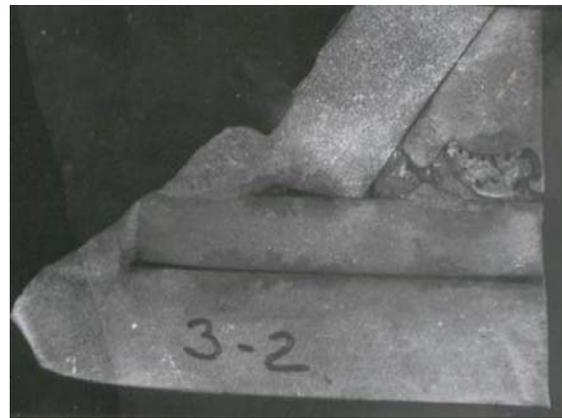
Figure 13. Macrograph of fillet weld with undercut causing strain concentration and plastic collapse

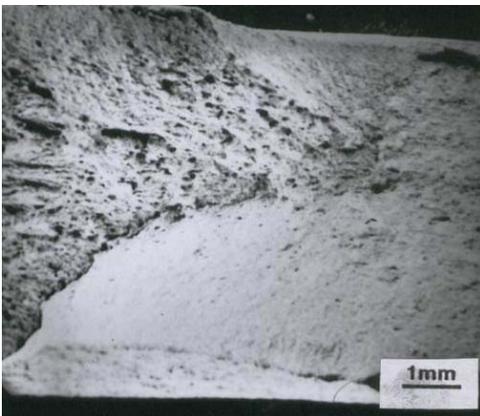
Analysis of the fracture surface has shown ductile fracture, followed prior plastic deformation. Scanning electron microscopy revealed the fibrous fracture [2], the crack growth through the thickness in the form of half ellipse crack. Shear leaps are typical for growing cracks in this case, and the slant fracture surface is inclined by 45° , in the direction of maximum shear stress.

Figure 14. Shear mechanisms with shear leaps

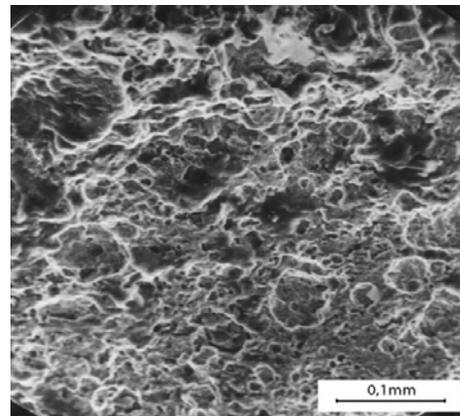
Figure 15. Ductile fracture surface
