FATIGUE BEHAVIOR OF DISSIMILAR WEATHERED RIVETED JOINTS OF HYBRID FIBER-METAL LAMINATE

* Tarpani J. R., Teixeira F. A., Oliveira R. A.

University of São Paulo, Av. Trab. São-Carlense, 400, São Carlos-SP, 13566-590, Brazil

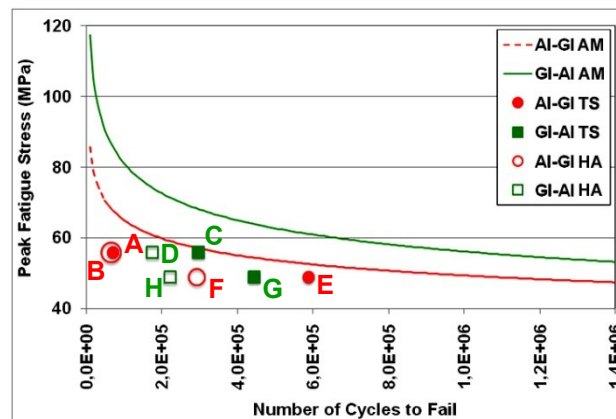
Fig. 2: S-N curves derived from as-manufactured (AM) Al-GI and GI-Al joints [4], and S-N data points obtained from testpieces subjected to repeated thermal shock (TS) and hygrothermal aging (AH), respectively.

- Fatigue-life of fastened joints was more deteriorated by hygrothermal aging than by repeated thermal shock.
- GI-Al joint configuration was more sensitive to both environmental conditioning.
- These tendencies were more evident under the peak stress of 49 MPa.
- Both the joint geometries exhibited lower-bound results after environmental conditioning, with GI-Al joint showing the poorest performance under lower stress (49 MPa) and Al-GI joint exhibiting the worse performance under higher stress (56 MPa).

The higher sensitivity of GI-Al joint to environmental factors corroborates the moisture absorption results reported in the moisture up-take item above. E vs. G results in Fig. 2 indicate that moisture up-take probably occurred in GI-Al joint configuration in response to repeated thermal shock, thus

enabling freeze-thaw cycle damage to develop [5]. Deleterious effects of both types of conditioning on Gl-Al joint fatigue-tested under lower peak stress was more evident due to the longer time this dissimilar joint was subjected to cyclic mechanical loading, which allowed the failure mechanisms resulting from subtle environmental conditioning damage introduced previously to become fully operative.

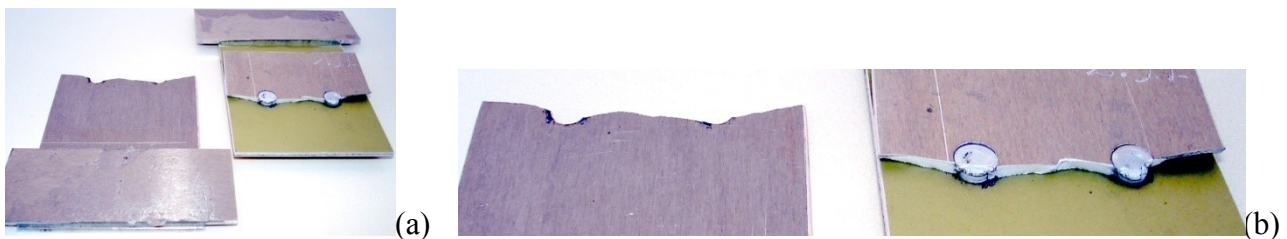
Non-conditioned Al-Gl joint (Al-Gl AM curve in Fig. 2). Fig. 3 depicts the Al-Gl joint fractured at 302,027 fatigue cycles by [4]. Fretting in maximum pressure points at the hole borders is promptly noticed, with cracking and complete fracture of the countersunk Al-alloy sheet. A visual inspection of the inner metal layer of Glare sheet did not allow for the detection of possible damage on it. Fragmentation and loss of 30-50% of conical rivet heads are clearly observed.

Fig. 3: (a) Fatigue fracture of Al-Gl joint without previous conditioning [4]; (b) Magnified view.

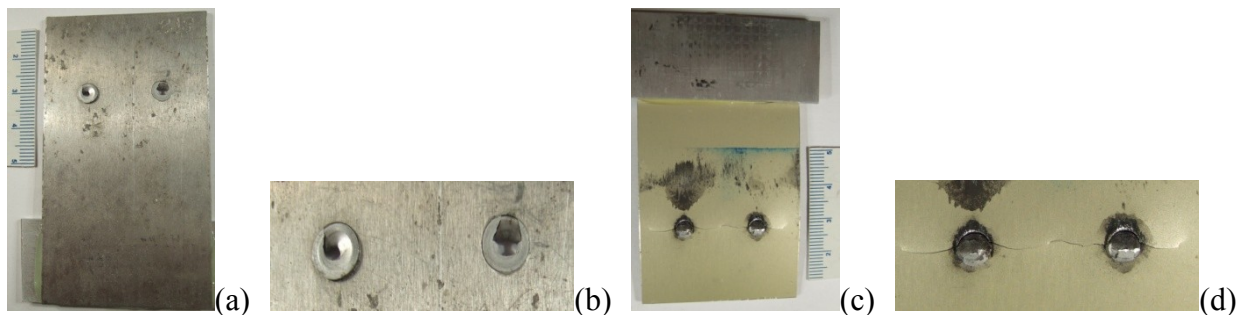
Thermally cycled Al-Gl joint (data point A in Fig. 2). Fig. 4 shows the Al-Gl joint fractured after 69,326 fatigue cycles, which is a much shorter life than as-manufactured specimen (Fig. 3). Failure mode includes pull-out of rivet shanks from matching heads and extensive cracking of inner metal layer of the flat-bottom hole Glare sheet, with cracks initiating at straight hole edges. This lengthy cracking rendered the joint increasingly compliant during fatigue testing, thus favoring rivet fracture mechanisms which in turn determined specimen's fatigue-life. Repeated thermal shock damaged hole border regions of Glare plaque, expediting the onset of fatigue crack growth at the inner metal layer and reducing testpiece's fatigue-life. Freeze-thaw effects caused interfacial damage, thus undermining adhesion between layers of Al-alloy and glass fiber/epoxy composite within Glare-FML as well as impairing mechanical strength and stiffness of its composite core. As a result, overloaded metallic outer layers speed up both crack initiation and propagation stages in Glare, further contributing to reduce the specimen's life under cyclic loading.

Fig. 4: (a) Outer face of countersunk Al-alloy sheet of the Al-Gl joint (A); (b) Detailed view; (c) Inner face of straight-bottom hole FML sheet; (d) Detailed view.

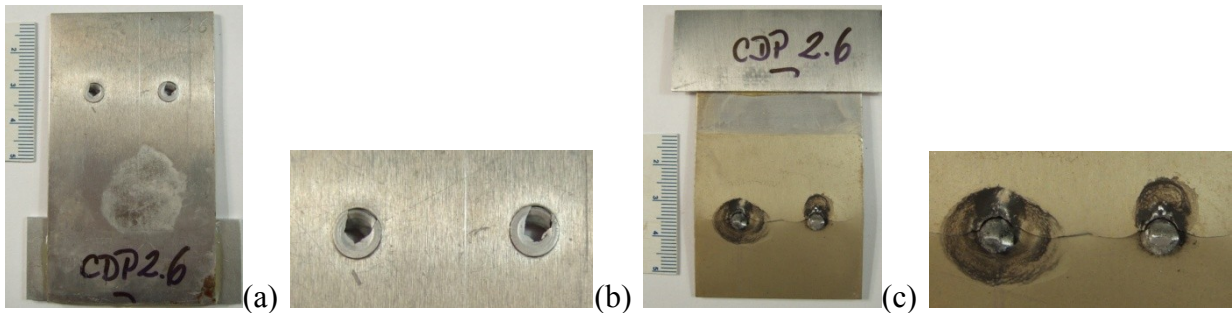
Hygrothermally aged Al-Gl joint (data point B in Fig. 2). Fig. 5 presents the Al-Gl specimen which endured 66,406 fatigue cycles, which is very close to the fatigue-life displayed by the previously thermally cycled joint shown in Fig. 4. The observed failure mechanisms and their chronological sequence seem to be quite similar to those established for Fig. 4, so that consistency and robustness of obtained results is ascertained. Due to this observed similarity, fretting is

probably not the controlling mechanism of failure process, since hygrothermal aging would favor this effect on the subsequent fatigue loading more effectively than repeated thermal shock. It can be concluded that applied stress must have been sufficiently high to preclude the complete development of fretting mechanism.

Fig. 5: (a) Outer face of countersunk Al-alloy sheet of the Al-GI joint (B); (b) Magnified view; (c) Inner face of flat-bottom hole Glare sheet; (d) Magnified view.

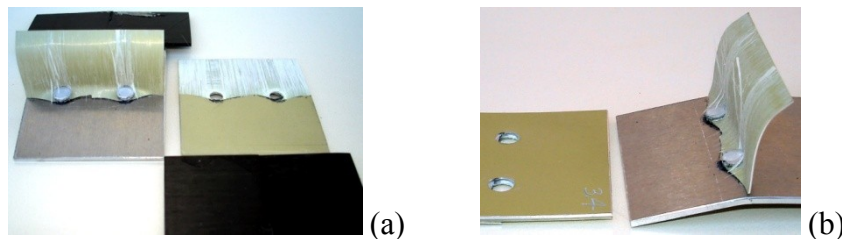
Non-conditioned GI-Al joint (GI-Al AM curve in Fig. 2). Fig. 6 depicts the GI-Al joint fractured under fatigue at 667,708 loading cycles by [4]. Fretting at rivet hole boundaries, as well as complete cracking of inner metal layer of the countersunk Glare sheet, alongside extensive fragmentation of both rivet heads are clearly noticed. In addition, almost complete through-the-thickness fracture of the straight-bottom hole Al-alloy sheet, with crack starting on its inner face, was unveiled. Fretting-induced cracking at the inner layer of Glare occurred in positions away from hole edges, thus preventing rivet heads from passing through the holes in the inner metal layer of countersunk FML sheet, leading to its extensive delamination.

Fig. 6: GI-Al joint fatigued-tested by [4]. (a) Frontal view; (b) Lateral view.

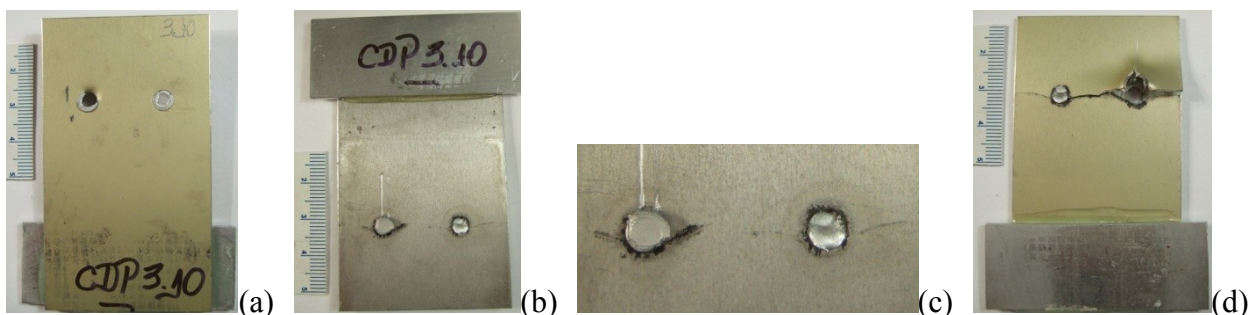
Thermally cycled GI-Al joint (data point C in Fig. 2). Fig. 7 shows the GI-Al joint fractured after 297,772 applied fatigue cycles, half the lifespan of non-conditioned specimen shown in Fig. 6. Specimen failure was due to extensive cracking of inner metal layer of Glare sheet and partial fragmentation of one fastener head. This process was accelerated by increasing specimen compliance due to the aforementioned cracking. Upon reaching a critical combination between damage extension of conical rivet heads and cracking degree at the inner metal layer of Glare-FML sheet, the undermined rivet came out through the Glare plaque thus overloading the twin fastener, which ruptured due to pure shear resembling a guillotine effect.

Fig. 7: (a) Outer face of countersunk Glare sheet of the GI-Al joint (C); (b) Inner face of flat-bottom hole monolithic Al-alloy sheet; (c) Detailed view; (d) Inner face of Glare sheet.

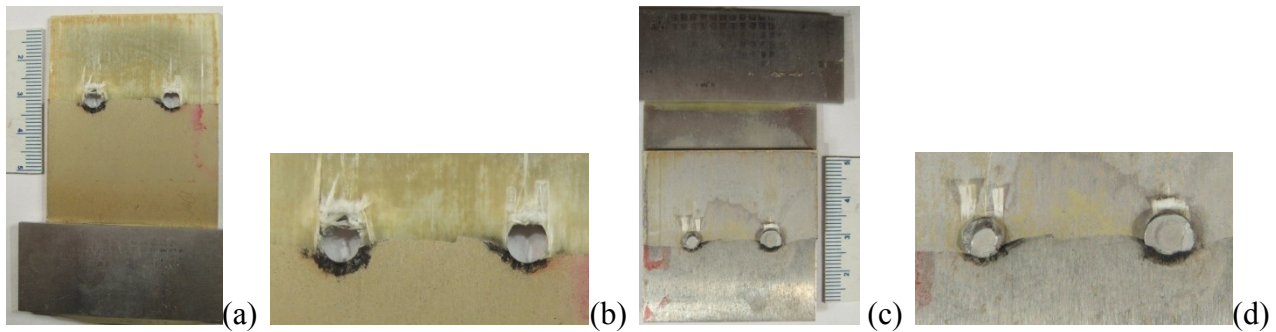
Hygrothermally aged GI-Al joint (data point D in Fig. 2). Fig. 8 outlines the GI-Al joint that failed catastrophically at 174,851 fatigue cycles, half the lifespan of the preceding joint (Fig. 7). This failure was basically due to transverse cracking of inner metal layer of the countersunk Glare sheet, boosted by accelerated fretting due to corrosion that took place during previous environmental conditioning. In the final stages of failure process, partially pierced rivet heads were pulled out through the Glare sheet. However, conjoined action of moisture and temperature during previous hygrothermal conditioning degraded and swelled the glass-epoxy core of Glare, thus reducing its mechanical properties [6-10]. This finding is corroborated by Figs 8c,d, which show entrapment and tearing of the expanded composite core layer under one completely fragmented fastener head.

Fig. 8: (a) Inner face of countersunk Glare sheet of the GI-Al joint (D); (b) Detailed view; (c) Inner face of straight-bottom hole Al-alloy sheet; (d) Detailed view.

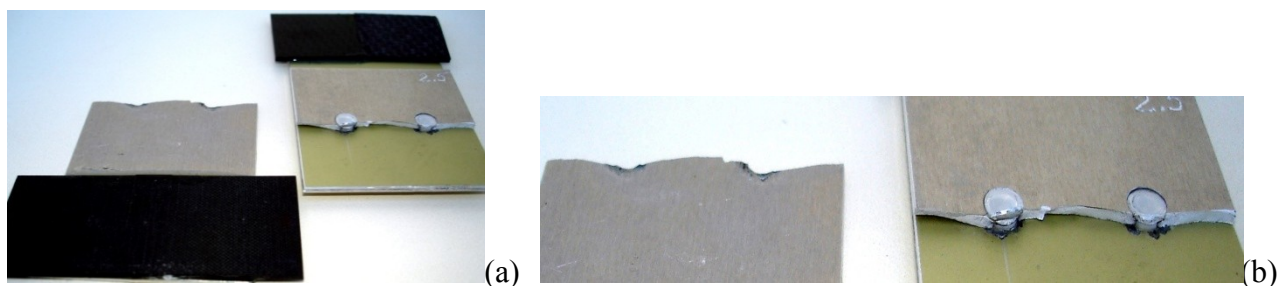
Non-conditioned Al-GI joint (Al-GI AM curve in Fig. 2). Fig. 9 shows the non-conditioned Al-GI joint fatigue fractured at 679,247 cycles by [4]. This joint is remarkably similar to that depicted in Fig. 3, which was also fatigue-tested without previous conditioning, but at a higher stress (56 MPa). Fretting is quite visible at maximum pressure contact regions between matching plaques, so are full cracking of countersunk Al-alloy sheet, permanent deformation of part of one rivet head as well as fractional splitting of the second fastener head.

Fig. 9: (a) Al-GI joint without previous conditioning fatigue tested by [4]; (b) Magnified view.

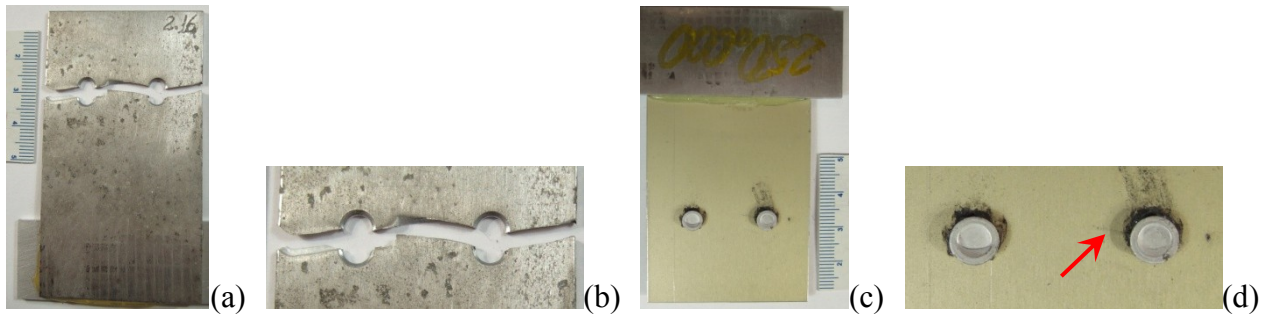
Thermally cycled Al-GI joint (data point E in Fig. 2). Fig. 10 shows the Al-GI joint subjected to repeated thermal shock and then fatigue-tested up to failure at 587,443 cycles, where the predominant mechanism is complete fracture of countersunk Al-alloy sheet. Failure mode of Al-GI joints in Figs 9 and 10 is visually very similar, except for entrapment of part of the Al-alloy sheet in the first case due to slight displacement of crack nucleation sites from the hole corners. Crack nucleation locus are polar in non-conditioned joint (Fig. 9) but lateral in thermally cycled joint (Fig. 10), leading to somewhat different crack paths between these specimens. Fatigue-life difference between these specimens is not statistically significant (~10%), indicating that the effect of previous environmental conditioning was negligible. This deduction has to be confirmed by checking for the presence of cracking at the inner metal layer of Glare in non-conditioned joint (Fig. 9), as indicated by an arrow in Fig 10d.

Fig. 10: (a) Outer face of countersunk monolithic Al-alloy of the Al-GI joint (E); (b) Detailed view; (c) Inner face of flat-bottom hole Glare sheet; (d) Detailed view.

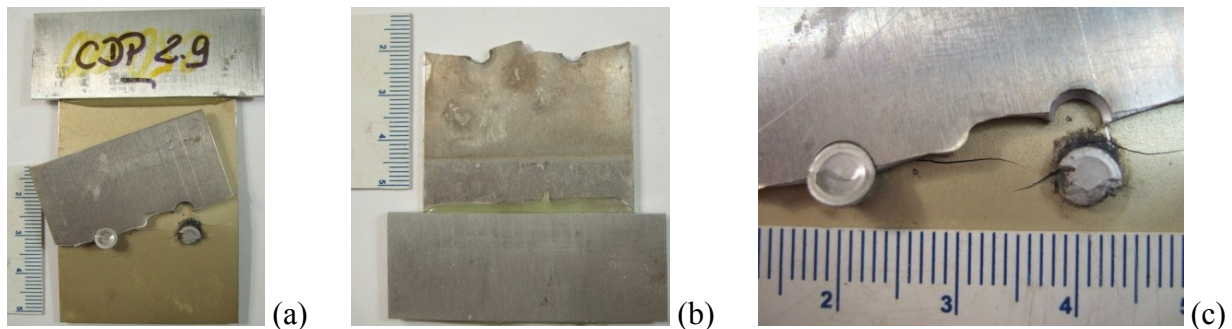
Hygrothermally aged Al-GI joint (data point F in Fig. 2). Fig. 11 images the hygrothermally aged Al-GI joint fractured after 292,529 fatigue cycles, half the lifetime of the specimen presented in Fig. 10. Although the predominant failure mechanism was rupture of monolithic Al-alloy sheet (see Fig. 10), previous environmental conditioning also favored cracking of inner metal layer of Glare-FML, albeit not sufficiently to cause it to collapse before the matching monolithic Al-alloy sheet. Simultaneous heat and moisture action created favorable conditions for fretting development, thus facilitating crack nucleation on both metallic surfaces of contacting sheets and advanced rupture of the specimen. Both rivet heads were markedly damaged, with 50% of one fastener head being fragmented and the other one undergoing extensive plastic deformation at the very final detachment between sheets.

Fig. 11: (a) Overall view of Al-GI riveted joint (F); (b) Inner face of countersunk Al-alloy sheet; (c) Detailed view of rivet heads, fracture of Al-sheet, and Glare sheet cracking.

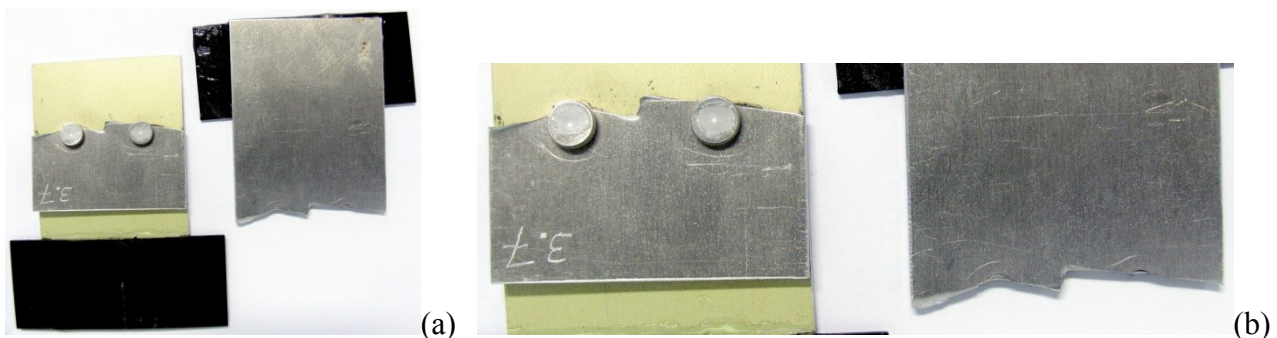
Non-conditioned GI-Al joint (GI-Al AM curve in Fig. 2). Fig. 12 depicts the GI-Al joint fractured by fatigue at 1,309,892 cycles [4], showing complete rupture of flat-bottom hole Al-alloy sheet. Cracks nucleated close to poles of drilled rivet holes, at some distance from their borders, so that subsequent cracking caused entrapment of the fractured portion of Al-alloy sheet. The same macro-mechanism had already been observed in non-conditioned GI-Al joint that was fatigue-tested under a peak stress of 56 MPa (Fig. 6), when fretting-generated cracks also developed in the bulk material instead of at drilled hole corners. However, in that case, fractured sheet was the countersunk Glare one, and not the monolithic straight-bottom hole Al-alloy plaque.

Fig. 12: (a) Non-conditioned Al-GI joint tested under fatigue by [4]; (b) Magnified view.

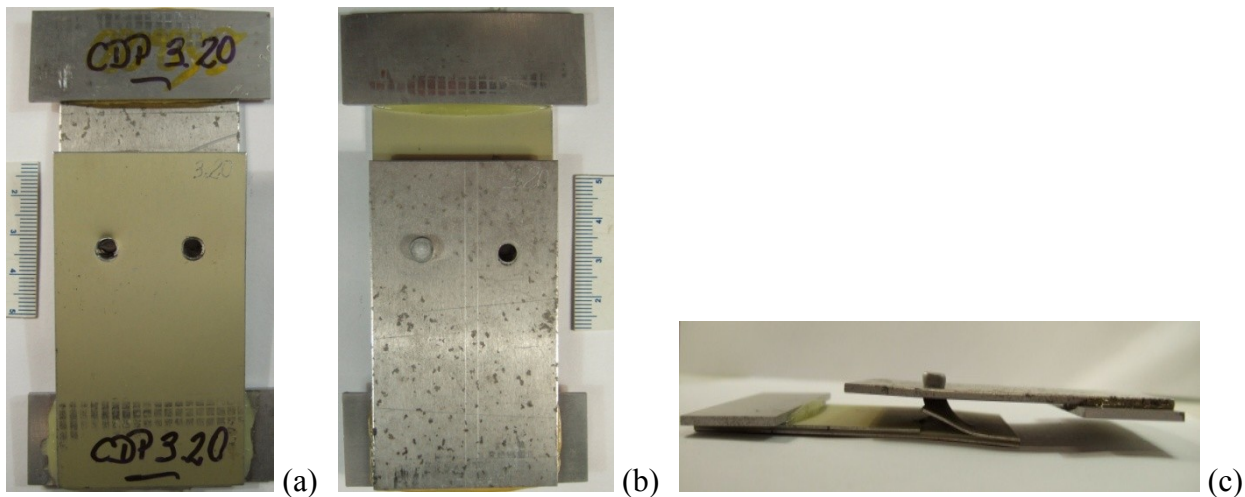
Thermally cycled GI-Al joint (data point G in Fig. 2). Fig. 13 illustrates the GI-Al joint fractured after 444,472 fatigue cycles, where failure comprised partial or total fragmentation of rivet heads, and corresponding partial or total cracking of inner metal layer of countersunk Glare sheet. Whereas the rivet whose head was totally fragmented during fatigue loading was pulled out at the end of the failure process, partially broken off rivet head caused delamination between inner metal and matching glass-epoxy core layers, aided by fatigue pre-cracking of the former layer. Therefore, the root cause of joint failure was synergy between the interdependent fracture mechanism of rivet heads and fatigue cracking of inner metal layer of Glare. Fatigue-life of this joint was three-fold shorter than that of corresponding non-conditioned joint (Fig. 12), signaling how deleterious repeated thermal shock can be for its subsequent fatigue performance under a peak stress of 49 MPa.

Fig. 13: (a) Outer face of countersunk Glare sheet of the GI-Al joint (G); (b) Outer face of straight-bottom hole monolithic Al-alloy sheet; (c) Lateral view of fatigue-fractured joint.

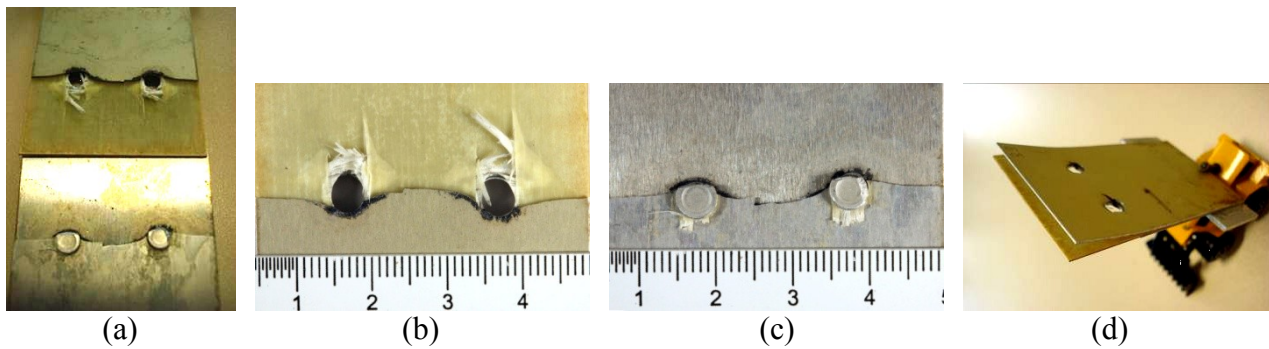
Hygrothermally aged GI-Al joint (data point H in Fig. 2). Fig. 14 shows the GI-Al joint fractured after 223,000 fatigue cycles, whose fracture aspects appear to be very similar to that of joint presented in Fig. 8, which was also subjected to hygrothermal aging but fatigue-tested to a peak stress of 56 MPa. This specimen presented complete cracking of inner metal layer of Glare, with cracked portion of this layer remaining attached by the rivet heads to the flat-bottom hole Al-alloy plaque. Intensive and extensive fretting was developed at hole boundaries, besides massive deterioration of rivet heads, notwithstanding to a lesser extent than that observed under higher peak stress (Fig. 8). The same reasoning exerted in the analysis of Fig. 8 with regard to hygrothermal aging effect on swelling and degradation of glass-epoxy composite core of Glare holds for Fig. 14, since entrapment of inner metal layer of Glare and presence of composite fragments under rivet heads occurred as well in the latter case. The unfeasibility of detecting eventual internal cracking in non-countersunk Al-alloy sheet in Fig. 14 is equivalent to Fig. 8. However, two facts clearly distinguish Fig. 14 from Fig. 8, namely, cracking of outer metallic layer of Glare and extensive delamination between this and the glass-epoxy composite core layers of the FML, as seen in Fig. 14. The latter impairing mechanism, which was caused by previous hygrothermal conditioning, weakened bonding between metal and composite layers, and became evident during fatigue load at the peak stress of 49 MPa owing to the longer timespan in which GI-Al joint was cyclically loaded as compared to the time spent under the peak stress of 56 MPa. This interfacial failure unbalanced the mechanisms of support and distribution of mechanically applied load, thus inducing and accelerating cracking in the outer metal layer of Glare, although the exact chronological rank of these events cannot be precisely confirmed. Lastly, fretting favored and speeds up by previous environmental conditioning shortened fatigue-life of joint by reducing the time for crack nucleation in inner metal layer of Glare.

Fig. 14: (a) Inner faces of Glare (top) and monolithic Al-alloy sheets (bottom) of the GI-Al joint (H); (b,c) Detailed views of previous image; (d) Extended delamination of Glare sheet.
