## Critical crack path assessments in failure investigations

Robert D. Caligiuri

*Exponent, Inc., 149 Commonwealth Drive, Menlo Park, CA 94025 USA*

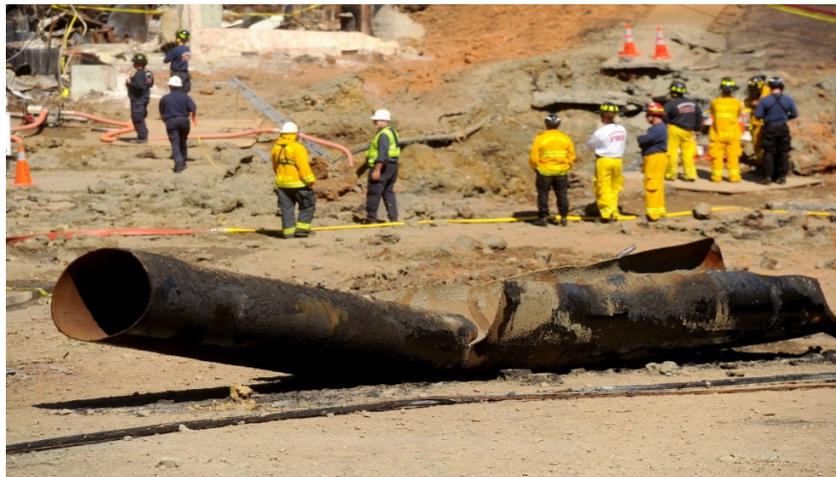
started in Pup 1 and extended some 28 feet (8.54 m). The force of the rupture created a large crater in the ground and ejected a large piece of the pipeline as shown in Fig. 1. The released cloud of natural gas ignited, causing considerable loss of life and property damage in the surrounding subdivision.

Figure 1: Photograph taken the day after the incident showing the ruptured segment of Line 132 that was ejected from the ground by the force of the rupture. Source: [www.dailyrepublic.com](http://www.dailyrepublic.com).

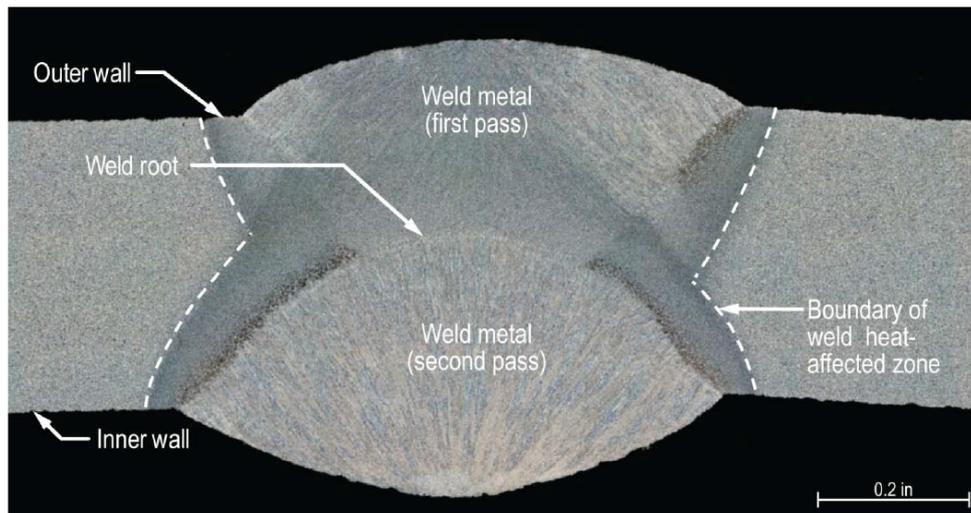
Segment 180 of Line 132 consists of pipe that is nominally 30 inches (0.76 m) in diameter and 3/8-inch (0.009 m) thick. Fabrication of such pipe starts with a flat steel plate, called a skelp, which is then rolled into a cylindrical shape in a pipe rolling machine and welded longitudinally to join the mating edges. The longitudinal seam weld can be made using one of several welding processes. One such process, and the one used to fabricate Segment 180 pipe circa 1948, is called double submerged arc welding (DSAW), which involves welding the seam from both the inside and outside of the pipe, with each weld penetrating more than half way through the thickness of the seam. A metallographic cross section of a proper DSAW seam is shown in Fig. 2.

Figure 2: Metallographic cross section of a proper DSAW weld from NTSB Final Report, Fig. 19b.

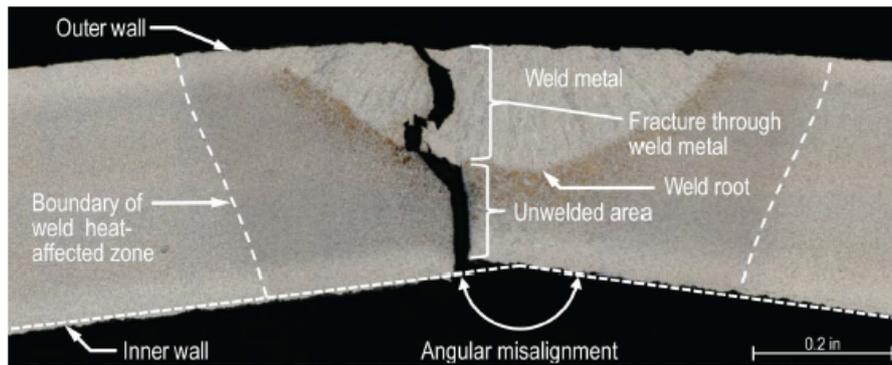
Based upon visual and metallurgical analysis of the subject pipe, it is clear that portions of Segment 180 – namely pups 1, 2, and 3 – were missing the interior seam weld found in properly fabricated DSAW pipe as shown with respect to Pup 1 in Fig. 3. Tensile testing conducted by the NTSB indicated that the base metal in Pup 1 through Pup 6 did not meet the 52,000 psig (358 MPa) strength requirement specified by PG&E in purchases of 30-inch (0.76 m) pipe in the late 1940s and 1950s. Further, the directionality of manganese-sulfide stringers determined during metallographic examination indicated the rolling direction of Pup 1 through Pup 3 was in the circumferential direction rather than the longitudinal direction associated with full lengths of pipe manufactured at a mill. This indicates the pups were not cut from longer pipe sections but were individually fabricated from smaller pieces of plate oriented 90 degrees from full length pipe rolling operations. Given that the rupture initiated through weld metal in Pup 1, the lower-than-specified base metal strengths exhibited in Pup 1 through Pup 6 and transverse rolling direction orientation in pups 1, 2, and 3 did not contribute to the rupture. The length of the pups (less than 5 feet (1.52 m)) also had no relationship to the root cause of the accident.

The failure of Segment 180 was in part due to the missing interior seam weld in Pup 1. However, the missing weld in and of itself was not sufficient to cause the rupture in Pup 1 on September 9, 2010. Two additional factors were also necessary to cause the pipeline failure in San Bruno: (1) ductile tearing at the root of the exterior longitudinal seam weld on Pup 1; and (2) fatigue cracking that initiated and grew from the ductile tear slowly over time by the action of normal operational pressure fluctuations in the pipeline. This fatigue cracking grew to a point that the relatively small increase in pressure on September 9, 2010, caused the Pup 1 longitudinal seam to rupture. Thus, the root cause of the failure was the unique combination of three factors; the elimination of any one of which, and the rupture would not have occurred.

Figure 3: Metallographic image from NTSB Final Report (Fig. 19a) that shows the single-side weld in Pup 1.

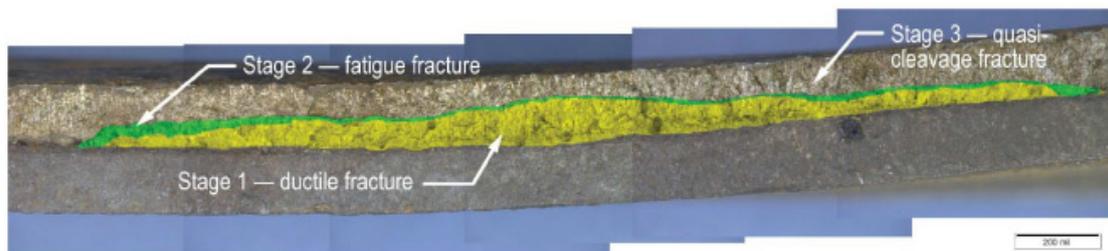
Fractographic analysis of the Pup 1 fracture surface provides clear evidence of the ductile tear and the fatigue crack growth zone. A ductile tear is characterized by appreciable plastic deformation and energy dissipation, and is created by a single loading event. A schematic from the NTSB Final Report that highlights the regions of ductile tearing and fatigue cracking is shown in Fig. 4. Ductile fracture morphology, characterized by microvoid coalescence, was observed within the ductile tear region in a scanning electron microscope (SEM), as shown in Fig. 5, and is indicative of ductile tearing. As indicated in the NTSB schematic reproduced in Fig. 4, fatigue crack growth morphology was observed between the ductile tear and the final brittle cleavage fracture zone. Cleavage fracture morphology is characteristic of fast, unstable fracture in steel. Cleavage fracture morphology within the final rupture zone in Pup 1 is shown in Fig. 6.

Figure 4: Montage from NTSB Final Report (Fig. 21) that highlights approximate ductile tear (yellow) and fatigue crack growth (green).

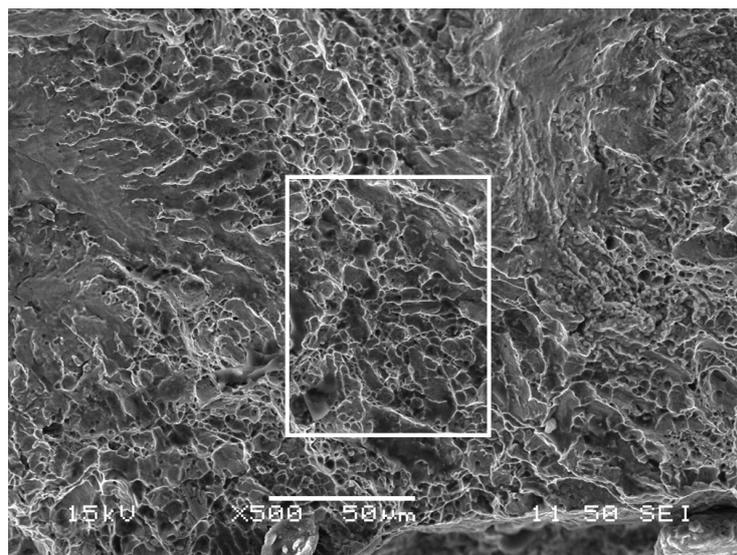
Figure 5: Exponent SEM image that shows microvoid coalescence fracture morphology within the ductile tear (the yellow area in Fig. 3). Representative microvoid coalescence morphology is indicated within the white box.

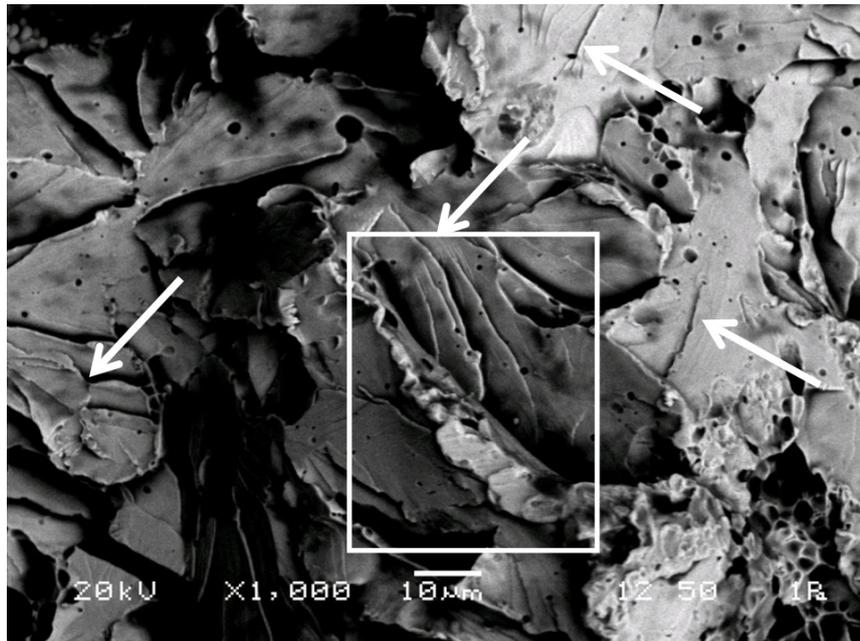
Figure 6: Exponent SEM image of brittle cleavage fracture morphology in Pup 1 final rupture zone. Representative river patterns associated with cleavage fracture are indicated by arrows.

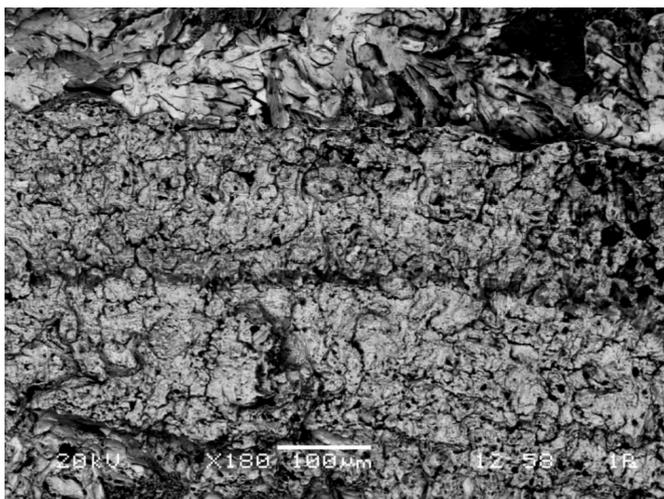
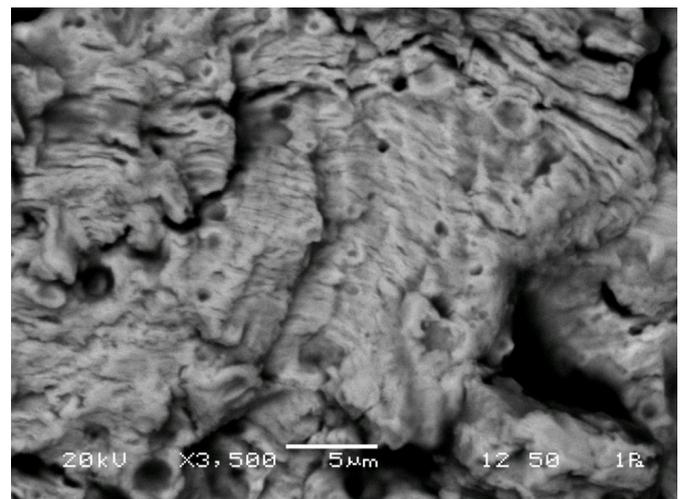
Fatigue cracking is characterized by stable crack growth that occurs incrementally over time in response to cyclic loading. Characteristic features called fatigue striations, indicative of fatigue crack growth under operational pressure fluctuations, were present at greater depths than the ductile tear as shown in Fig. 7. This indicates that the creation of the ductile tear had to have preceded the initiation and growth of the fatigue cracking. Further, this indicates that the magnitude of the single loading event that caused the ductile tear was greater than the operational pressure fluctuations that later caused the fatigue crack growth.

Figure 7: Exponent SEM images: (a) Fatigue striations were observed within Regions A & B, between the ductile tear (Region D) and the final brittle fracture (Region C); (b) Close-up of Region B in image (a), showing representative fatigue striations (within the box).

Fractographic examination of the Pup 1 rupture surface clearly indicated that fatigue cracking extended the length and depth of the ductile tear as shown in Fig. 7. The initiation of fatigue cracking from the “blunted” tip of the ductile tear likely took longer than the time it took to grow the initiated fatigue cracking. This is because of the rounded shape of the tip of a ductile tear, as opposed to the sharper tip of a growing fatigue crack.
