A STUDY OF HYDROGEN EMBRITTLEMENT IN AUTOMOTIVE FASTENER STEELS

B. Lonyuk^{1*}, R. Hop², D.N. Hanlon¹, S. van der Zwaag³, J. Zuidema³ and A. Bakker³

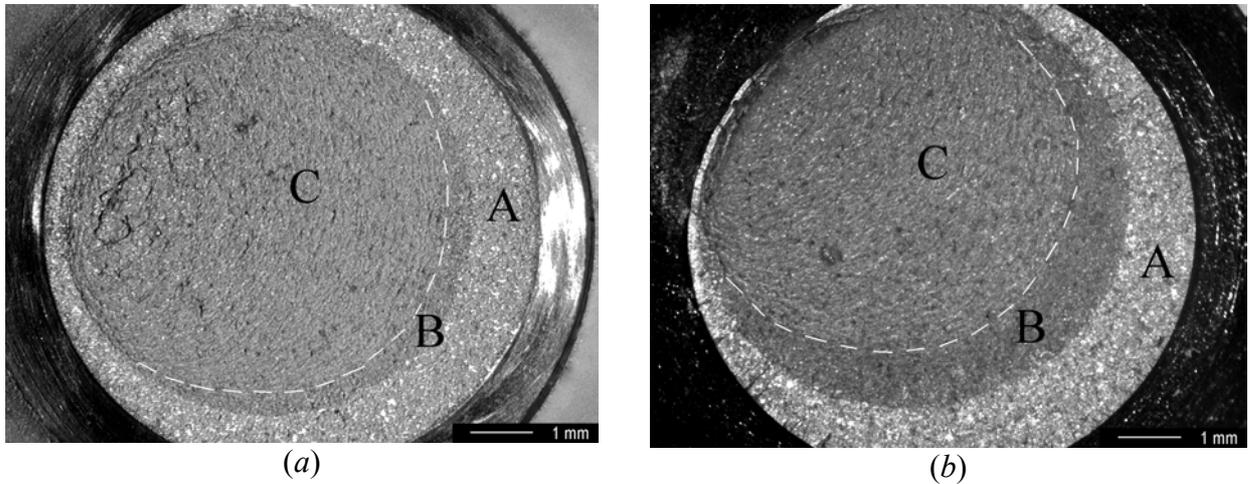
The microfractographic investigations of the fracture surfaces of slow strain rate failure specimens revealed three zones (Figure 3): fatigue precracking, slow-crack propagation and overload failure. The

region of stable, subcritical crack growth was observed for all conditions investigated (quenched and tempered; quenched, tempered and plated; quenched, tempered, plated and annealed). Microfractographic investigations of the fracture surfaces of samples tested at 1 mm/min showed no evidence of stable crack growth. Instead, the surfaces were composed of two regions: fatigue and overload.

Figure 3: Fracture surface of a slow strain rate failure samples: (a) – unplated material; (b) – plated material. A – fatigue precrack; B – slow-crack propagation area; C – overload failure.

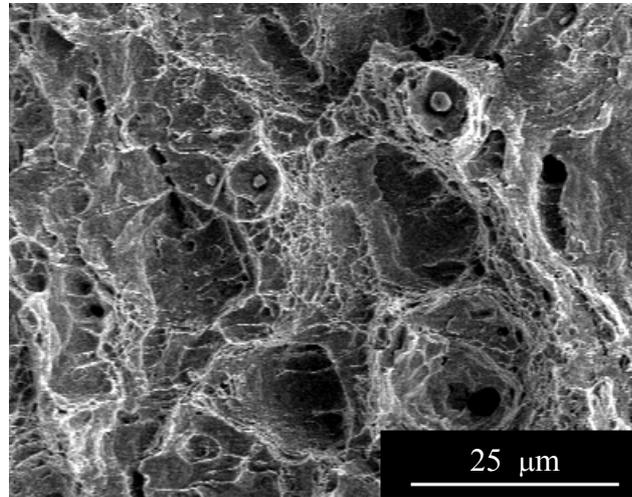
Observation of the overload region of the fracture toughness samples subjected to fracture toughness testing at 1 mm/min revealed a ductile fracture mode due to microvoid nucleation and growth (Figure 3). Fast fracture areas of the slow strain rate failure samples indicated the same ductile type of fracture.

Figure 3: Fracture surface in the overload region close to the fatigue precrack for a sample failure at the 1 mm/min.

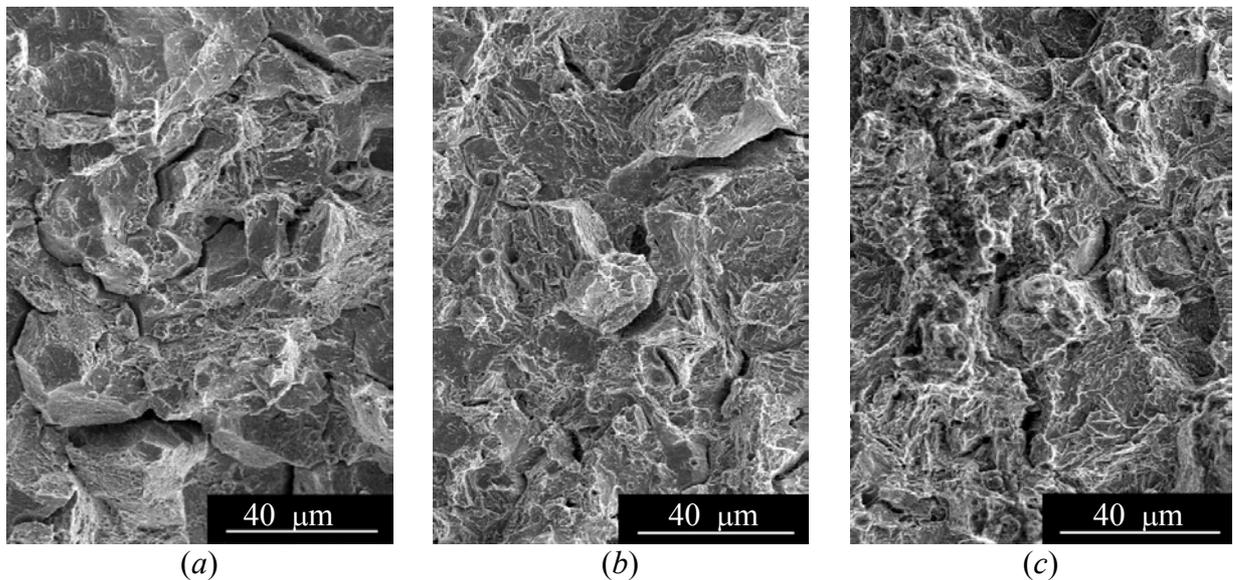
The most attention was paid to the investigation of the slow-crack propagation areas. Fracture surfaces were observed to comprise features indicative of brittle failure in this region. Many secondary cracks were also evident. It may be concluded that this embrittlement is due to either dissolved hydrogen (for the quenched and tempered material) or hydrogen introduced by the plating process (for plated material). It has been shown that for quenched and tempered material cracking was intergranular with respect to the prior austenite grain boundaries (Figure 4a). Whereas, the observed fracture mode for the plated material was quasicleavage (Figure 4b). The result shown in Figure 4 is not consistent with a known effect of hydrogen on the fracture mode. For plated material, where more hydrogen may be

Therefore the observed intergranular fracture for quenched and tempered material is probably a consequence of hydrogen segregation to prior austenite grain boundaries and a resulting lower cohesive force in those regions. In this case the characteristic distance may be the prior austenite grain diameter. For plated materials the hydrogen at martensite laths, carbide precipitates, etc. may play a more important role and the characteristic distance could be related to the spacing of such microstructural heterogeneities.

Figure 4: Slow-crack propagation area for quenched and tempered material (a), plated and unannealed (b) and plated and annealed (c) materials.

The application of a low temperature annealing on the material was observed to increase the threshold stress intensity factor (cracking started at higher stress level compared to unannealed material Table 3). The fracture surface for annealed samples was revealed to be similar to that for unplated material (Figure 4b).
