FRACTURE BEHAVIOR OF A CORRODED ANNULAR PLATE UNDER A MULTI-AXIAL STRESS STATE

M.OHASHI

National Research Institute of Police Science 6-3-1, Kashiwanoha, Kashiwa, Chiba277-0882, Japan

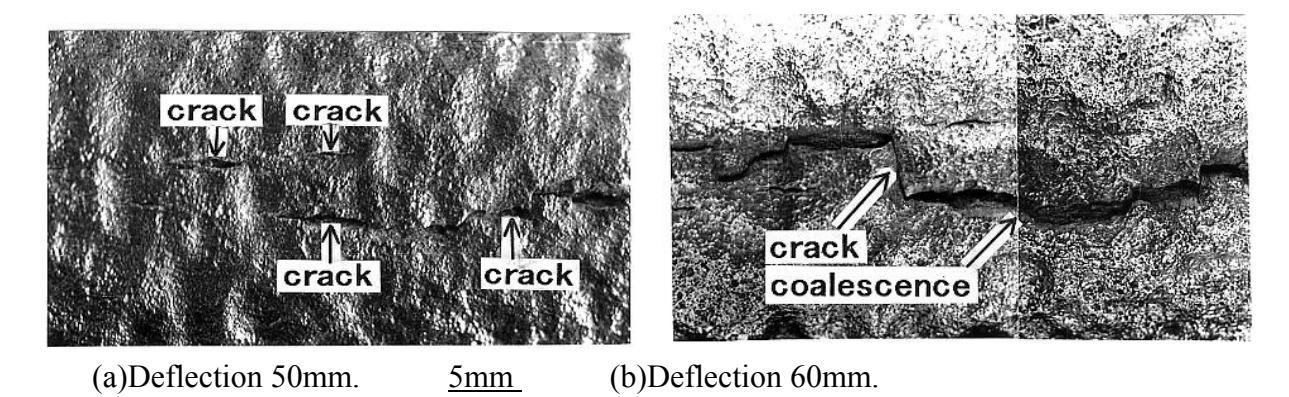
The reason of different shapes of the stress-deflection curves was successfully explained from successive observation of crack growth behavior on the corroded surface. Photographic evidence showed that the multiple cracks had initiated after a deflection of 35mm on the corroded surface of specimen A and B. Thereafter, rapid crack growth occurred through crack growth by itself and coalescence with other cracks. Typical examples of crack coalescence are shown in Fig.5. Several cracks, initiated around pits, grew rapidly into large crack by

coalescence with neighboring cracks. Hence, it should be emphasized that the linking up of multiple cracks and the subsequent development of extensive cracking is considered to be a characteristic event of the roughened corroded component, and is expected to occur in the high deflection region depending upon the degree of corrosion damage. Plastic constraint, derived from the welded joint, produced a multi-axial stress state, and presumably accelerated crack growth among multiple cracks.

Fig.5. Crack coalescence with increase of deflection for specimen B.

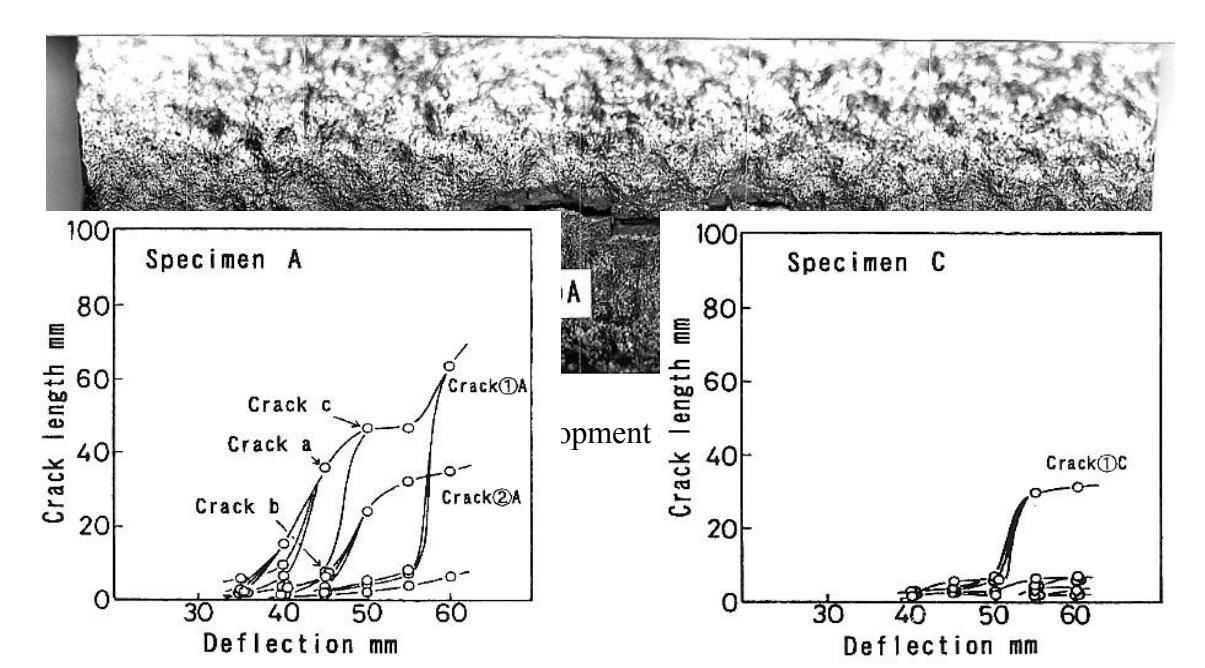
Well developed cracks at a deflection of 60mm for specimen A are demonstrated in Fig.6. In contrast, the development of cracks for specimen C is less extensive in concurrence with a lesser degree of corrosion damage. The increase in surface crack length for specimen A is shown in Fig.7. Several cracks had developed on the corroded surface at a deflection of 35mm. These cracks grew rapidly to join other cracks with increase of deflection. A coalescence of crack a and crack b in Fig.7 leads to larger crack c at a deflection of 50mm. As a result, an

extensive crack (I) A and (2) A with a length of 64 and 35mm had been formed for specimen A.

growth rate, and the largest crack①C in Fig.8 is 31 mm long.

Fig.7.	Relation between crack length
and deflection for specimen A.

Fig.8. Relation between crack length and deflection for specimen C.

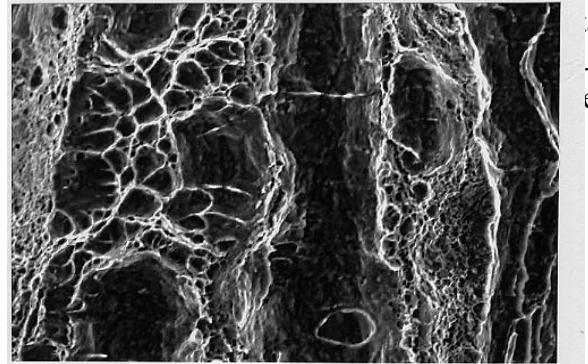
Also, poor ductility of the annular plate was well explained from a detailed fractographic examination. A typical fractograph of the annular plate is shown in Fig.11. The fracture surfaces are composed of equiaxed dimple area and featureless zone that is supposed to be caused by cracking and decohesion of non-metallic inclusion. The greater portion of the fracture surface is covered by featureless area. An average value of area fraction covered by dimple for 14 views was found to be a small value of 22% because of low ductility of the annular plate.

Fig.11. SEM fractograph of the annular plate. Fig.12. Relation between dimple area fraction and fracture strain.
