# FATIGUE INVESTIGATIONS OF DAMAGED RAILWAY RAILS OF UIC 60 PROFILE

**Abstract:** The development of procedures to calculate the service life of railway rails requires test results which describe the damage of rails thus affording their validation. Within the DEUFRAKO integrated project NOVUM, ten rail specimens were tested under constant and variable amplitude loads to investigate the propagation of lateral cracks and to ascertain the service life. The test conditions were based on real rail loading and were used in the 3-point-bending test frame under alternating stress. An eccentric notch was applied as pre-arranged damage in the 60 E1 (260) rail specimens. The notched rails showed a similar behaviour like rails with strong head checks damaged by rolling contact fatigue.

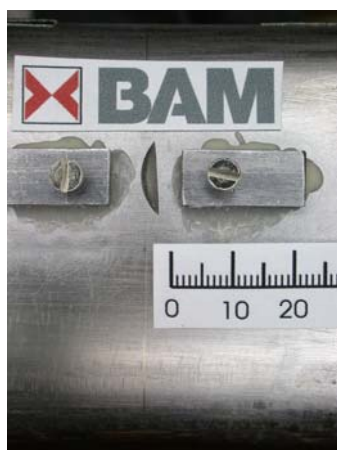
**Fig. 2:** Rail surface with notch

The rail specimens were prepared with a circular shaped transversal notch at a distance of 10 mm from the longitudinal axis. The notch depth was 2.0 mm and the chord length was 12.0 mm. It was manufactured by an angular milling cutter simulating the incipient damage, the so-called head checks [5]. Head checks are cracks running near the gauge line on the head surface. First, they run nearly parallel to the surface and further on they bend down and propagate as transverse cracks. The notch was milled at an angle of 70°, therefore it has the shape of a sickle in Fig. 2. Rail material was taken from two different layers, both perpendicular and horizontal, in both cases transversally to the longitudinal axis. Accompanying investigation of crack propagation and determination of threshold values  $\Delta K_{th}$  were performed on SE(B)-specimens (Fig. 3).

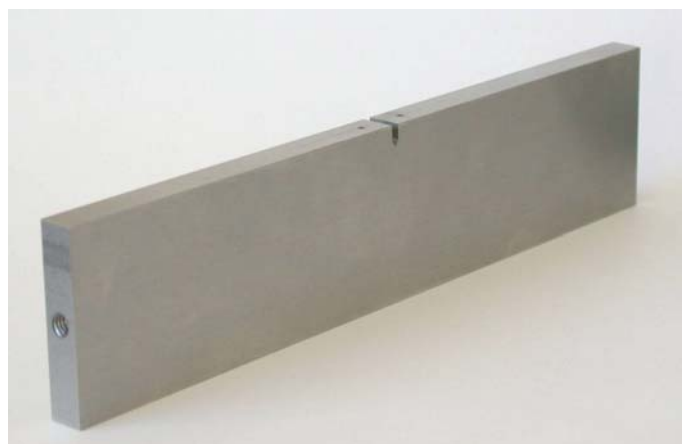
**Fig. 3:** SE(B) specimen  
174.0 mm x 39.0 mm x 8.0 mm

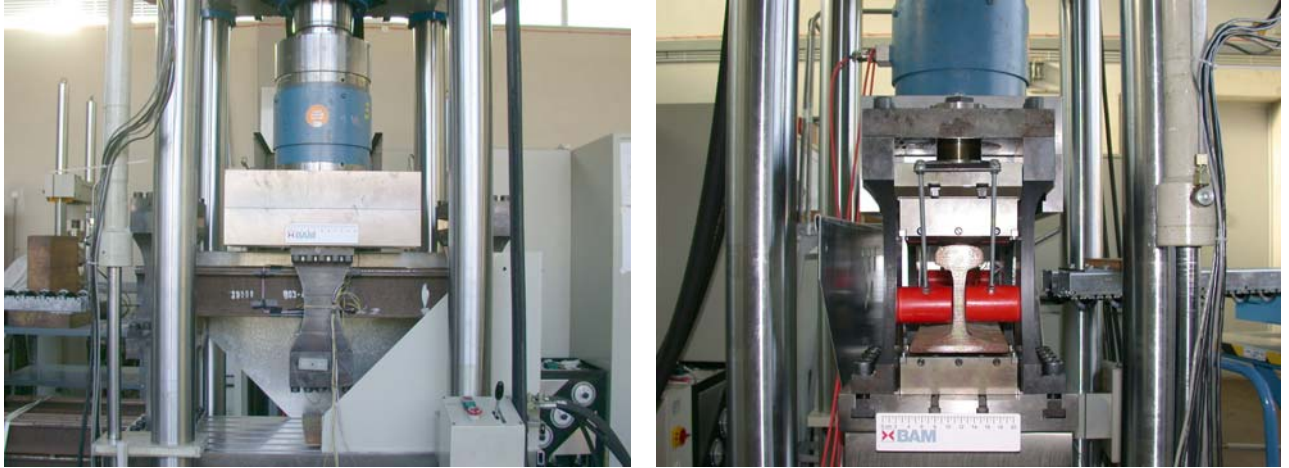
**Fig. 5:** Test rig for rails with central load transmission in an 1-MN testing machine and built-in specimen #24 (front and side view)

The bending table was built in a servo-hydraulic test machine (MTS) with 1 MN nominal load as displayed in Fig. 5. The hydraulic actuator is assembled within the cross head. A 5 MN load cell (Lebow) was used to measure the test load. It was calibrated in the range of -1250 to 1250 kN and assembled at the end of the piston.

The test machine worked in a closed loop load control with a sinusoidal load curve with a test frequency of 1.3 Hz. The controller was a TestStar-II Classic system (MTS). In addition, an adaptive controller (MAS-Link system based on Atari) was used as an external control loop for the service loading test with a load spectrum.
