Fatigue damaging analysis of a glass/polyester composite with acoustic emission

M. Benantar^{1,a}, M.A. Belouchrani^{1,b} and Z. Aboura^{2,c}

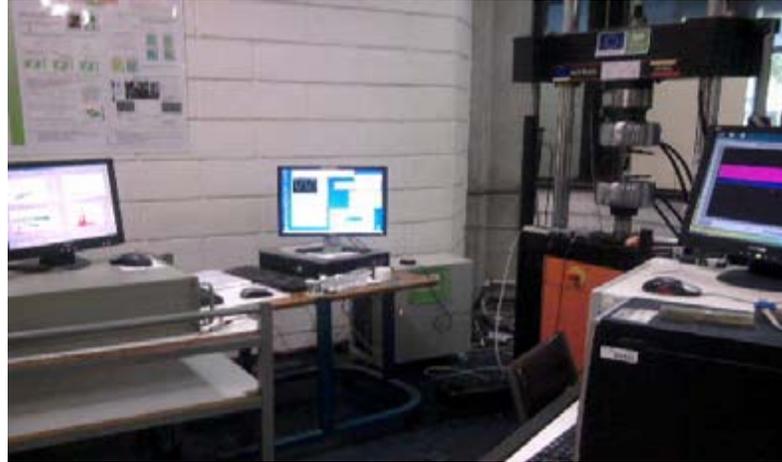
Fig.2. Machine and instrumentation for fatigue tests.

In our study, fatigue tests are performed at imposed loading. Used amplitudes were derived from preliminary tensile quasi-static tests. We recall that several loading levels were considered, and three samples were tested until failure at each level with a frequency of 2 Hz and load ratio $R = 0.3$. These fatigue tests were performed on a servo-hydraulic machine INSTRON 1341 with a loading capacity of 25 kN. The strains are measured by an Instron extensometer with a maximum extent of 2%.

To track the status of the material and the evolution of its damage, a chain of acoustic emission is used. This monitoring of acoustic emission testing was performed using two resonant sensors (micro PAC-80) of 10mm in diameter.

Acquisition is done via the software supplied with Euro Physical Acoustic capture card (Figure 2). The technique of acoustic emission needs some parameters setting to allow comparison tasks [7]. Emissions have to be recorded in the best conditions and have to correspond to the material damage but not to machine parasites. For our tests, the parameters are fixed as shown in Table 1.

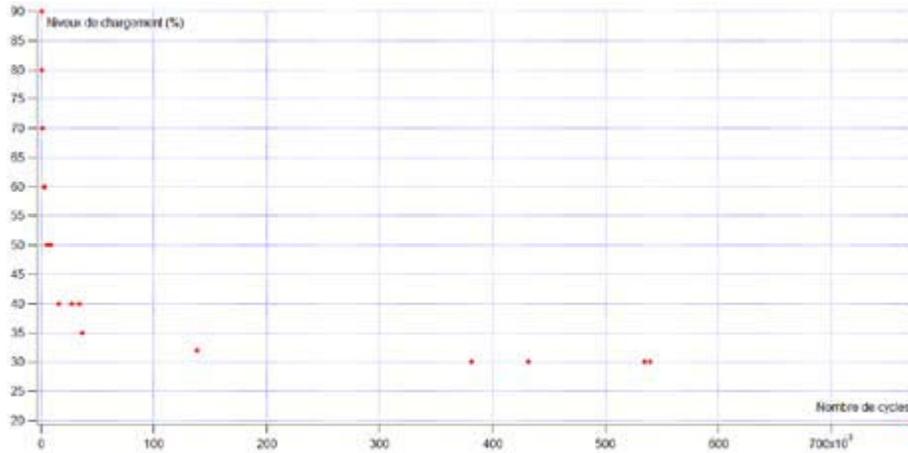
Fig.3. Wöhler curve for the used material.

The fatigue tests conducted at various loading levels allowed plotting of the Wöhler curve for the material (Figure 3).

On this curve, it can be noticed that for less than 20% loading, life time of the material becomes more important and no damage is observable. For the material damage kinetics study, decreasing of stiffness is used as damage indicator. Hence, the damage variable used to plot the evolution of damage versus the number of cycles is the elastic stiffness E . The measure of this stiffness allows assessing the value of damage using the following relationship:

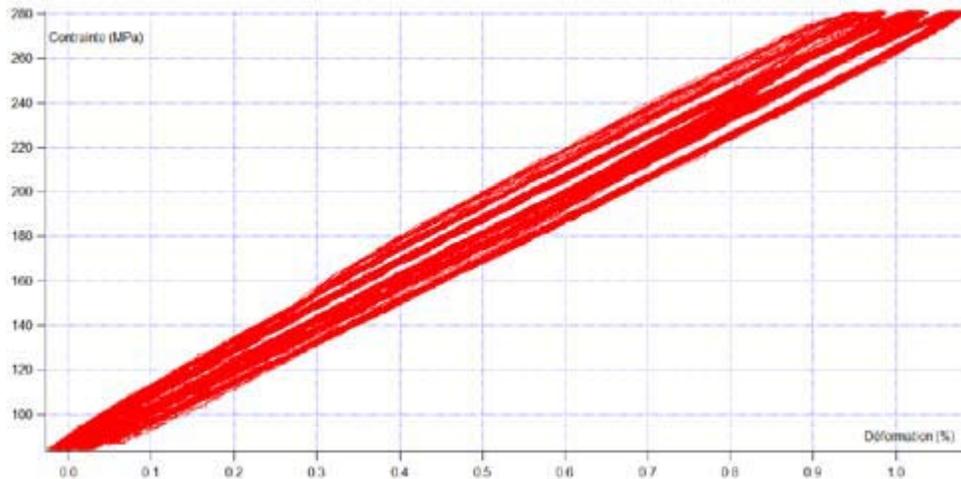
Fig. 4. Stress-strain curve.

Taking the example of the specimen charged at 70%, the evaluation of rigidity during the loading cycle (obtained on the stress - strain curve of Figure 4) for certain percentages of the number of cycles at break has allowed deducing the evolution of damage versus the number of cycles.

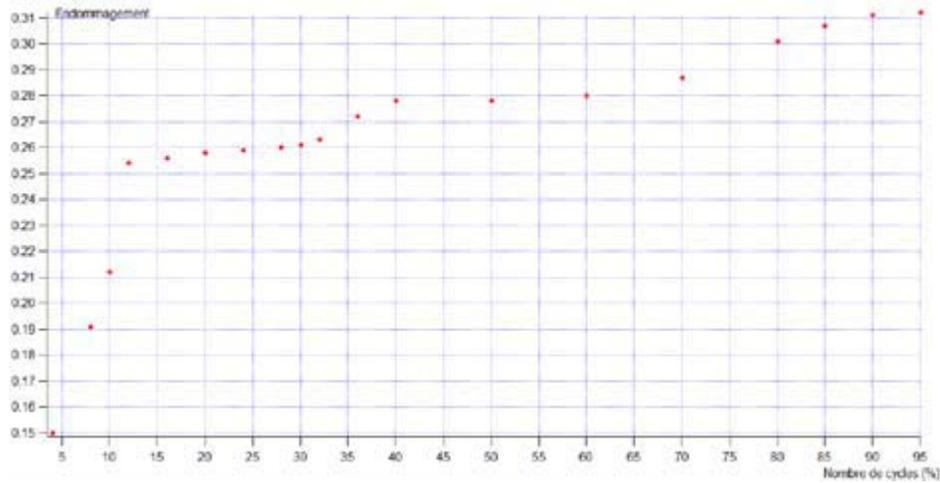
Fig.5. Evolution of damage versus the number of cycles.

In figure (5), we notice a nearly linear fast evolution of damage coefficient followed by a first stage of stability. Then, we see a hop followed by a second stage of stability at 70% the number of cycles to failure, where there has been a fast evolution of the coefficient of the damage until the final break. These hops and successive stages can be due to the chronological occurrence of different damage mechanisms.

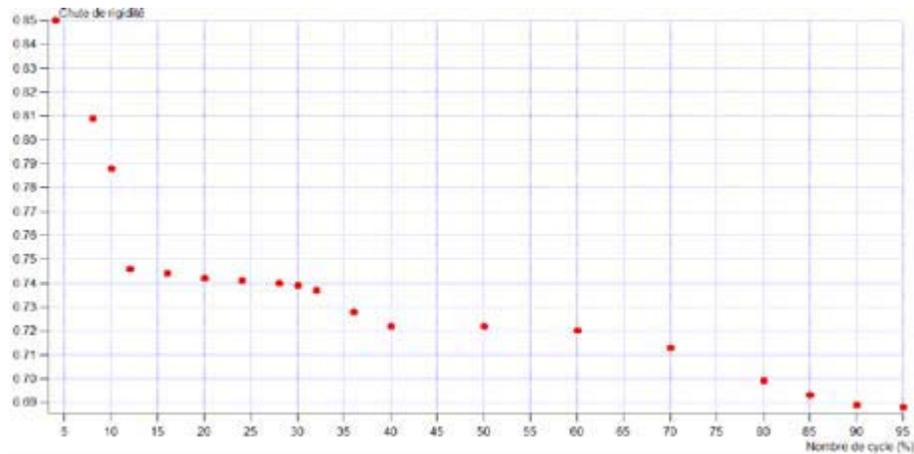
Fig.6. Evolution of decrease in rigidity versus number of cycles.

Figure (6) gives the evolution of the modulus of rigidity versus on the number of life cycle to break. We can see a fast decrease of the module up to 12% of the life cycle (high slope). After this point, the modulus of the material begins to stabilize at an almost fixed value then, there has been a second decrease followed by a second stage. From 70% of the life cycle to break, the material loses its rigidity rapidly until final failure.

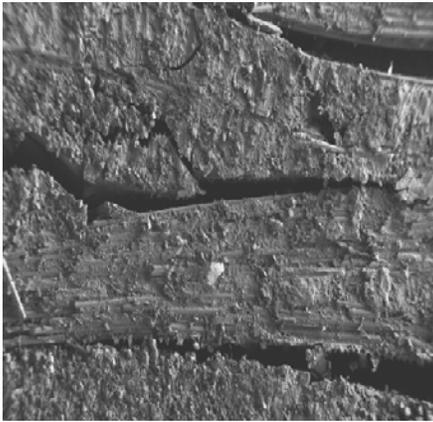
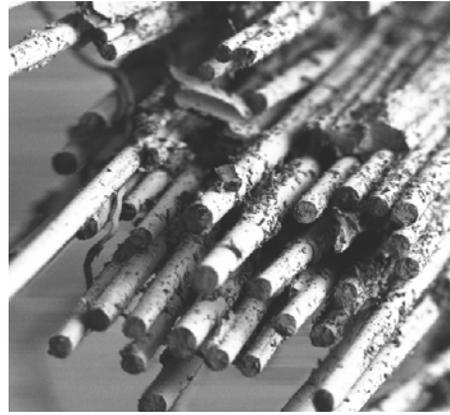
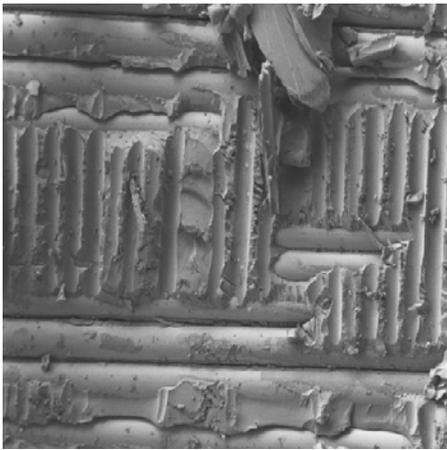
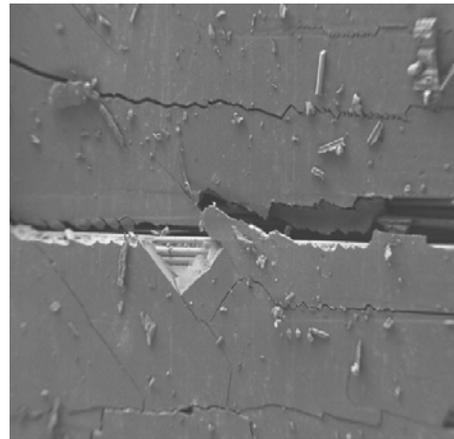
Fig.7. Observed Damage mechanisms.

The final rupture of the specimen, during the tensile test with elastic relaxation, results from the presence of different damage mechanisms:

- Matrix rupture;
- Fiber/ matrix debonding;
- Delamination between layers;
- Fibers rupture.

(a) Delaminating

(b) Fibers rupture.

(c) Fiber-matrix debonding

(d) Matrix rupture

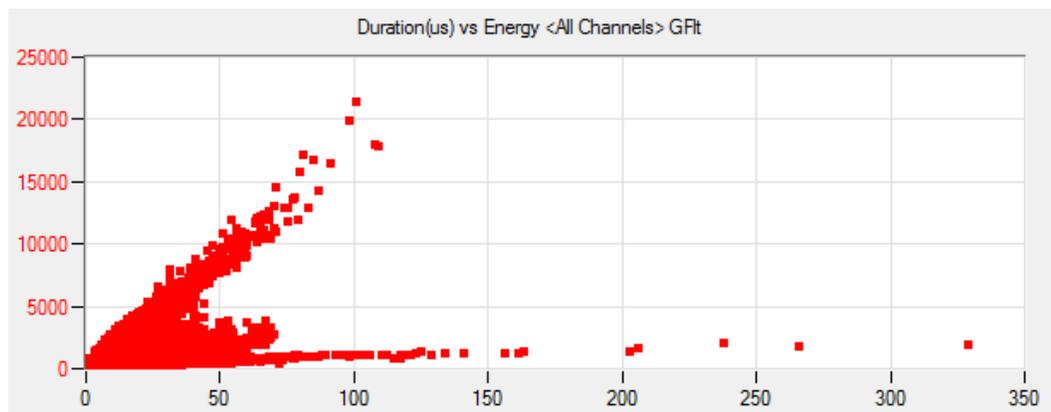
Fig.8. Correlation between duration and energy of acoustic hits.

Correlation analysis applied to acoustic emission data, obtained during fatigue tests, shows the possibility to distinguish two families of signals forming a "V" for the correlation between energy and duration. However, the display of energy versus the duration for each hit gives an original visualization of the test. Until now, we are unable to tell if we are in presence of events that occur during the loading or the unloading of the specimen. However, the phenomena related to the "V" and having a rather large energy are the source of the material damage that leads to ultimate ruin.

The preprocessing of these data shows that the acoustic events presented during a fatigue test are separated by the correlation analysis. To determine what type of phenomena the signals of the two branches are related to, several investigations were made. First, the static tests on the same material give hits only on the first branch (the vertical), the second branch may represent phenomena different from those observed in static. Regarding the nature of the hits present in each branch, we found out that the major part of friction and micro-buckles that may occur after release of the composite, are only present in branch 2. These micro-buckles are isolated or discolored fibers which cannot return to their initial state.
