A. Milosavljević*, M. Srećković**, V. Šijački-Žeravčić*, S. Ristić***,
V. Rajković****

The new, multicomponent Ni alloy has been investigated regarding its interaction with impuls lasers, since the mechanisms of such interactions are not well understood so far. Damages obtained by ruby laser in the Q switch regime are investigated by scanning electro microscopy (SEM). The experimental results provided a relationship between parameters such as cavity depth and diameter with an energy input.

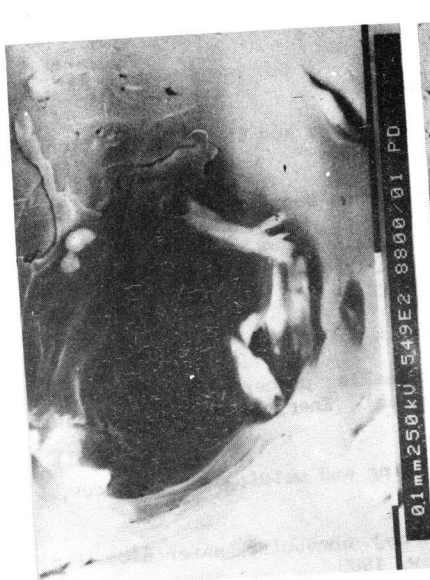
Figure 2 shows general appearance of a damage, being irregularly shaped. The secondary phases presence is obvious. It would be interesting to identify its presence also by diffractional electro analysis. The outer damage diameter is 0.142 mm, while the inner diameter, characterizing damage center area (being in depth), is approximately 0.053 mm. Edges of damage are uneven.

Figure 2 Damage 1 (Table 1)
magnification 549x

Samples shown in Fig. 2 and 3 were obtained using energies of 0.75 J and 1.8 J, respectively. The outer diameter of damage (0.498 mm) in Fig. 3 is much larger than the one in Fig. 2, as well as the inner diameter of a central damage area, being 0.136 mm.

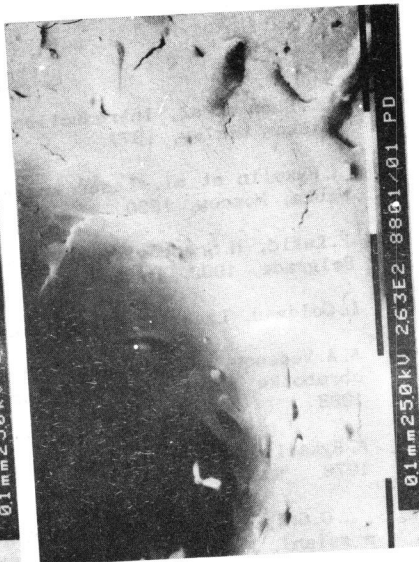
Figure 3 shows an edge of a damage, indicating large number of micro pores, with diameter approximately 0.045 mm.

Figure 3 Damage 2 (Table 1)
magnification 263x
