Failure of steam line causes determined by NDT testing in power and heating plants

ABSTRACT. This paper examines leakage and damages of steam and provides an overview of NDT testing in order to determine the cause of steam lines failure in power plants and heating plants. This approach may be applied to similar structures and its application in preventive maintenance would help extend the life of steam pipes.

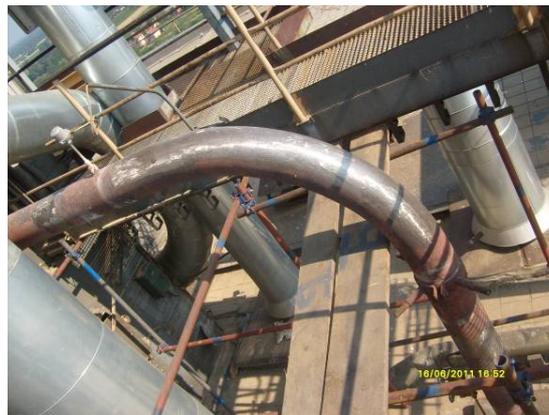
Figure 1: Part of the steam line during NDT.

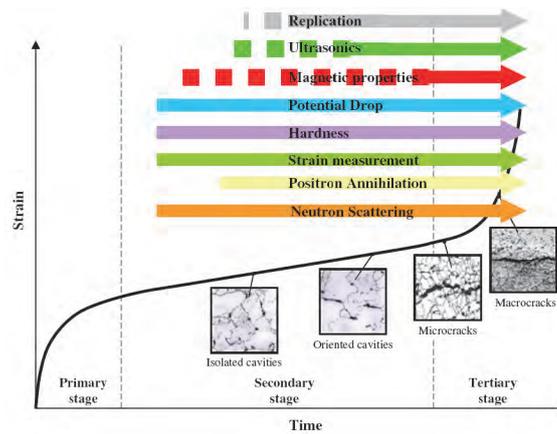
Figure 2: Application of NDT methods in detecting defects in the life of the steam line [6].

If necessary, other tests that would give us a reliable and useful results to determine causes of steam line failure could be done. Fig. 2 shows the possibility of evaluating some damage using NDT methods in the life of the steam line.

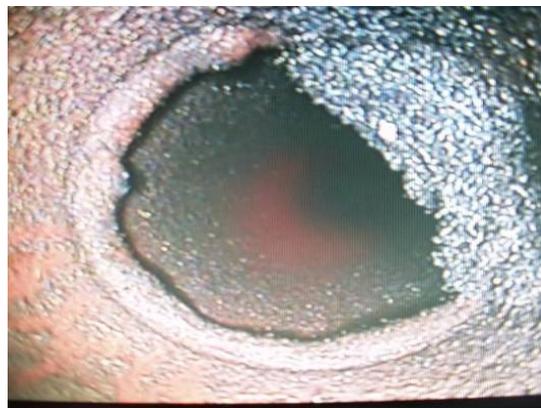
Figure 3: Photo of interior surfaces steamline.

Control of the inside of the tube (endoscopy) allows optical access to the interior of steam lines. It is performed using an endoscope, and as a result we get control of video or photograph controlled inner surface, Fig. 3.

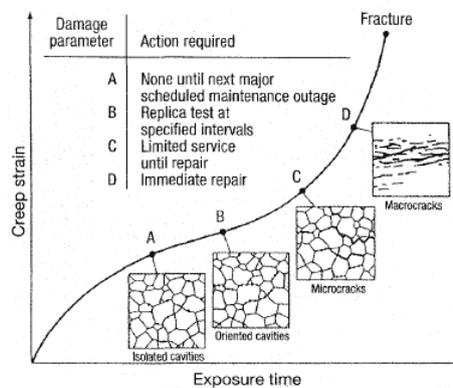
Figure 4: Overview of possible damage to the established method of replica [9].

Metallographic examination, Fig. 4, the surface layer of material of pipe bends, weld joints and pipes on the old steam pipe RA 10 block A1, is conducted by the method of nondestructive testing of materials, using metallographic replica, according to [8].

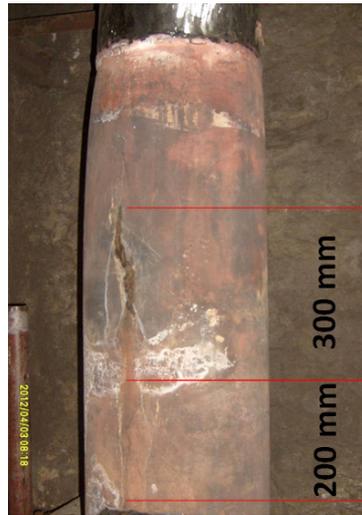
Structures of the steam line is exposed to the low cycle fatigue loads. This load caused a fatigue damage of pipes and leakage of steam lines on observed object, Fig. 5, which was confirmed by visual inspection. After that, NDT methods are used for testing the steam pipeline section and supporting structure before and after damage. Fig. 6 and 7 show the measurement of control and testing methods, NDT, and in Tab. 2 and 3 the results of measurements of diameter and wall thickness of the damaged part of the steam line are listed.

Figure 5: Determination of damage by visual inspection.

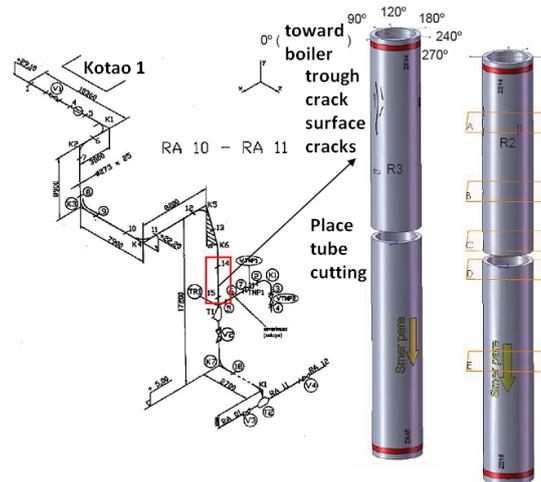
Figure 6: Scheme of measurement tests (dimensional inspection of the damaged steam line part).

Part of the tube	Diameters (mm)				
	A	B	C	D	E
Plane measurements					
Axis measurements 0°-180°	288.9	276.8	285.0	285.9	283.1
Axis measurements 90°-270°	282.4	284.0	285.1	284.3	283.4

Part of the tube		Wall thickness (mm)					Remark
Plane measurements		A	B	C	D	E	
Designation of measuring point	0°	21.2	20.1 (R3)	22.4	22.4	22.9	23.2 (A-R1)
	90°	24.3	24.7	25.6	25.8	25.5	24.7 (A-R2)
	180°	27.0	27.3	27.0	27.9	27.1	/
	270°	24.2	23.3	23.1	23.9	23.7	/

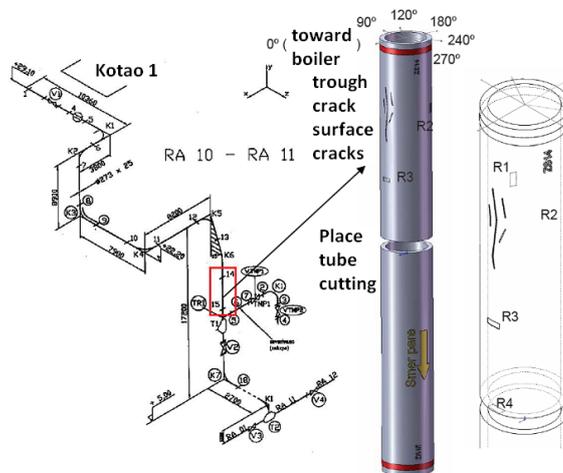
Figure 7: Scheme of measuring and making replicas of the damaged steam line part RA-10.

Fig. 8 and 9 show the typical microstructure of the surface layer of the old pipe taken from a replica in accordance with the drawing in Fig. 7.

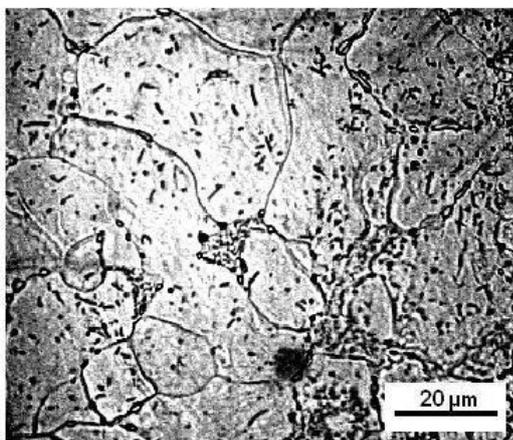
Figure 8: Replica RA10-R1. Assessment of the microstructure [11]: Level B / Level C: Initial spheroidization and carbide precipitation per grain boundary in places with the presence of globular pearlite. 4% nital.

In microstructure of tested replica taken from the surface of the material of the old pipe, a certain degree of quality degradation was observed which is caused by initial spheroidization and carbide precipitation per grain boundary in places with the presence of globular pearlite- the level of quality degradation of microstructure B / C, according to [11]. Products of corrosion and corrosion damage in spots are present in the microstructure of tested replica.
