Fatigue properties and fracture mechanism of load carrying type fillet joints with one-sided welding

ABSTRACT. The structures of the hydraulic excavator and the crane have numerous one-sided welded joints. However, attachments with box like structures are difficult to weld at both sides. Therefore, high accurate evaluation method is needed. In this study, the fatigue properties and the fracture mechanism of the load carrying type fillet joints with one-sided welding were investigated experimentally to evaluate its fatigue damage with high accuracy based on the experimental results. As the results, fatigue cracks in the test piece initiated from the tip of the unwelded portion and propagated into the welding materials. Multiple welding defects were observed in the unwelded portion, but did not appear to be crack origins. Although these welding defects affected the direction of crack propagation they exerted minimal influence. The three-dimensional observations revealed that fatigue cracks initiate at an early stage of the fatigue development. We infer that the fatigue lifetime is chiefly governed by the crack propagation lifetime. Cracks were initiated at multiple sites in the test

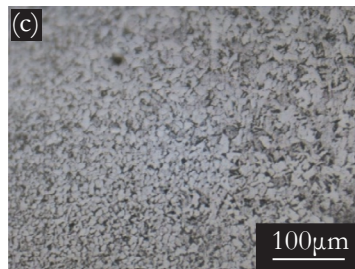
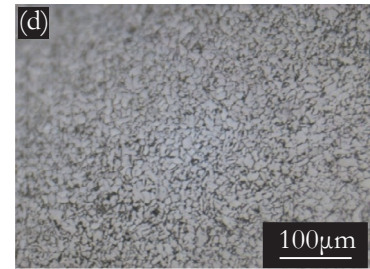
Figure 6: Microstructure observation at the material in detail.

Fig. 4-6 show the microstructure of the one-side fillet weld zone. Three structural categories can be recognized; welding material structure, a heat affected zone, and the base material. Observations of each area reveal that the metallographic structure of the welding material had melted and solidified into a dendritic structure, and the base material has a ferrite structure. Closer to the welding metal zone, the crystal grain of the base material enlarges. The hardness results of the one-sided fillet welding are plotted in Fig. 7. The hardness was measured along the three horizontal broken lines shown in Fig. 4. The origin of the horizontal axis in Fig. 7 is the vertical line in Fig. 4, which separates the welding material (negative side) from the base material (positive side). According to Fig. 7, the welding material is 1.2 times harder than the base material. The welding material hardened because martensite was generated by the cooling

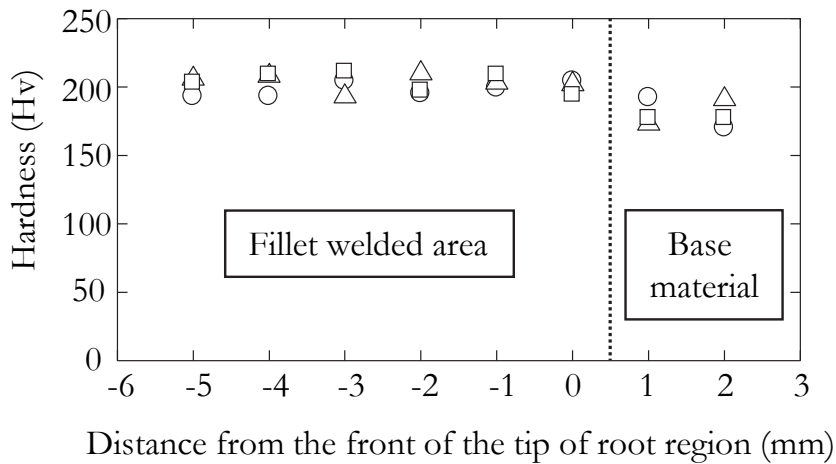
Figure 7: Hardness distribution from the edge of fillet weld.

process. Focusing on the heat affected zone, we observe that the hardness slowly decreases as the base material approaches the welding material.

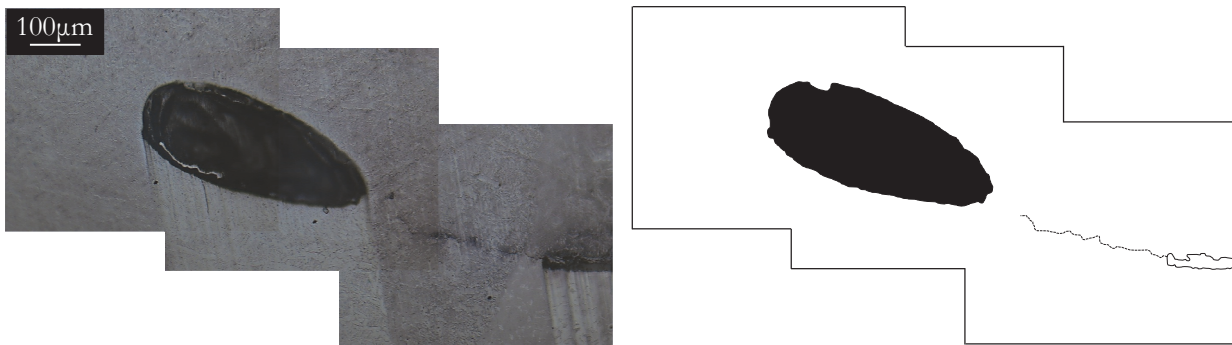
Figure 13: Crack propagation from tip of root region with welding defect.

In this subsection, we consider the influence of welding defects on fatigue crack initiation and propagation behavior by observing the crack from the root tip of the unwelded portion. The observation results for part of the unwelded portion are presented in Figs. 12 and 13. These images were captured under a load amplitude of 9kN. The test was terminated before it had gone to completion, and the test piece was cut axially to the load and observed near the unwelded portion.

Figs. 12 and 13 show different sections of the same test piece. The test was stopped after 8×10^3 cycles (the longest life N_f at this load amplitude was 1.6×10^5 cycles ($N/N_f=5\%$)).

As in the previous macro observations, the fatigue crack in Fig. 12 initiates at the tip of the unwelded portion and propagates through the welding material. As already mentioned, fatigue crack propagates at some angle from the vertical load axis. However, tiny cracks appearing immediately after the main crack propagate along the vertical load axis. Large welding defects near the unwelded portion, (Fig. 13) exert much less influence on fatigue crack initiation behavior than small defects, because the fatigue crack begins from the root tip of the unwelded portion.

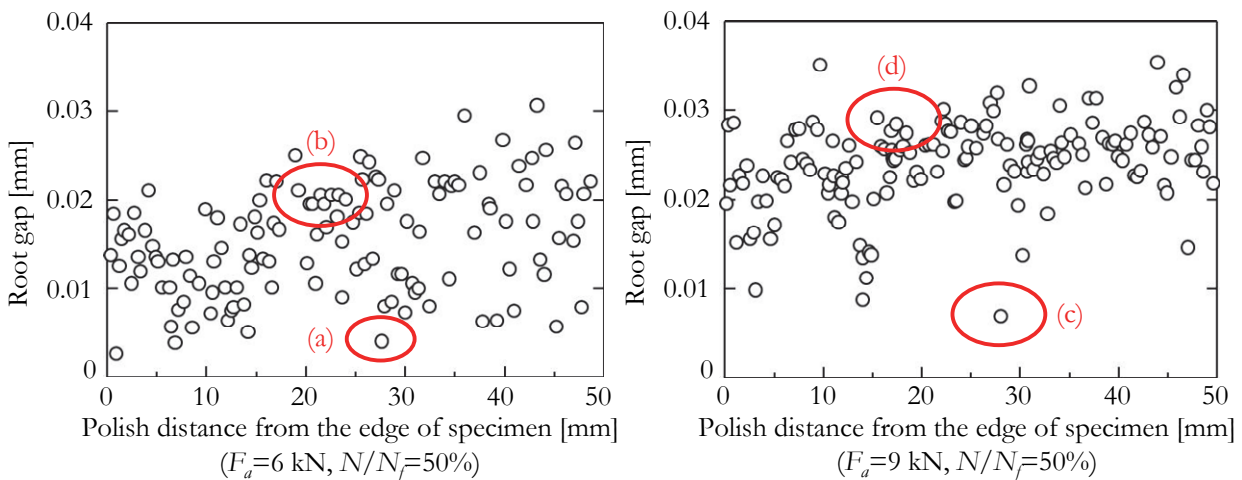
Figure 18: Measurement of the root gap.

As a quantitative evaluation index we define the root gap as the distance from $10\mu\text{m}$ opposite the crack propagation direction in the unwelded portion. The relationship between root gap and position across the sample width is plotted in Fig. 18. Typical observations of the unwelded portion are presented in Fig.19.

The root gap in the unwelded portion is typically $0.02 - 0.03\text{mm}$ (see circles labeled (b) and (d) in Fig. 18), but multiple narrow gaps in the unwelded portion are also observed (enclosed by circles (a) and (c) in Fig. 18). This unwelded sharp portion may be the origin of a fatigue crack.
