# SPALLING OF RAILWAY TUNNEL CONCRETE AND ITS CAUSES

A number of accidents of concrete block spalling from tunnel linings occurred recently in Japan. Although there were no personal injuries, trust of people in the safety and durability of tunnel was lost, because some accidents took place in Shinkansen ( high speed railroad ) tunnels. Investigations, model tests and numerical analyses were performed on the largest three accidents in particular to study the mechanisms and causes of spalling of concrete. This paper outlines the accident at the Fukuoka Tunnel out of these accidents and reports the causes of spalling through investigations, model tests and numerical analyses.

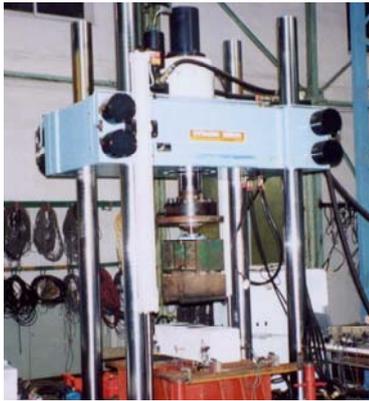
Photo 2: Experimental equipment

Based on the results of measurement shown in Chapter 3, a negative air pressure of 5kPa was repeatedly caused on linings by trains. Therefore, we performed bend fatigue tests of plain concrete to study the effect of repeated load on linings. We performed static bend tests and bend fatigue tests. Photo 2 shows the experimental equipment, and Figure 5 the dimension of specimens. The specimen was a concrete beam made of plain concrete with a width of 200mm, height of 200mm and length of 700mm. The compressive strength of concrete was about  $18 \text{ N/mm}^2$ . On some specimens, we made a notch with a width of 0.2mm on their bottom side to study the effect of the presence and depth of initial cracks. The depth of the notch was 10 mm or 50 mm. In the tests, we measured the load and displacement at the loading point and strain
