# STUDIES ON THE ORIGIN OF DEFORMATION AND DAMAGE IN LONG-SPAN HISTORICAL STRUCTURES

P. ROCA & R. CLEMENTE

Department of Construction Engineering, Universitat Politècnica de Catalunya, Barcelona, Spain

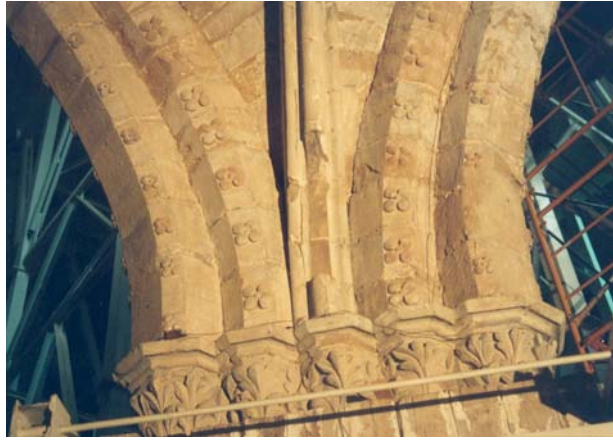
Figure 1: Pier of Tarazona Cathedral affected by damage in compression

2- As is well known, cracks parallel to the direction of applied compression may appear in materials such as concrete or stone even for stresses significantly lower than the compressive strength. Longitudinal cracking is not rare in vertical masonry components subject to moderate compressive stresses, below 30-60% of the estimated compressive strength of the masonry. The authors have observed vertical cracking and other effects related to compression (such as crushing and disappearance of nervures or material) in some of the piers of almost all the studied Cathedrals. Vertical cracks and related lesions in piers are particularly significant in Mallorca Cathedral and the Basilica of Santa Maria del Mar in Barcelona. Even more apparent effects (such as crushing and loss of material) could be seen in Tarazona Cathedral before its recent restoration (Fig. 1; see in Roca and Gonzalez [1] for a more detailed discussion).

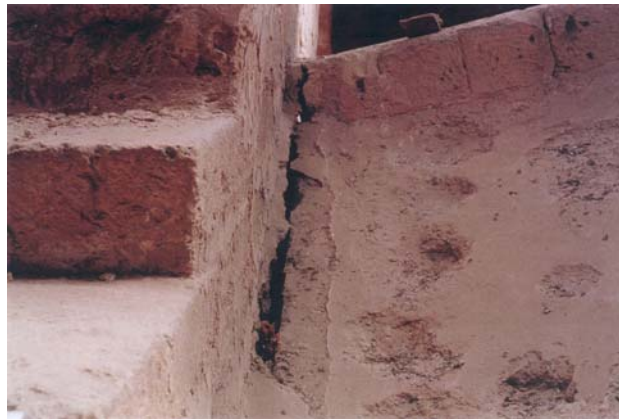
Figure 2: Crack between transverse arch and cross vault in the nave of Mallorca Cathedral

3-Division (fragmentation) by large cracks affecting the entire contact between structural members or parts of the construction is not uncommon in historical constructions. In many cases, these large cracks are caused by soil settlements. Similar effects may be caused or influenced by thermal environmental actions; large cracks affecting walls or vaults are observed which, because of their location and geometry, strongly suggest an acquired role of expansion joints. Examples are found in Girona and Barcelona Cathedrals, with cracks appearing along construction joints, and Mallorca Cathedral, where wide discontinuities are observed between some of the transverse arches and the vaults of the nave (Fig. 2).
