Experimental investigations on the crack growth behavior in graded ferritic martensitic steel

Tobias Stein^{1,*}, Frank Zeismann¹, Angelika Brückner-Foit¹

¹ Institute of Materials Engineering, Quality and Reliability Group, University of Kassel,
Moenchebergstrasse 3, D-34109 Kassel, Germany

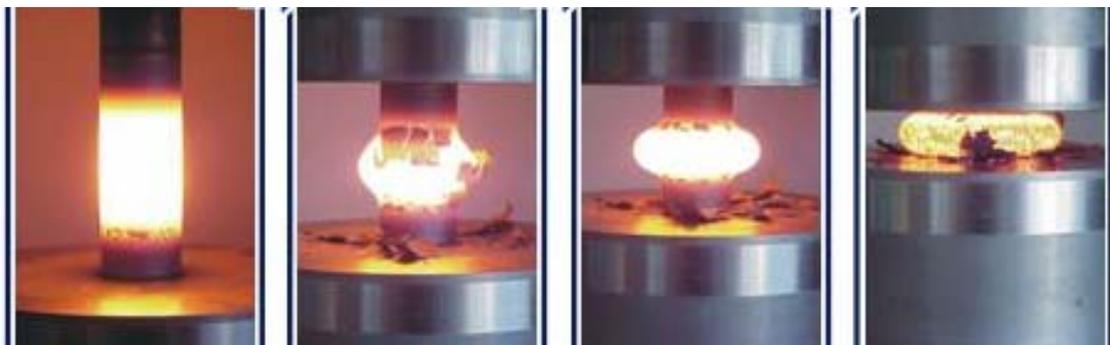
Figure 1: Integrated thermo-mechanical forming process of the flange shaft [6]

An integrated thermo-mechanical forming process, as shown in Fig. 1, was applied to a shaft resulting in a flange shaft with a graded microstructure [3]. First the shaft was heated up above austenitization temperature by induction heating and then put into the molding press to form the flange, which lead to a local martensitic transformation of the original ferritic-perlitic phase.

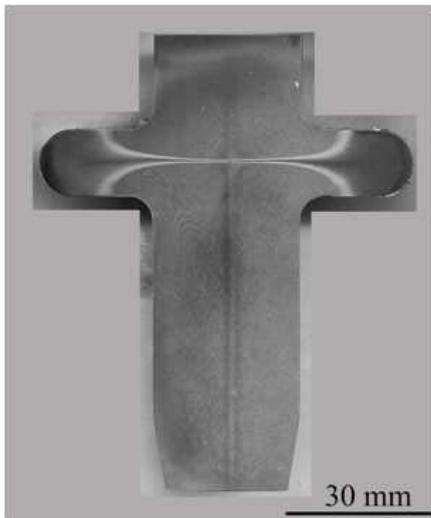
Figure 2. Micrograph of the flange shaft, etched

Due to the high natural strain during the forming process a fine grained microstructure is formed, which contains dispersed small defects like inclusions and carbides. The resulting phase distribution is given in the etched micrograph in Fig. 2. It is characterized by the ferritic-perlitic base cold-worked material (grey) in a in the core of the flange shaft and a martensitic phase (dark) at the outside of the flange. The phases are linked by a transition zone (white) of varying width and material properties. For an unambiguously phase identification micro-hardness measurements are used. As shown in Fig. 3, the martensite possesses hardness values above 650 HV (Pos. 1), the transition zone about 450 HV (Pos. 2) and the deformed base material has hardness values below 300 HV (Pos. 1).
