CRACK PATH INSTABILITY IN ALUMINIUM LITHIUM ALLOYS

Y. H. Tai, D. T. Asquith and J. R. Yates

ABSTRACT. *Anisotropy and crack path stability in aluminium lithium alloys remain a concern which has limited its widespread use especially in primary structural components. The aim of this work is to investigate the crack path stability of 2050-T851 aluminium lithium alloy in ductile tearing of compact tension specimens loaded under quasi-static mode I conditions. Results show significant anisotropy exists in 2050-T851 but it has been significantly improved when compared to previous results obtained for 2195. Initial analysis of the fracture surfaces and experimental data has produced some interesting observations which warrant further investigation into the role of microstructure.*

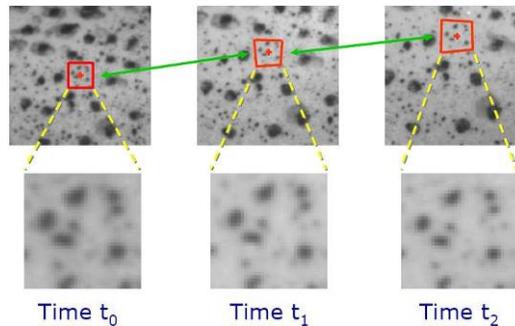
Figure 1: Illustration of subset matching and deformation tracking used for DIC (*Image courtesy of Limes GmbH*)

A digital image is essentially a two-dimensional array of intensity values which can be divided further into small subsets. 2D image correlation works by matching small square subsets of an undeformed image to locations in the image of the surface after deformation (as illustrated in Figure 1) by means of mapping and cross correlation functions. Further information regarding the functions and technique used can be found here [2].

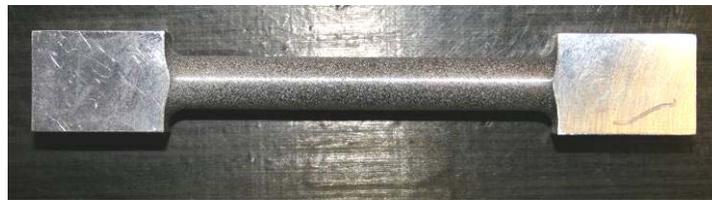
Figure 2: Prepared tensile specimen with speckle pattern on surface

Standard tensile tests were performed to obtain the material stress strain curve. As the material was supplied in 15 mm plate form, the tensile specimens could be machined into round cross-section with a diameter in the gauge length of 8.0 mm. The specimens were cut from both L (loading along rolling direction) and T directions (perpendicular to rolling direction) to determine the extent of material anisotropy. A random speckle pattern was applied to the surface to facilitate the displacements measurements using DIC. Figure 2 shows one of the prepared specimens.

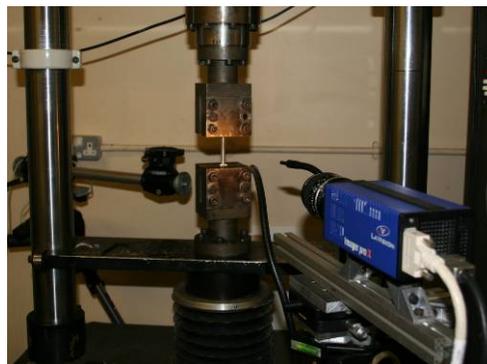
Figure 3: Tensile test experimental set-up with 2D DIC

The tensile tests were in a 100kN servo electric Mates test machine in displacement control mode at a rate of 0.01 mm/s. 2D DIC was used to measure the elongation of the specimen. To minimise problems caused by paint crazing, the surface was sprayed lightly with a combination of black and white acrylic based spray paint. This gave a good random speckle pattern which can be seen in Figure 2. In order to minimise problem caused by reflections from the surface of the specimen especially when out of plane deformation occurs, photographic dulling spray was applied prior to testing. Figure 3 shows the experimental set used for this work. A total of four tests were done, two in each direction.

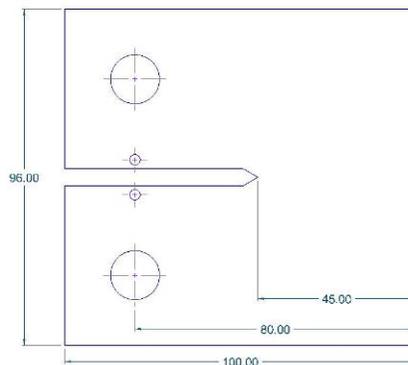
Figure 4: Schematic of 10 mm thin sheet CT specimen

For crack path instability and tearing toughness tests, thin sheet CT specimens were machined from the plate into 10 mm thick specimens. The design of the specimen was based on the guidelines in the ASTM E2472 standard [5] and had in-plane dimensions of 100 x 96 mm. The specimens were machined from the plate in both TL (crack propagating along rolling direction) and LT (crack propagating across to rolling direction) configuration. The notch was machined by electrode discharge machining (EDM). The specimens were fatigue pre-cracked prior to testing to generate a sharp crack in a bid to minimise crack path instability at initiation.

Fatigue pre-cracking was done at a $\Delta K_I = 24 \text{ MPa}\sqrt{\text{m}}$ which is approximate 60 percent of the fracture toughness of this material at a R ratio of 0.1. It required approximately 5000 cycles to generate fatigue cracks $\sim 1 \text{ mm}$ long which results in a final notch length of 36 mm and crack length to specimen width ratio of 0.45. This will allow for approximately 25 mm of geometry independent crack extension. Figure 4 below is a schematic diagram of the CT specimen used in this study.

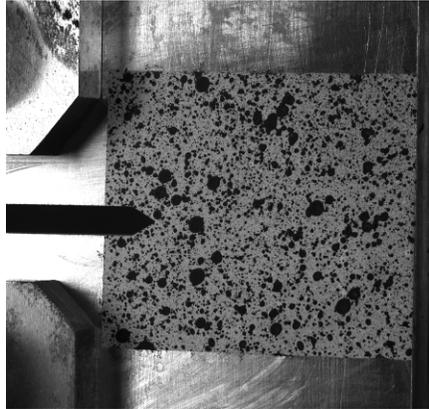
Figure 5: Prepared CT specimen loaded in grips prior to testing

The tests were carried in a servo hydraulic Mayes test frame with hydraulic grips. Bespoke grips were made to hold the specimen and minimise buckling during the tearing process. Displacement rate of the actuator was set at 0.05 mm/s which meant the tests were carried out under quasi-static conditions. 3D DIC was intended to be used for displacement measurements which required a random speckle pattern to be applied on the surface of the specimens. This was done by spraying the area of interest with white paint which was then speckled using black paint. Figure 5 below shows a prepared specimen loaded in the grips prior to tearing. Image acquisition and data acquisition was done with the Vic3D DIC system which allowed for the synchronisation of parameters of interest (eg. load and actuator displacement) with the images obtained.

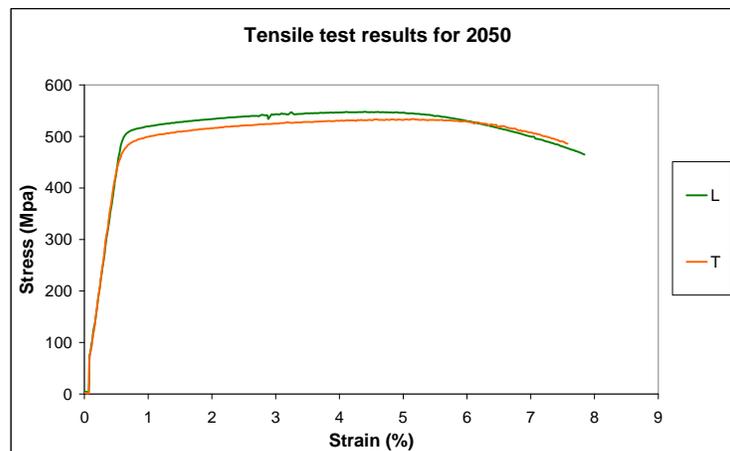
Figure 6: Stress strain curves for 2050 in L and T direction

Results from the tensile test show that this material exhibits a small degree of anisotropy in its behaviour as illustrated by Figure 6 below. The mechanical properties obtained from the experimental data are summarised in Table 2. Total elongation of specimens in both directions was quite similar at 7.5% and 7.8%. However, the strain hardening behaviour differs slightly. Ultimate tensile strength in the L direction occurs at 4.2% strain where as the ultimate tensile strength in the T direction occurs when strain levels reached 5.8%.

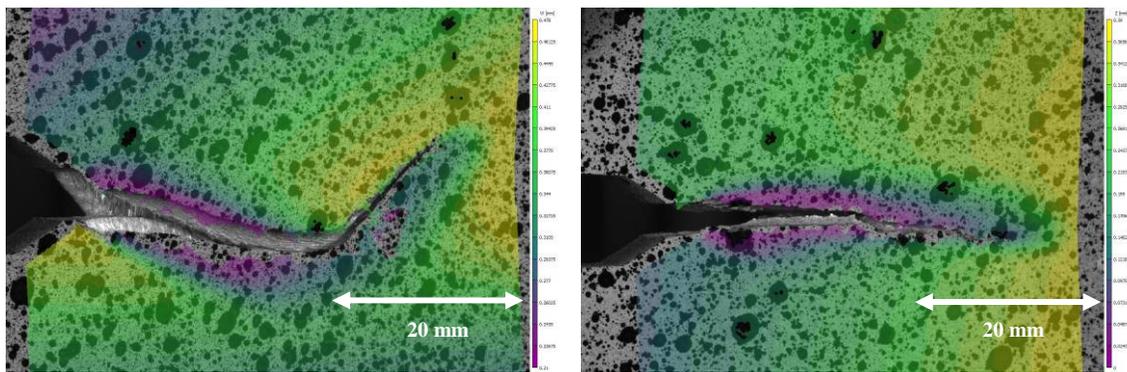
Figure 7: Out of plane deformation maps of tear specimens, LT (left) and TL (right)

From the tensile test results, there was a good indication that anisotropic behaviour will be observed in the tear tests. However, the extent of the anisotropy was not expected. Figure 7 shows the torn specimens with out of plane deformation maps superimposed on the surface. The crack path of the specimen in the LT direction is highly unstable. There was a significant amount of crack tunnelling and the fracture mode comprised of a combination of slant and shear fracture.

Further evidence of the fracture instability is encountered in the load CMOD plot for the LT specimen shown in Figure 8. There is a sudden drop in load (21 kN to 7.2 kN) which in turn was followed by the crack beginning to turn approximate 45 degrees as shown in Figure 7. The corresponding CMOD increases by 0.37 mm (1.16 mm to 1.53 mm). Preliminary investigation of the fracture surface suggests sudden fracture between grain boundaries to be the most likely cause. The cause of the crack turning has not been established but based on literature data it would most likely be microstructure related [4]. Further analysis of the fracture surfaces and data is needed to determine the cause of this phenomenon.

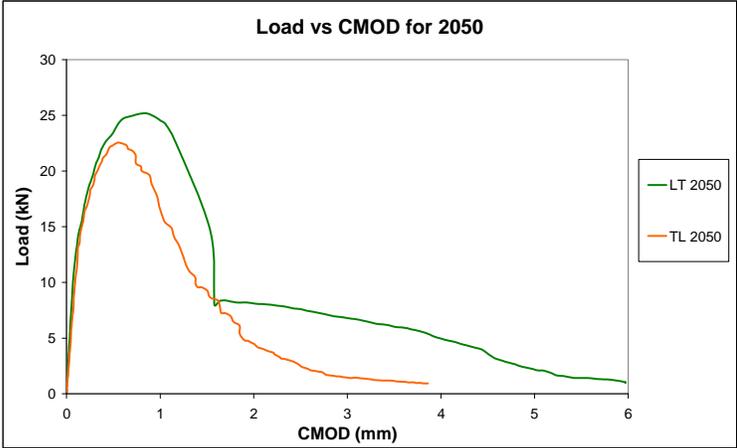
Figure 8: Load CMOD for 2050 CT tear specimens

For the specimen in the TL direction, the crack path was deemed to be stable. There was minimal amount of crack tunnelling and it was predominantly flat fracture throughout the tearing process with only small shear lips forming at the edges. The tearing resistance was significantly less when compared to the LT direction. Comparing results from the tensile test and tear test, it is clear that the difference in anisotropy is significantly greater for the tear test.

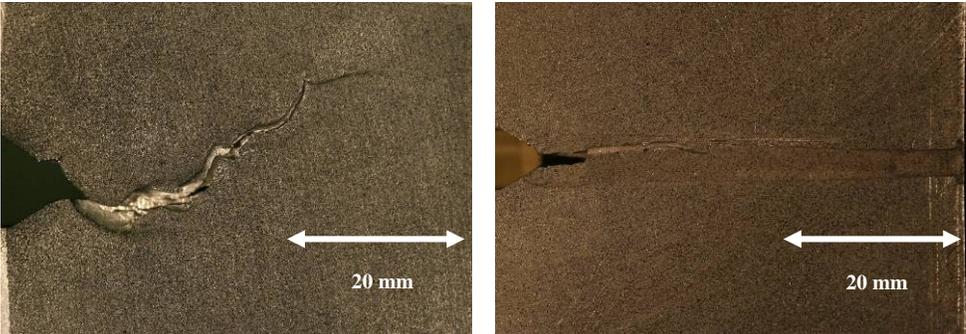
Figure 9: Torn 2195 specimens, LT (left) and TL (right)

If the results are compared to previous results obtained from similar experiments using 2195 [1], it can be shown that there is an improvement in the tearing properties of 2050. Figure 9 shows the torn 2195 specimens. The difference in tearing toughness between TL and LT is significant greater as illustrated in Figure 10. Severe crack tunnelling was observed in the LT direction and there were periodic sudden drops in load during the fracture process which was followed by deviation in the crack path as shown in Figure 9.

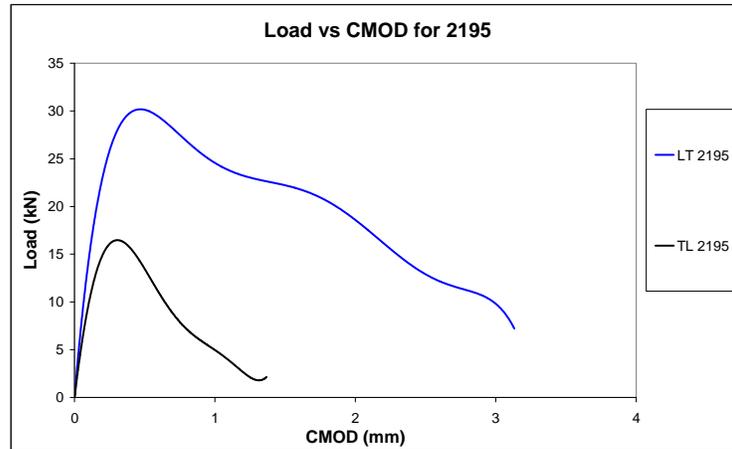
Figure 10: Load CMOD for 2195 CT tear specimens
