# Crack Paths in Weld Details under Combined Normal and Shear Loading

**ABSTRACT.** *In welded plate structures, fatigue cracks may initiate at the intersections between the flanges of longitudinal stiffeners and the web-stiffener attached to a transverse girder. The weld toe cracks may initiate and propagate in the flange of the longitudinal stiffener, while in certain cases they may initiate from the root of the fillet weld resulting in the separation of the web-stiffener from the flange. In order to investigate such a morphological change of crack growth behavior, series of fatigue tests have been carried out, and the morphological variation of these fatigue cracks are successfully identified in terms of the normal and shear stress distribution acting along the fillet weld between the flange and the attachment.*

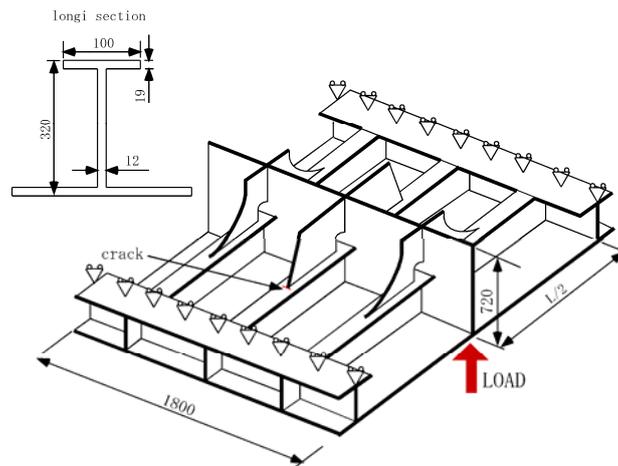
Figure 1 is a schematic illustration of the fatigue test specimen, Sp2003. The material used is a structural steel SM490A specified in JIS standard. The specimens are designed so that the applied stress, residual stress, and structural redundancy are equivalent to those attained in ship structures. The specimens consist of three longitudinal stiffeners and a transverse girder at the middle span. The center longitudinal stiffener is connected to the transverse girder with a large bracket. A fatigue crack initiation is expected only at the intersection of the center longitudinal stiffener and the end of the web-stiffener. The loading condition is the three-point bending, and the applied hotspot stress range is set to 120MPa at the critical point.

Figure 1. Fatigue test specimen, Sp2003.

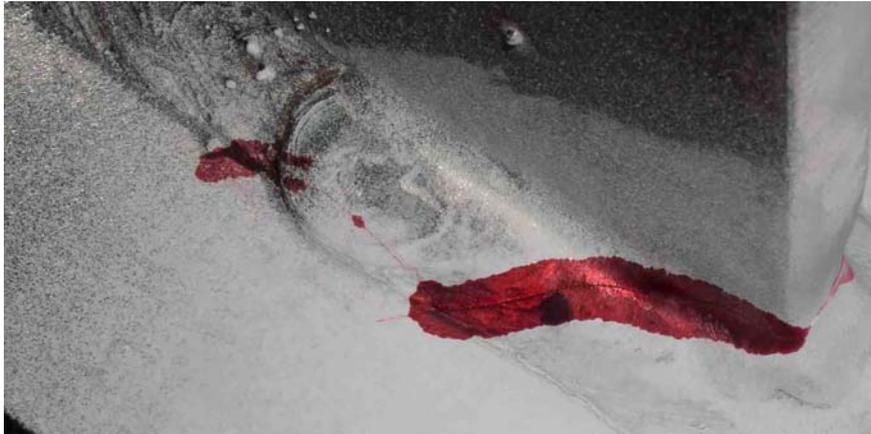
The fatigue cracks exhibited the following behavior (see Fig.2);

- (1) a fatigue crack initiates at the end of the bracket, and propagates into the face-plate,
- (2) other cracks initiate from the weld root, and propagate to coalesce with the first crack,
- (3) the first crack is arrested in the face-plate, and
- (4) the secondary cracks propagate into the face-plate.

Figure 2. Crack propagation in test specimen, Sp2003.

From the observed crack growth behavior, it is inferred that the cracks may repeat the above process (2)-(4), so that they may result in the separation of the web-stiffener from the face-plate.

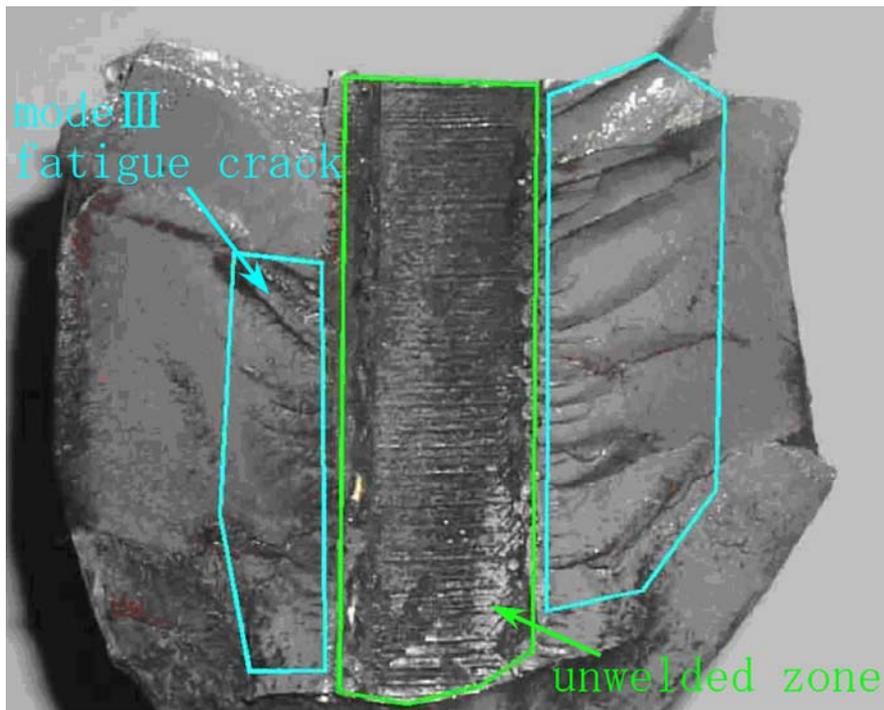
Figure 3 shows the fracture surface of the specimen, where multiple fatigue cracks are initiated from the weld root, and their crack surfaces show slightly inclined angles due to the high out-of-plane shear stress with respect to the plane of the lack-of-penetration zone.

Figure 3. Fracture surface of test specimen, Sp2003.

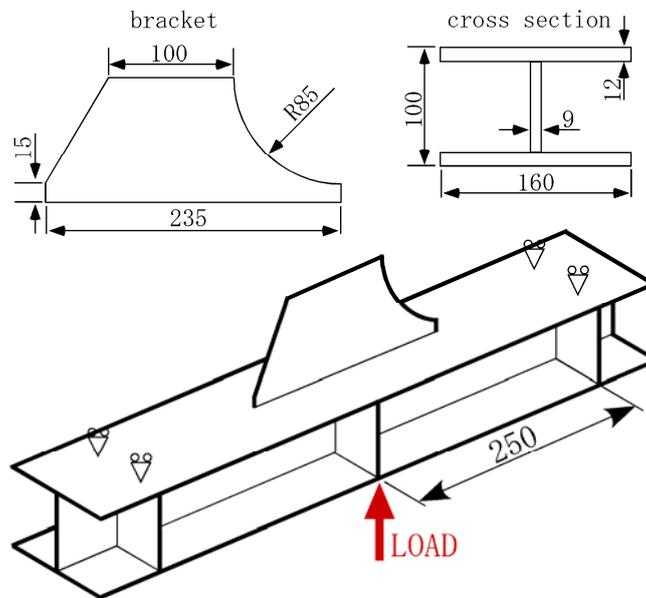
Figure 4 is a schematic illustration of the fatigue test specimen, Sp2005, and the loading condition, where a fatigue crack was initiated at the weld toe of the face-plate, and propagated in the flange (see Fig.5).

Figure 4. Fatigue test specimen, Sp2005.

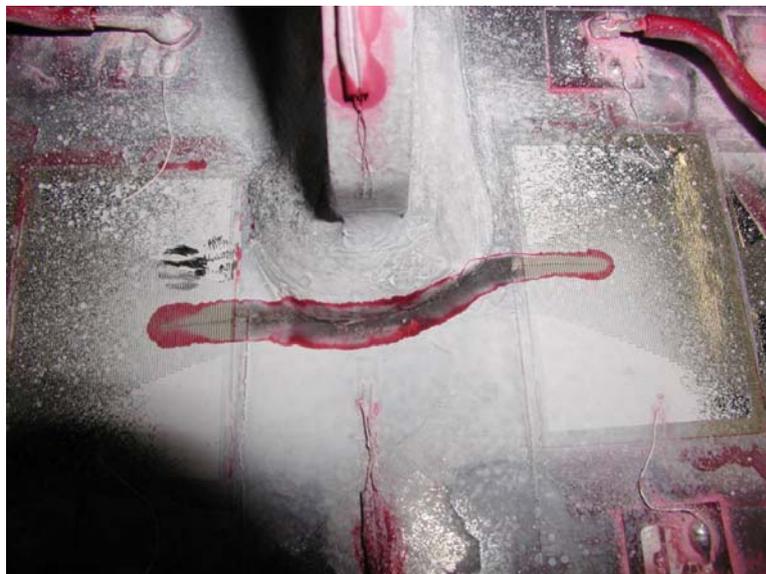
Figure 5. Weld-toe crack of test specimen, Sp2005.

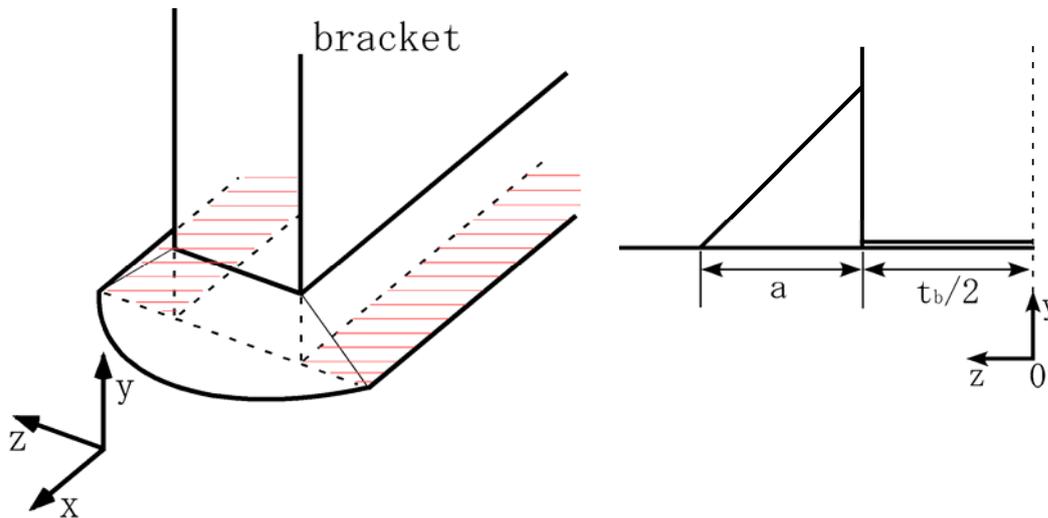
In order to identify the governing parameters of the two distinct cracking behavior observed in Sp2003 and Sp2005, finite element stress analyses are carried out by considering the effects of non-penetrated weld using three-dimensional solid elements. The weld geometry is modelled as illustrated in Fig.6, where the non-penetrating zone of width,  $t_b$ , is discontinuous in the finite element calculation.

Figure 6. Modelling of weld toe ( $a$ :leg length,  $t_b$ :width of non-penetrating weld).

In order to evaluate the local stress-effects to the crack morphology, averaged normal stresses and shear stress are introduced in the present paper. As expressed in the following equations, the longitudinal normal stress is averaged in the leg length of the weld and attachment thickness, while the shear stress and lateral normal stress are averaged in the fillet weld;

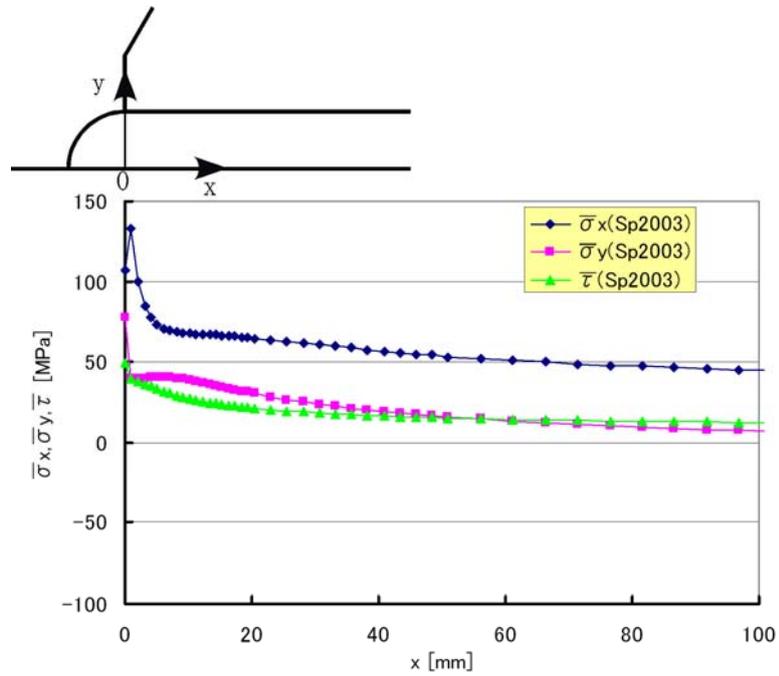
The distribution of the averaged stresses are evaluated for the specimens, and the results are illustrated in Figs.7 and 8, where one can see the relatively higher shear stress is in Sp2003 in comparison with that in Sp2005. This is clearly indicated by the ratio of the

Figure 7. Averaged stress distribution of Sp2003.

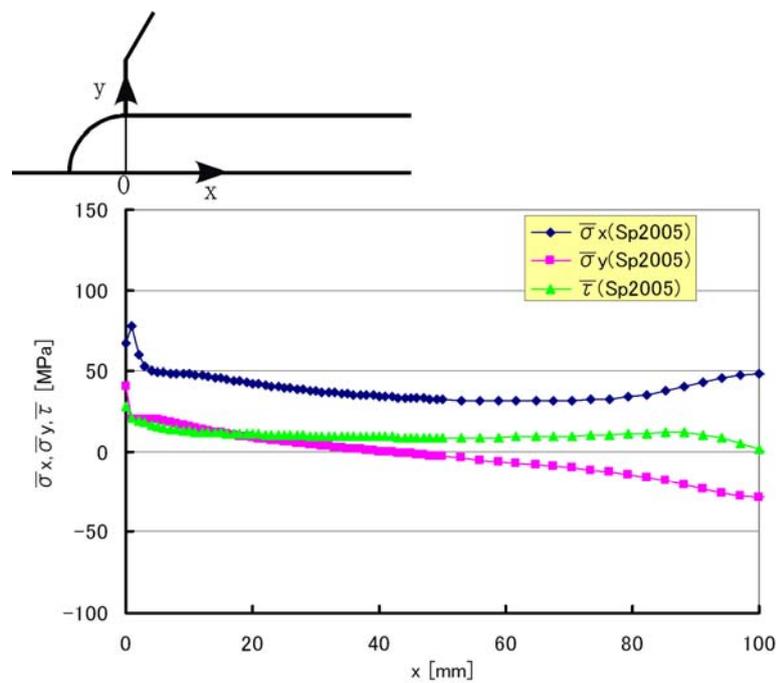
Figure 8. Averaged stress distribution of Sp2005.

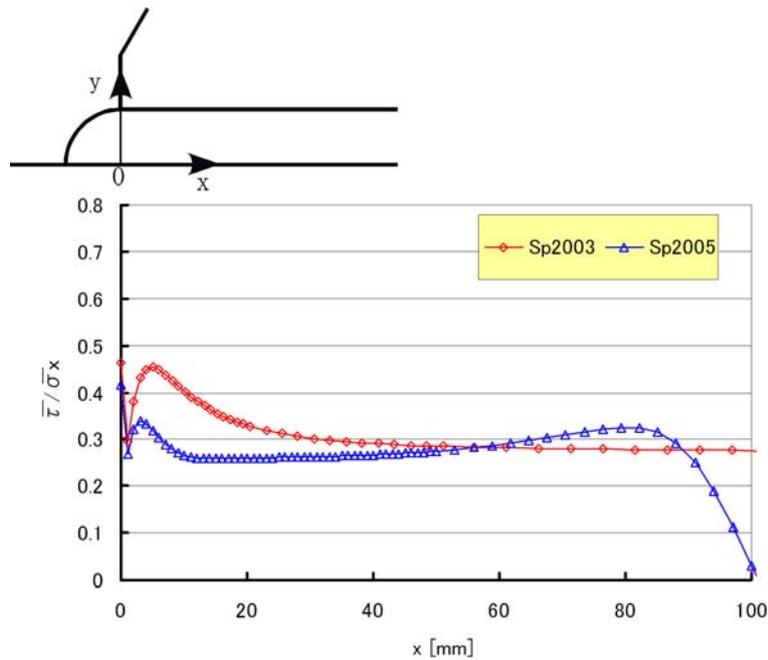
shear stress to the longitudinal normal stress in Fig.9, and this difference may result in the completely different cracking pattern of these two specimens.

Figure 9. Averaged shear and normal stress ratio of Sp2003 and Sp2005.

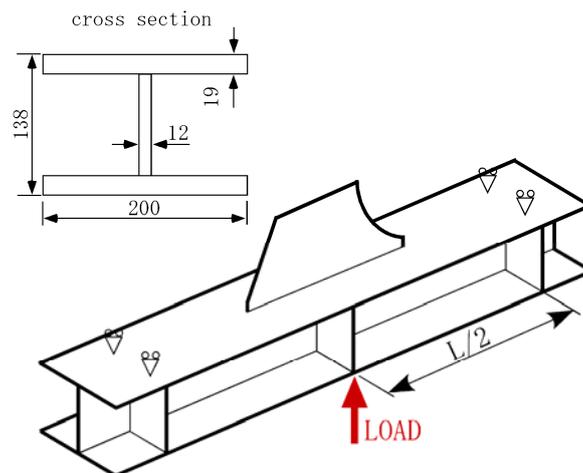
Based on the experimental and numerical results in the previous subsections, we have designed four test specimens in order to categorize the cracking patterns in terms of the stress parameters near the weld toe of the wrap-around weld connection. The basic geometry of the test specimen is illustrated in Fig.10, where the weld toe of the attachment on the upper flange is the possible crack initiation site.

Figure 10. Common geometry of test specimens No.1-4.

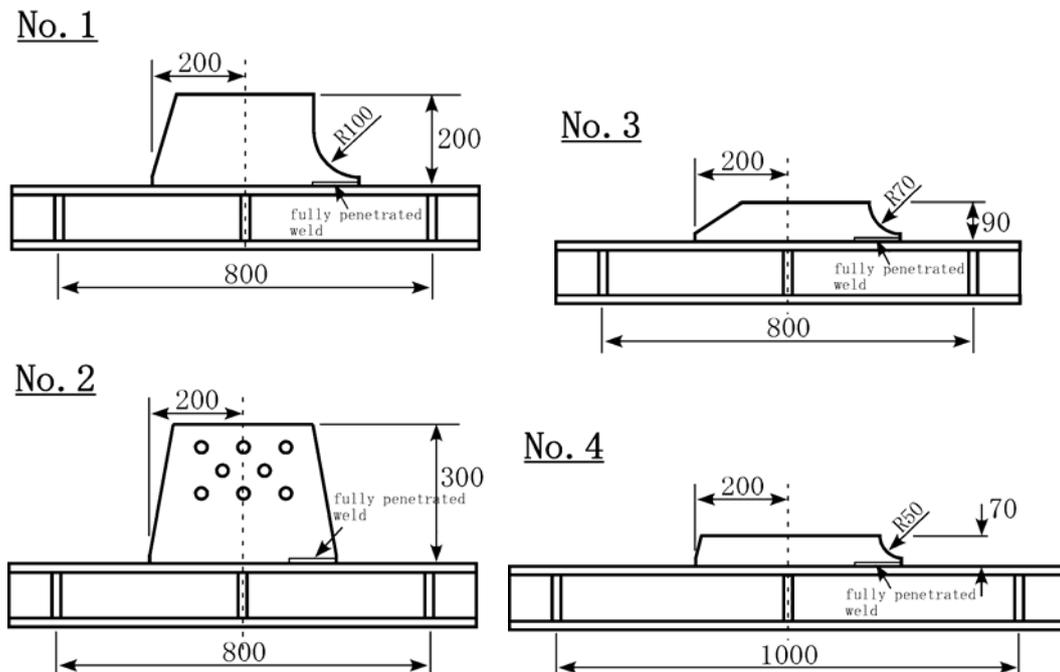
Mechanical properties and chemical composition of the steel are listed on Table 1. The attached brackets of the specimens are designed differently as shown in Table 2 and Fig.11, so that the shear and normal stress levels are changed resulting in a variety of crack growth behavior. The loading conditions are listed on Table 3.

Figure 11. Geometry of test specimens No.1-4.

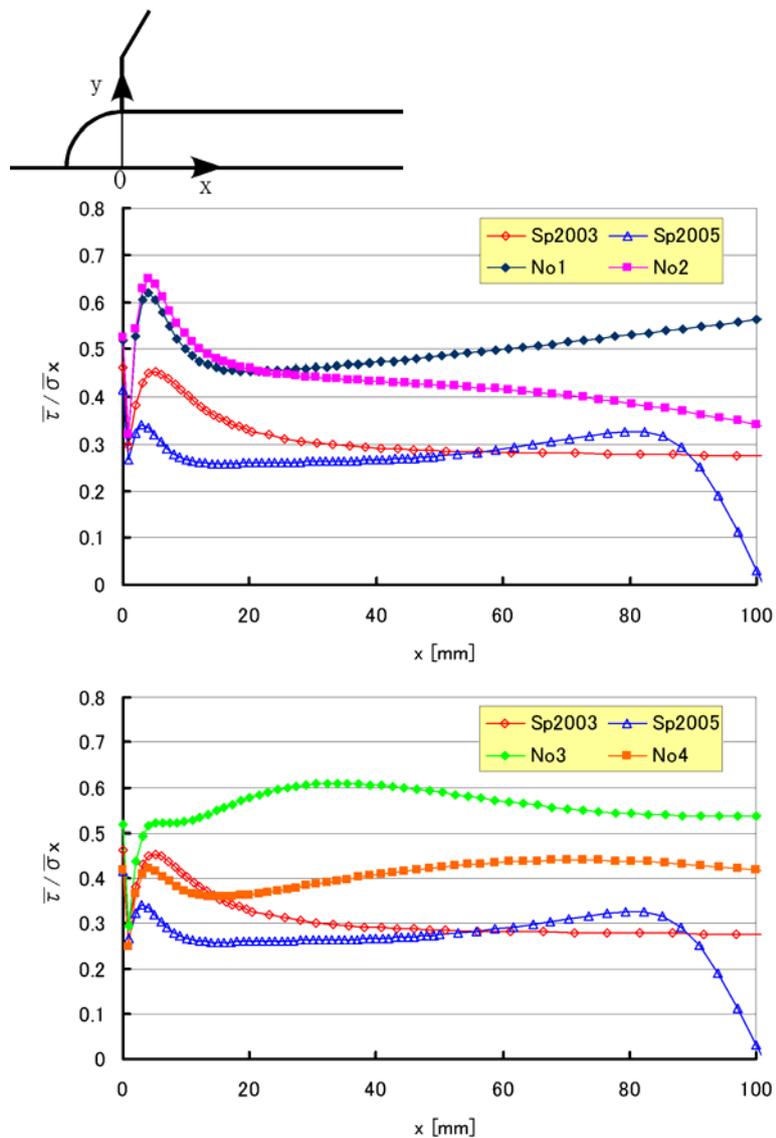
As illustrated in Fig.12, all specimens No. 1-4 have relatively high shear stress near the weld toe so that they may exhibit the failure mode to bracket separation, among which specimen No.4 has relatively low shear stress along the fillet weld.

Figure 12. Averaged shear to normal stress ratio of specimens.

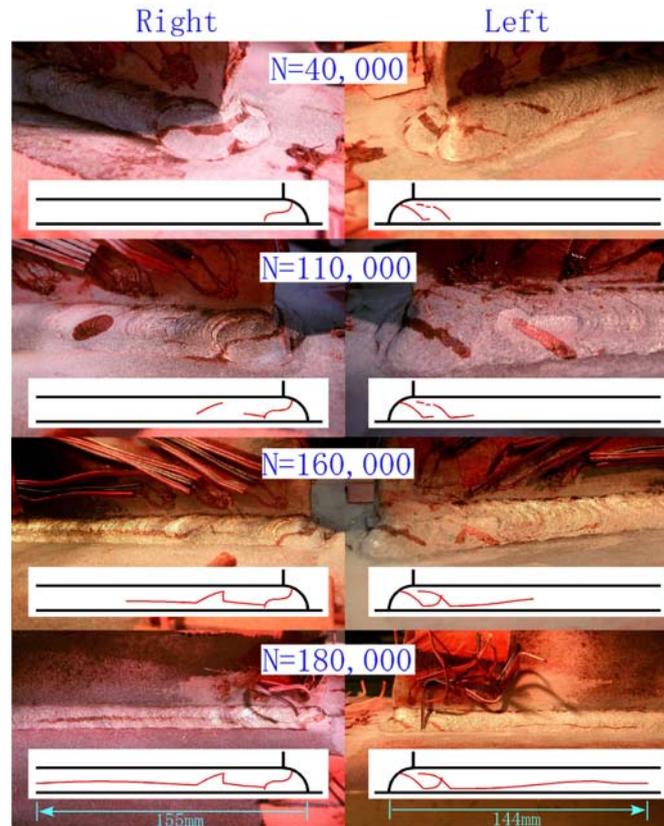
The four specimens are tested, and the crack morphology is investigated by observing the specimen surface during the tests and also by examining the fracture surface after the tests. Specimens No.1-3 exhibit the bracket separation mode of failure (see Fig. 13), while the mixed flange and bracket separation failures are observed in Specimen No. 4 (see Fig. 14).

Figure 13. Bracket separation mode of failure in Specimen No.1.

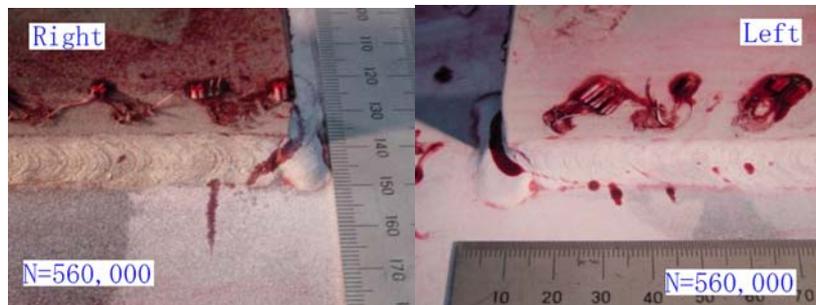
Figure 14. Mixed flange and bracket separation failures in Specimen No.4.

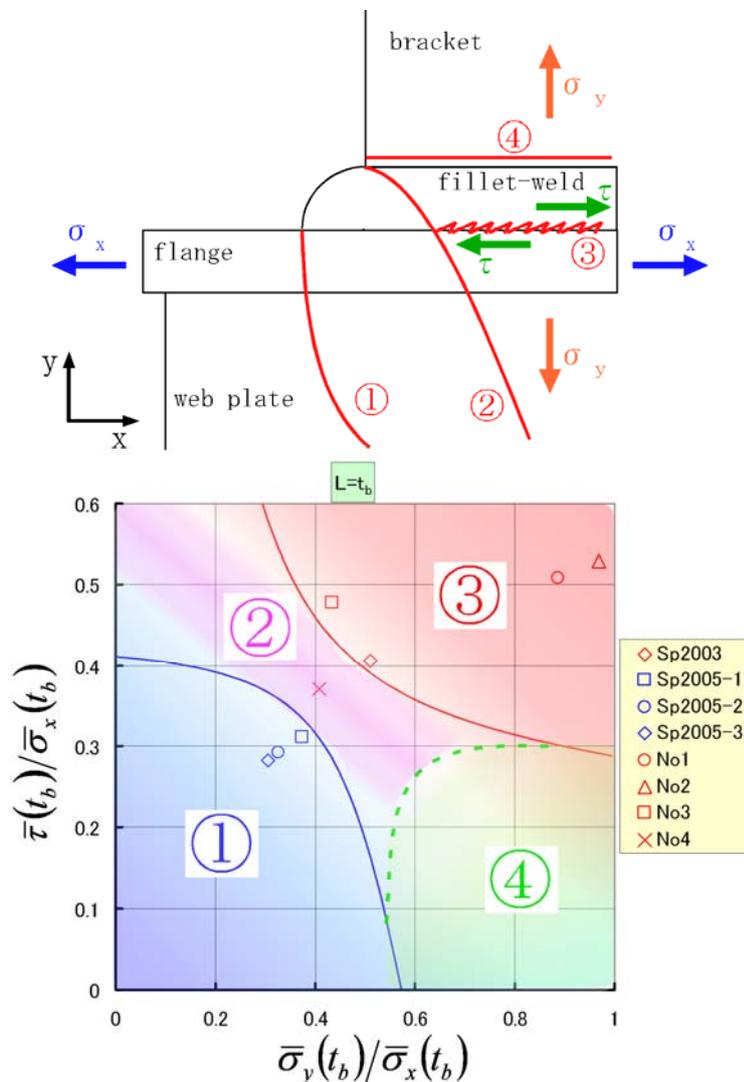
All the results of eight test specimens (Sp2003, Sp2005-1, Sp2005-2, Sp2005-3, and No.1-4) are plotted in Fig.15, so that we may draw the approximate boundaries of the for failure modes in this mapping chart.

Figure 15. Identification of failure modes near the wrap-around weld.

Based on the series of finite element stress analyses carried out for the fatigue test specimens, we propose the two parameters; i.e. the ratio of the averaged shear stress and longitudinal stresses, and the bi-axial stress ratio of the lateral and longitudinal normal stresses, which are schematically illustrated in the upper part of Fig.15. The lower part of the figure is the possible mapping of the crack morphology in terms of these parameters. Naturally we can expect the failure mode (1) in the lower left zone due to the small effect of shear, while the failure mode (3) may occur in the upper right zone. The relatively high lateral stress may lead to the failure mode (4). The relatively high shear stress may initiate mode III cracks in the weld, but the longitudinal normal stress may lead the crack into the flange identified as the failure mode (2).
