# COMPARISON, BY ELECTROCHEMICAL MEASUREMENTS, OF THE MICROBIOLOGICALLY INDUCED CORROSION BEHAVIOR IN STAINLESS STEELS

J. I. Pastor Manso; F. Montero Ortego and J. Izquierdo Gómez

IBERDROLA GENERACIÓN – SETEG - Tecnología de Materiales,  
Pº Virgen del Puerto, 53-57 28005 Madrid Spain  
jipastor.manso@iberdrola.es

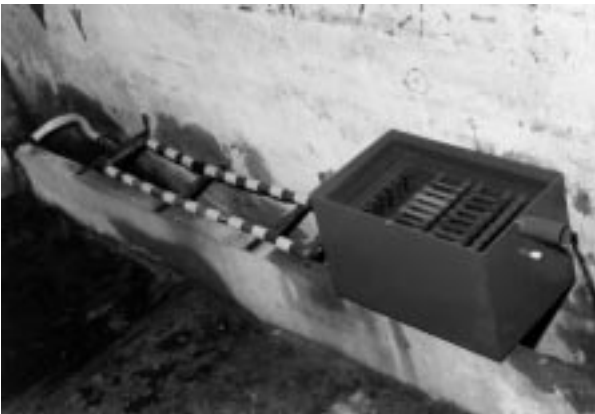
**Figure 1:** Situation of the test bed

In the figure 1 we can see a general vision of the situation of the dynamic test bed, in the figure 2 we can see the laying of the specimens inside of the test bed.

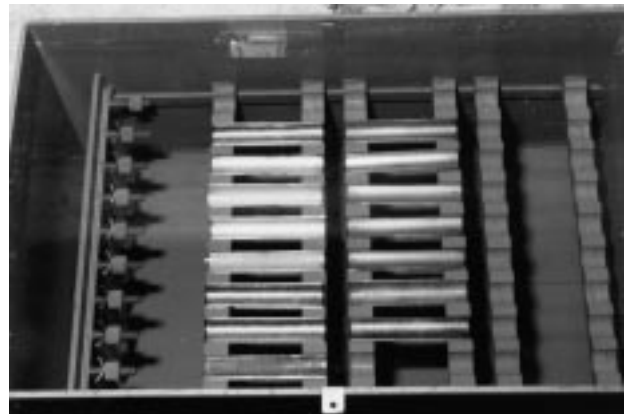
**Figure 2:** Laying of the specimens inside of the bed

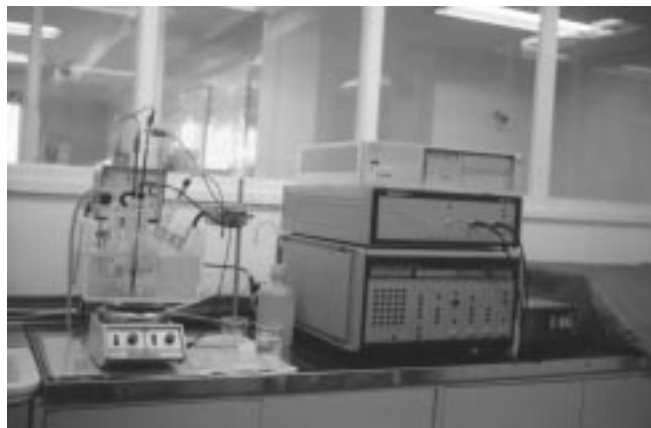
**Figure 3:**Equipment for electrochemical measurements

In the figure 3 we can see the system utilised to made the electrochemical measurements.

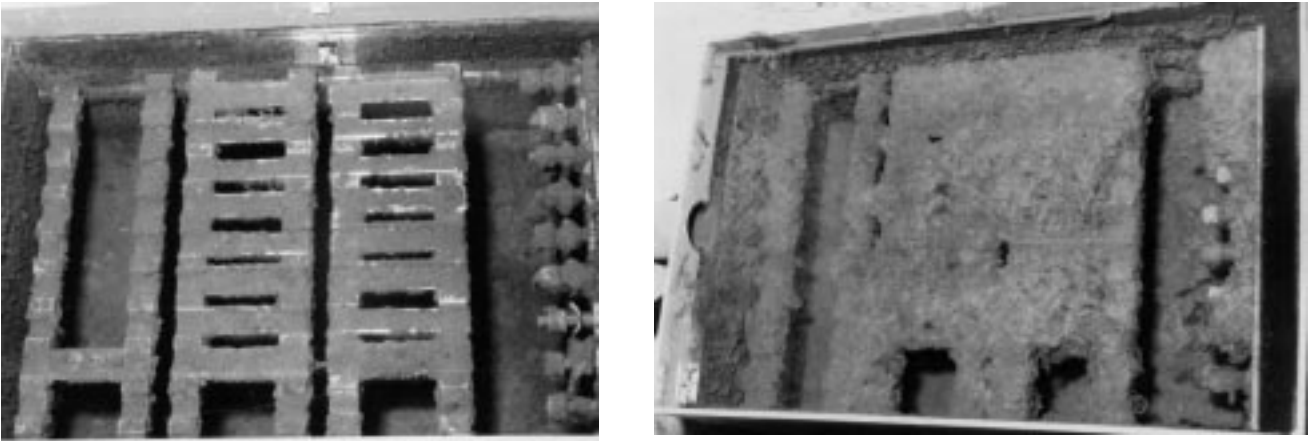
**Figure 4:** Test bed after 163 days (left) and 17 months (right).

In the figure 4 we can see the state of the test bed after 163 days and 17 months.

The specimens ocular inspection showed a thick organic film. The microscopic observation showed that this film was made up by weeds, protozoan and a lot of quantity of bacteria, mainly cells filaments. In the figure 5 we can see a micrography of the fouling founded over the specimens.

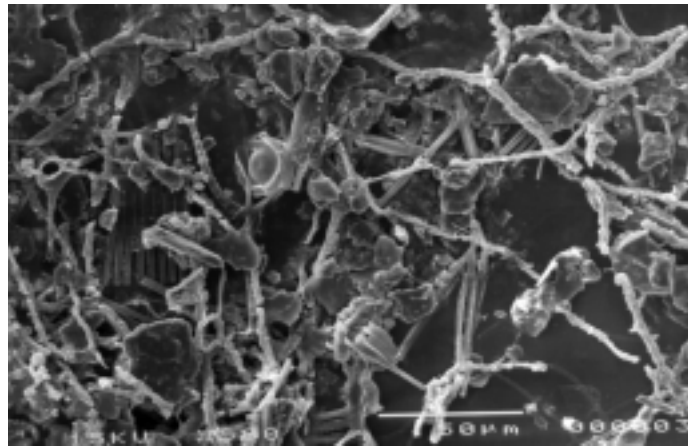
**Figure 5:** Biofouling founded over the specimens

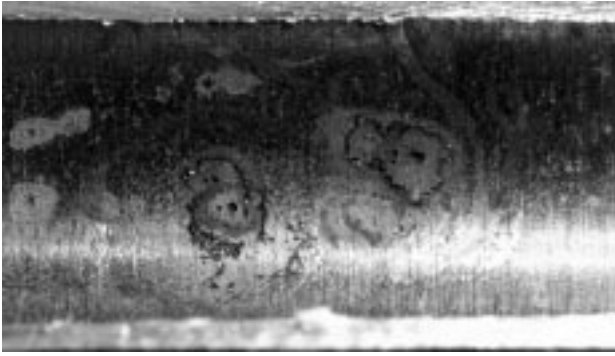
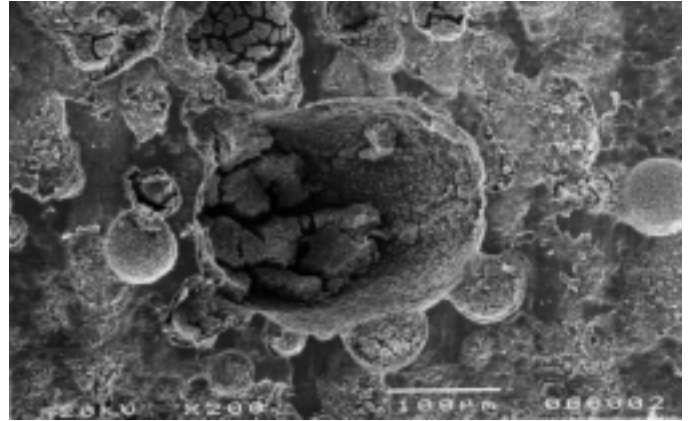
**Figure 6:** Pitting at the internal surface of the tubes

**Figure 7:** SEM photography of the pitting process.

- AISI-308 sensitized: Elongated areas with intergranular corrosion and pitting.
- AISI-321 sensitized: Pitting at the initial part of the tube.
- AISI-420 no sensitized: Pustules at the initial part of the tube, with severe corrosion in areas where the water remained stagnant.
- AISI-420 sensitized: Severe corrosion at the initial part of the tube on the external area. Pitting at the internal surface covered with ferrous pustules. Figures 6 and 7.
- AISI-431 sensitized: General corrosion and pitting with pustules.

To check the corrosion was produced mainly by sulphate reduced bacteria, we used energy dispersive X-ray analysis to determine the origin of the corrosion products that we found in the pitting process.

The comparison between metal and corrosion products analysis shows clearly the bacteria origin of the last ones, because the great quantity of sulphur that we found (15%). This quantity of sulphur could only come from with this type of bacteria.

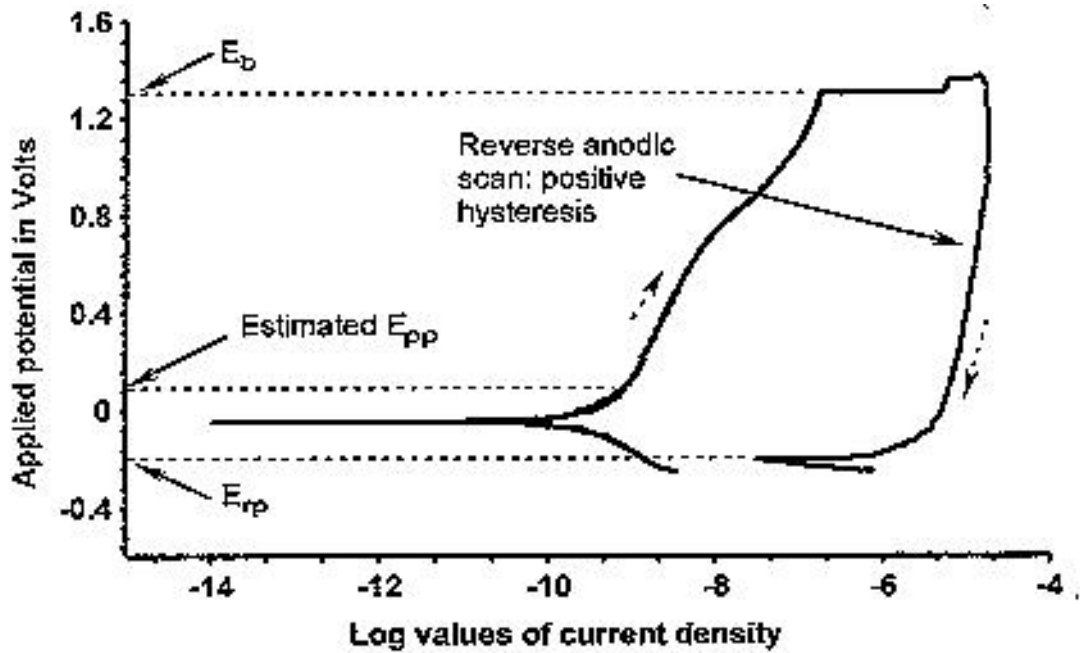
Figure 8: Typical curve of cyclic polarisation technique.

This method (cyclic polarisation), based in ASTM G 61-86 rule, consist in the application of a difference of potential from the material corrosion potential to reach a suddenly increase of current density, which indicate the beginning of the pitting process. After that an inversion in the polarisation direction to the corrosion potential show us the area where the material will stay in its passive state against pitting.

By this way we obtain two values, the one hand  $E_b$  or pitting potential, that is the potential over which pitting start, on the other hand  $E_{rp}$  or repassivation potential, that is the potential under which the material remain passive. Between  $E_b$  and  $E_{rp}$  the initiated pitting will continue but new pitting wont start. In figure 8 we can see a typical curve obtained from this technique.

Therefore when pitting potential ( $E_b$ ) is high the corrosion resistant to this type of corrosion is also high and the passive area is as greater as the difference between  $E_b$  and corrosion potential.
