INVESTIGATIONS OF RAIL FRACTURES AT VIENNA UNDERGROUND AND MEASURES TO REDUCE THEM

G. VALENTA

T. VARGA, F. LOIBNEGGER

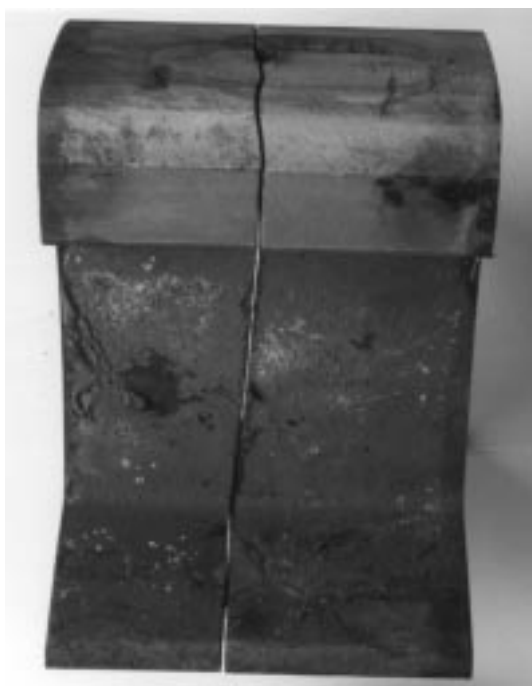
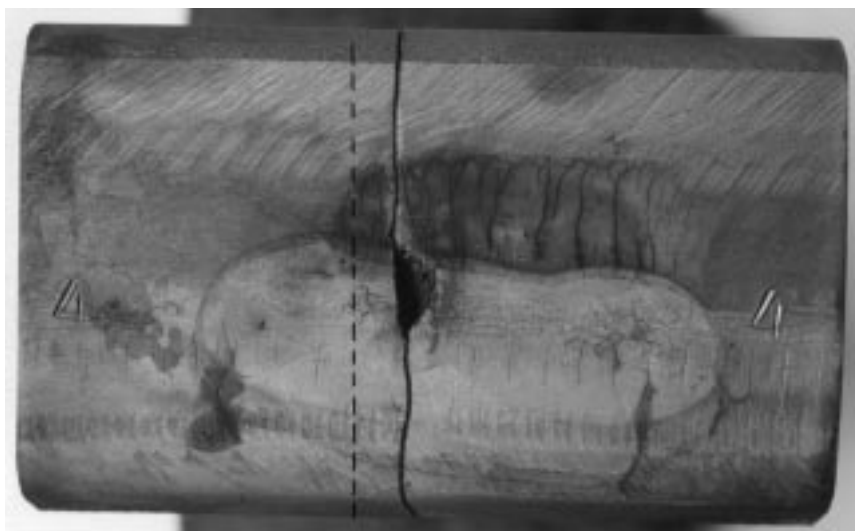
Figure 3: Fracture of a HSH Rail (Head Special Hardened)

Example 1

This rail fracture (Fig. 3) occurred two years after laying (track is situated in the open air) at a temperature of -1°C . The fracture was vertically situated (head – web - foot). Fatigue crack band markings could not be discovered, because the fracture was fish-plated after discovery and should have been welded at a later point of time. A sample of this rail containing the fracture was sent to the rail manufacturer and it came out that a welding on the rail surface had been carried out where the fracture had obviously started from (Fig.4).

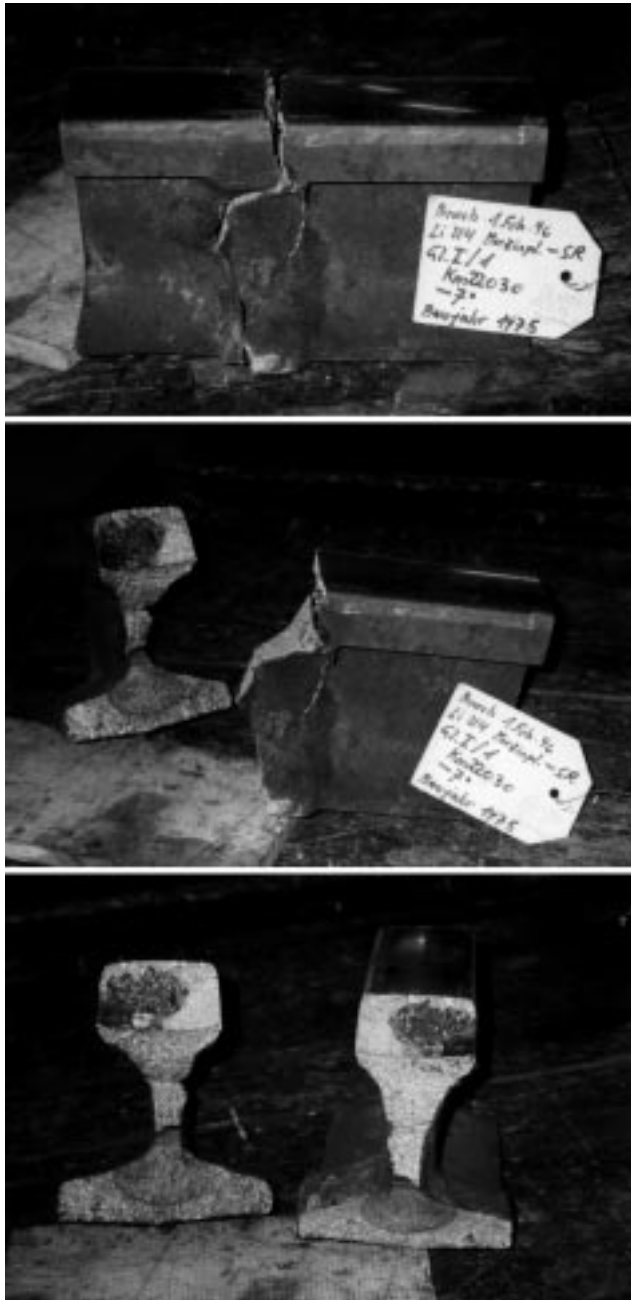
Figure 6:; Fracture of Welding (at welded fish-bolt hole)

Example 3

The rail was laid in 1975, quality 900A.

This fracture occurred on February 1st, 1996 at a temperature of -7°C .

The track is situated in the open air. It appeared that as long as the defect remained an interior defect no fracture occurred. Owing to wear the inclusion got contact to the surface, moreover the tensile stress was increased by sudden coldness.
