# A BRIEF HISTORY OF FRACTOGRAPHY

S. P. Lynch\*\* and S. Moutsos\*

\*Monash University, Clayton Vic. 3168 Australia, + DSTO, Fishermans Bend, Vic. 3207 Australia

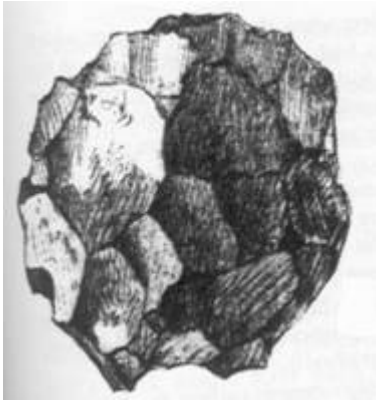
Figure 5. Photograph of a single grain of steel produced by intergranular fracture of an overheated bar (Tschernoff, 1878, reproduced in Smith, 1988 [3]).

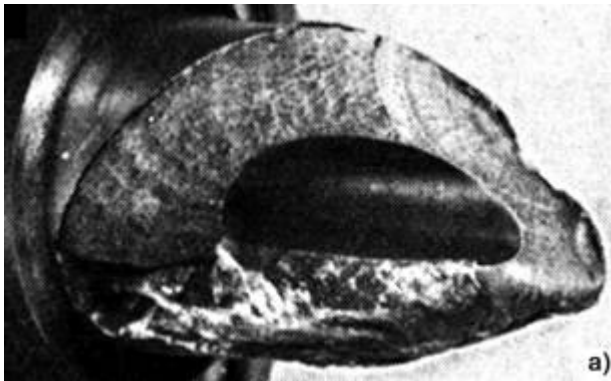
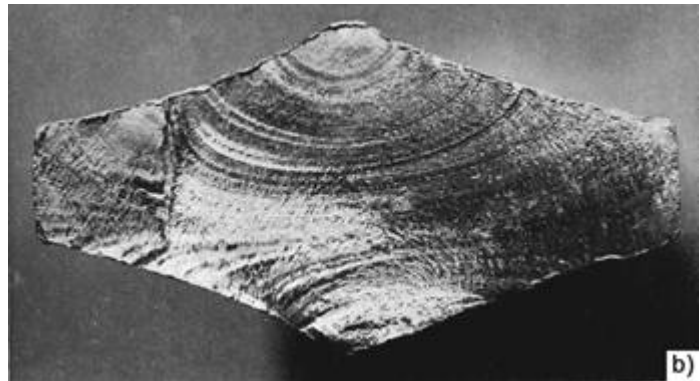
Figure 12. Macroscopic appearance of early fatigue failures showing 'conchoidal' progression markings : (a) for a propeller shaft (Gough, 1926) [27] and (b) for an unidentified component (Cazaud, 1948) [28] (Exact scales are not known).

Fatigue fracture surfaces were first sketched in the early 1840's, with Glynn [26] describing a railway-axle failure having a smooth, cleaved ('crystalline') appearance with blue/purple tints around the periphery and a fibrous appearance in the centre. These fracture-surface observations led some early investigators to conclude that vibration resulted in crystallisation of metals, whereas others correctly maintained that the appearance of fractures depended on the mode of failure. Macroscopically visible 'conchoidal' markings (also called 'beach markings' etc.) on fatigue fracture surfaces would probably have been observed for failures of components in the mid-to-late 1800's, but the first photographs and description as crack-front markings that the authors can find are in Gough's 1926 book 'The Fatigue of Metals' [27] (Fig. 12(a)). An essentially correct explanation for these markings was possibly first proposed by Cazaud [28] in his 1948 book on 'Fatigue of Metals', in which there are a number of examples of fatigue fracture surfaces with progression markings (Fig. 12(b)). Thus, Cazaud suggested that (variable) plastic deformation and work-hardening around cracks resulted in their momentary deflection.
