An Investigation on the Fatigue Performance of Hydraulic Gate Wheels

Dimos Polyzois and Abdul Nabi Lashari
Department of Civil Engineering, University of Manitoba
75B-Chancellor Circle, Winnipeg, MB, R3T 5V6, Canada
polyzoi@cc.umanitoba.ca

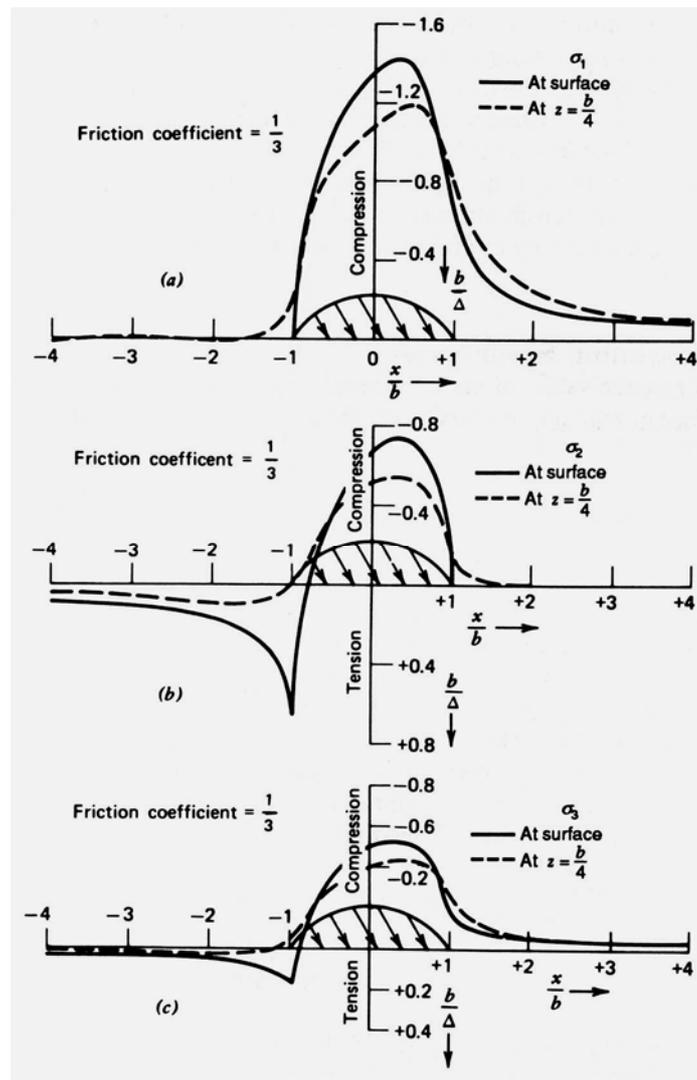
Fig. 1. Distribution of contact stresses [4]

The principal stresses at the contact area are higher than the stresses at a point beneath the contact area; whereas the maximum shearing stress is greater at a point a small depth from the contact surface. Due to fabrication errors or due to deflection of the gate girders, however, it is possible that the direction of the roll is not coincident with direction of the roller path. In this case, frictional forces develop between the wheel and the roller path. The addition of these forces causes a change in the shearing stresses in the contact area. Furthermore, the location of the point at which the maximum shearing stresses occur moves from beneath the surface of the contact towards the contact area. Fig. 1 shows the distribution of the principal stresses at the contact surface of a wheel with a coefficient of friction of $\frac{1}{3}$. The figure also shows that the frictional force cause an increase in the principal stresses by 40%. It is important to note that the principal stresses σ_1 and σ_2 are tensile

stresses near the edge of the contact area. These values are sometimes quite large. The presence of the tensile stresses result in fatigue failure by pitting of bearing surfaces under repeated loads [4].

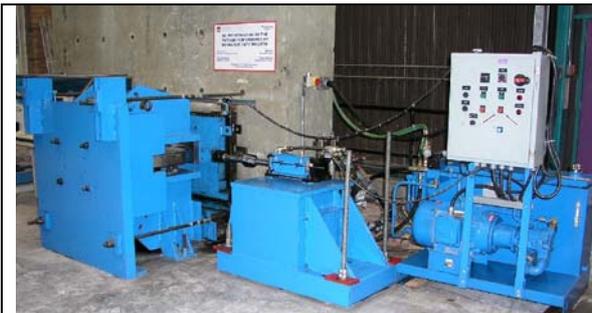
A unique test set up, shown in Fig. 2, was specially designed and constructed for this experimental program. The hydraulic pressure generated by the pump was transferred to a hydraulic actuator through two hydraulic hoses, one for forward motion of the actuator piston rod and other for backward motion of the actuator piston rod. The 15 kW (20 horse-power) motor of the pump was

designed to generate a maximum pressure of 17.2 MPa. This pressure value corresponded to a lateral load of 184.5 kN on the hydraulic actuator. The purpose of the hydraulic actuator was to deliver a lateral cyclic load through a 51 mm diameter solid steel piston rod, which was attached to 127 x 102 x 76 mm solid steel plate through threads, shown in Fig. 3. This solid plate was attached to an 863 x 609 x 76 mm solid steel plate through welding and four countersunk steel bolts in order to avoid any kind of failure during cyclic loading. In order for the actuator to deliver the cyclic loading continuously and without interruption, two small magnetic sensors were used. These magnetic sensors were installed on a small steel frame mounted on the hydraulic actuator and wired to the power panel switchboard of the pump. The hydraulic actuator was attached to a steel frame through four 19 mm diameter steel bolts.

Fig. 2. Test set-up

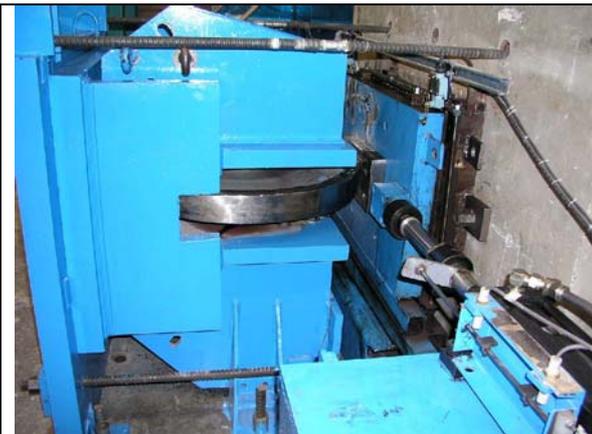
Fig. 3 Wheel Under Testing

In order to support the roller path plates two 863 x 609 x 76 mm steel plates were used in this unique test set-up, as shown in Fig. 3. One plate was permanently attached to the 609 mm thick strong concrete wall of the Structural Engineering Laboratory. The other plate was attached to the 51 mm diameter solid steel piston rod of the hydraulic actuator. The roller path plates were attached to this plate through steel bolts. A series of high strength solid round bars was placed between the two plates to allow the plate with the roller path to roll freely back and forth. The roller was placed in this steel fixture horizontally and secured in place with a long solid steel shaft, 152 mm in diameter and 495 mm in length, inserted through the steel fixture and the 152 mm diameter hole of the wheel. A radial compressive load equivalent to service load was applied on the wheels by compressing the whole steel fixture against the roller path plate through four high strength rods which ran through the 609 mm thick strong concrete wall. These four high strength rods were calibrated in order to monitor the axial load during testing. Four hydraulic jacks were used to apply the axial load. The average radial load on Wheel R1, side A during cyclic testing was 825 KN.

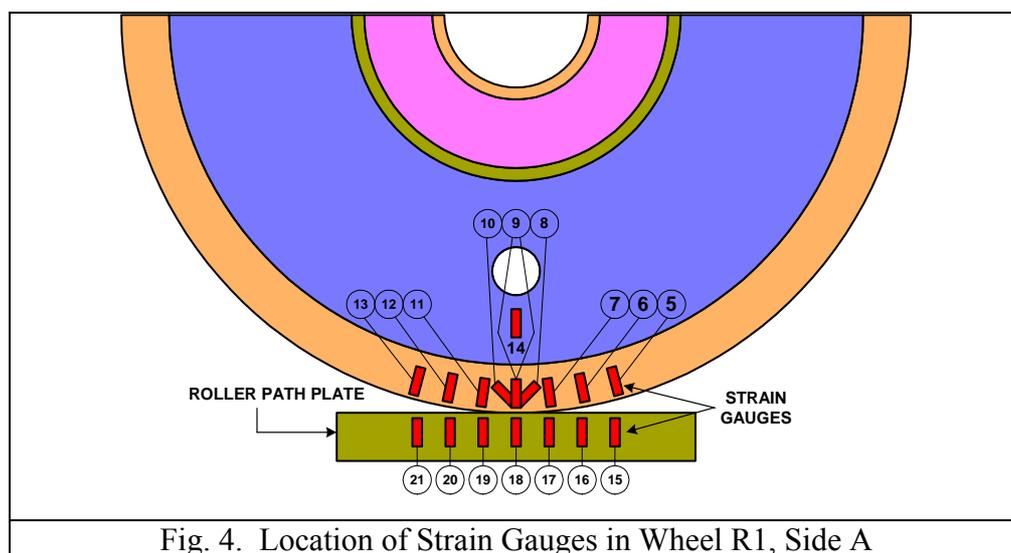
Strain gauges were installed on all wheels and roller path plates in order to monitor and record the strain values during cyclic loading. Each wheel was tested with two different roller path plates utilizing two opposite sides of the wheel. The strain gauge location for Wheel R1 – Side A are shown in Fig. 4. All strain gauges were connected to a computer controlled data acquisition system.

Fig. 4. Location of Strain Gauges in Wheel R1, Side A

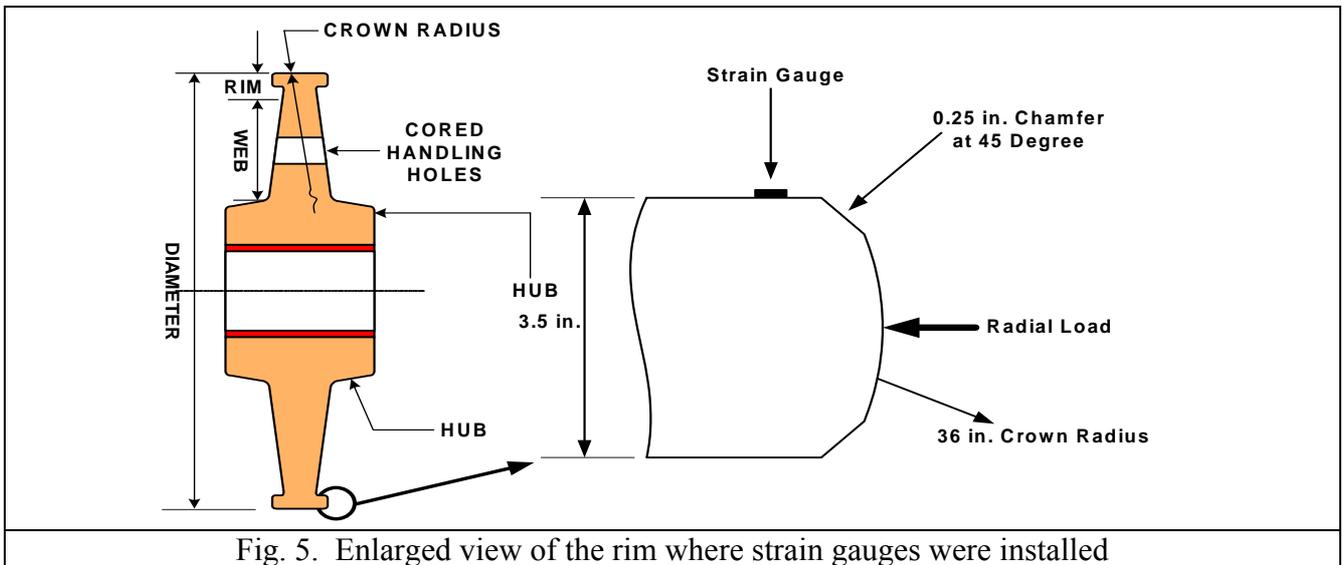
Maximum tensile strains were observed in the strain gauges installed on the rim surface of the wheel when these strain gauges were farthest away from the contact point and minimum tensile strains were recorded when the strain gauges were either in contact with the roller path plate or very close to the contact point. The reason for minimum tensile strains, when the strain gauges were either in contact or very close to the contact point, was that the rolling rim surface had a depth of 89 mm (3½ in.) and a crown radius of 914 mm (36 in.) along with a chamfer of 6.4 mm (¼ in.) long, inclined at 45° in between the rolling surface and rim surface, as shown in Fig. 5.

Fig. 5. Enlarged view of the rim where strain gauges were installed

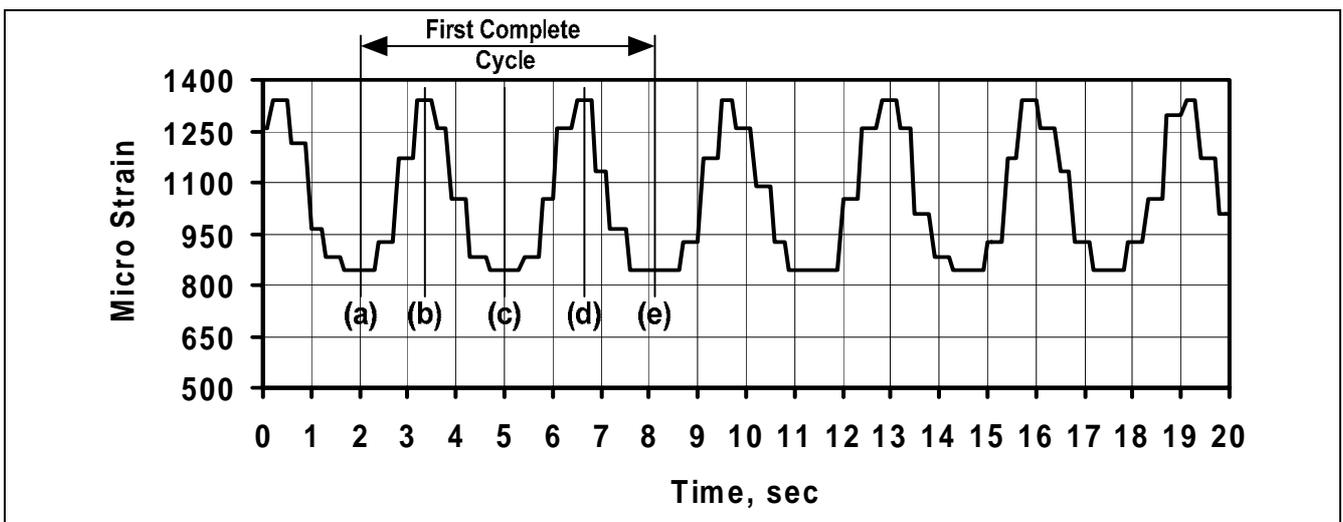
As shown in Fig. 6, the strain recorded by strain gauge 9 in Test T1A, varied from 842 $\mu\epsilon$ (in tension), when the strain gauge was in direct alignment with the point in contact with the roller path, to 1340 $\mu\epsilon$ (in tension), when the strain gauge was the farthest away from the contact point. The location of strain gauge 9 during the first cycle is illustrated in Fig. 7. In the majority of the strain gauges installed on the rim surface of the wheel, it was found that with the increase in the number of cycles, the strain dropped from a high tensile strain to a low tensile strain or even to compressive strain. An example is shown in Fig. 8, where a continuous drop in the micro-strain was observed in strain gauge 6 up to 500,000 cycles. After that strain level, the strain remained constant until the test was stopped at one million cycles. There are two interesting observations that are of importance to note. First, the strain difference between the minimum and the maximum values became smaller as the number of cycles of loading increased reaching a constant value after a certain number of cycles. Second, both the maximum and the minimum strain values decreased as the number of cycles increased, reaching a constant value after a certain number of cycles, for all strain gauges installed on the rim surface except strain gauges 8 and 10, which were part of rosette strain gauge and were placed at 45° to a plane perpendicular to the rolling surface of roller path plate.

Fig.6. Strain recorded by gauge 9 in Wheel R1, side A, during the first three cycles

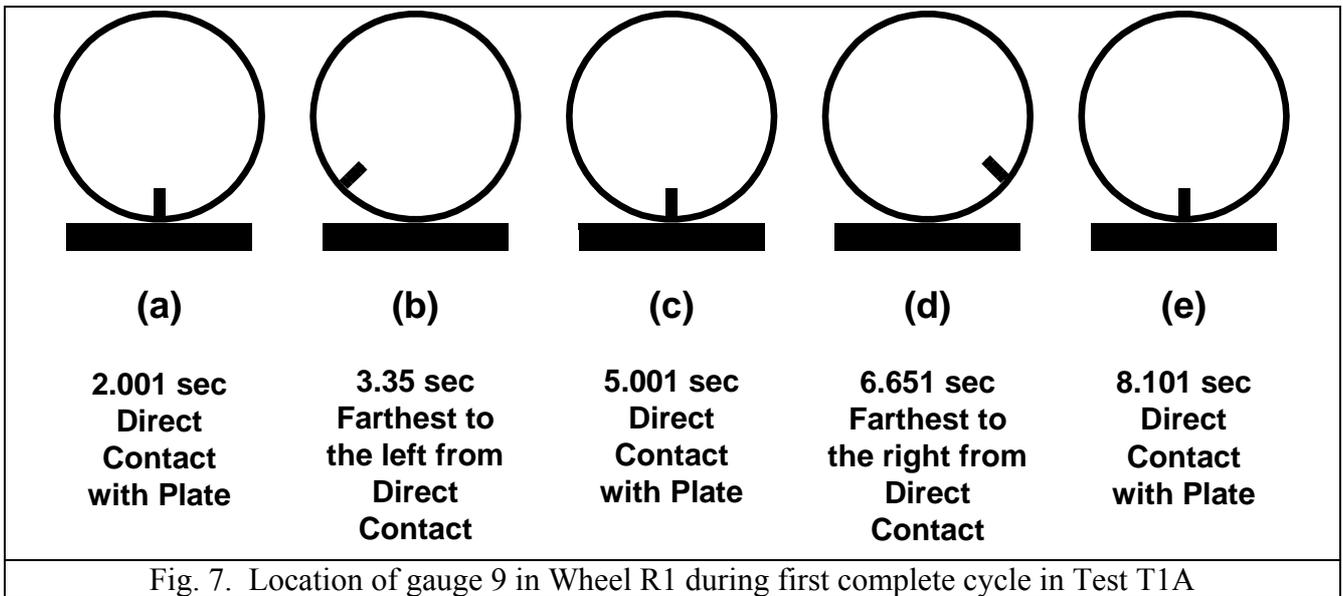
Fig. 7. Location of gauge 9 in Wheel R1 during first complete cycle in Test T1A

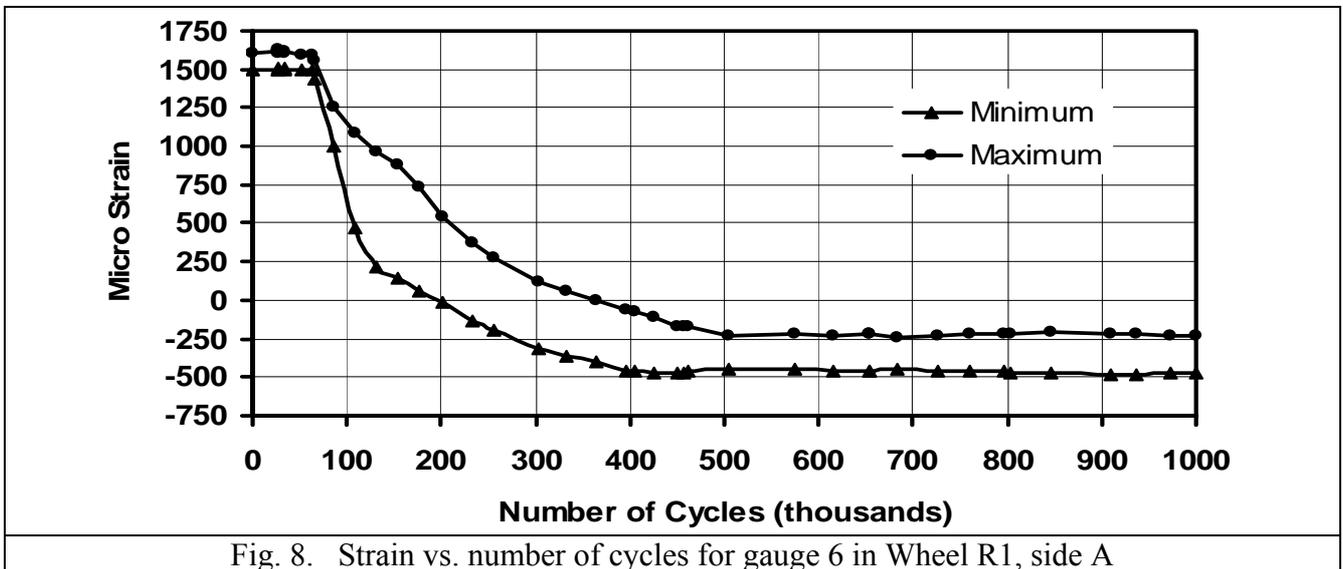
Fig. 8. Strain vs. number of cycles for gauge 6 in Wheel R1, side A

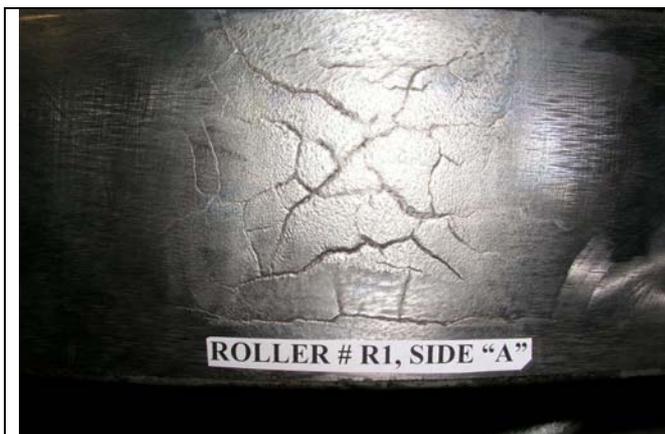
The contact area on side A of Wheel R1, which was subjected to one million cycles of repeated loading, is shown in Fig. 9. Two sets of major and minor cracks are evident in this figure. Almost similar trend and behavior was observed in the crack pattern of Wheel R1, side B, which was subjected to 818,726 cycles of repeated loading. The tested contact area of Wheel R2 after 200,000 cycles is shown in Fig. 10. There was no sign of any kind of crack or deformation in the tested contact areas of either Wheel R2 or R3. Cracks were also evident in the roller path Plates P1 and P2, but not in the heat-treated Plates P3 to P6.

Fig. 9. Contact area of Wheel R1, Side A, after 1 million cycles

The test results demonstrated clearly that the cast iron wheel performed very poorly under cyclic loading forming cracks in the contact area. The non-heated roller path plates also performed very poorly. The forged steel wheels and the heat-treated roller path plates, on the other hand, performed well.

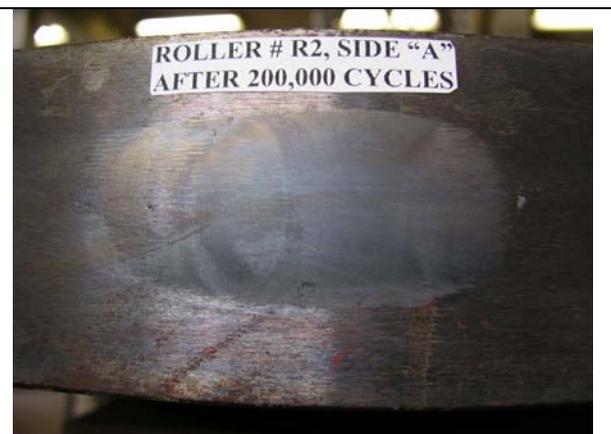
Fig. 10. Contact area of Wheel R2, Side A, after 220,000 cycles
