L. E. CULVER, J. C. RADON and J. C. BALHAZAR*

A fractographic study conducted on the fatigue cracked surfaces of BS 1490 LM-30 (U.S. A390) aluminium-silicon alloy revealed that the silicon-rich constituent determines the mode of fracture. The fracture mechanism was basically of a mixed cleavage-tearing type which consisted of cleavage of the silicon particles ahead of the crack front followed by tearing of the remaining ligaments of the aluminium-rich phase left in the wake of the crack. The fractured surfaces resulted from fatigue tests run at frequencies of 50 and 0.25 Hz, and at temperatures of 20 and 250°C. The ASTM compact specimens used were loaded at stress ratios, R , of 0.08, 0.5 and -1.0.

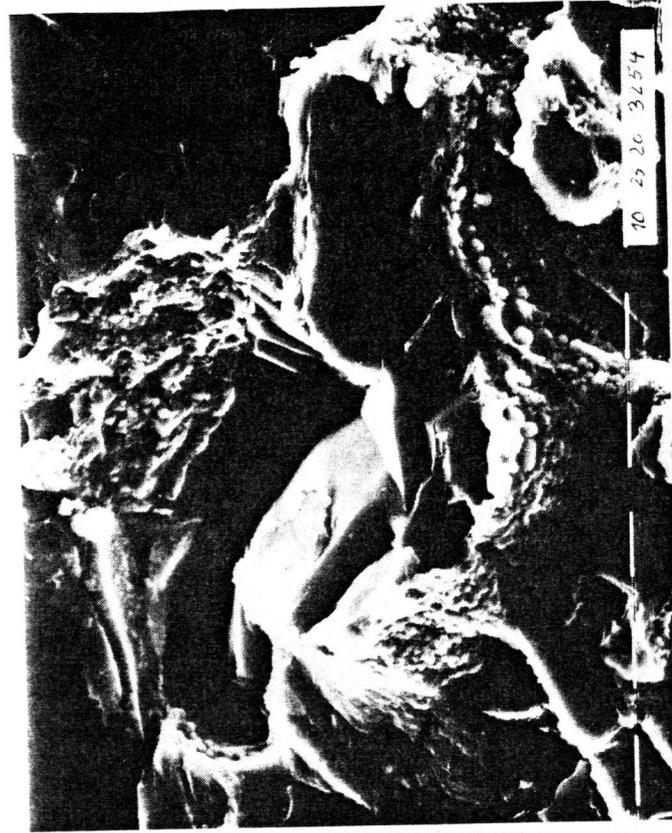
Figure 4 - Ductile fracture by microvoid coalescence of the
aluminum-rich constituent. (1000x)

Although tearing had been the main fracture mechanism observed in the aluminium-rich constituent, patches of microvoid coalescence were observed at 250°C in the Paris regime of fatigue crack propagation, Figure 4, where cleaved facets are separated by arrays of dimples. This mechanism was also observed, but to a much lesser extent, in the threshold regime. Striations occurred mainly at 250°C for a stress ratio $R=-1.0$, Figure 5, but were irregular in their form. For the same conditions, reducing the frequency from 50 Hz to 0.25 Hz caused finer striations, though they were still irregular in shape and distribution, Figure 6.

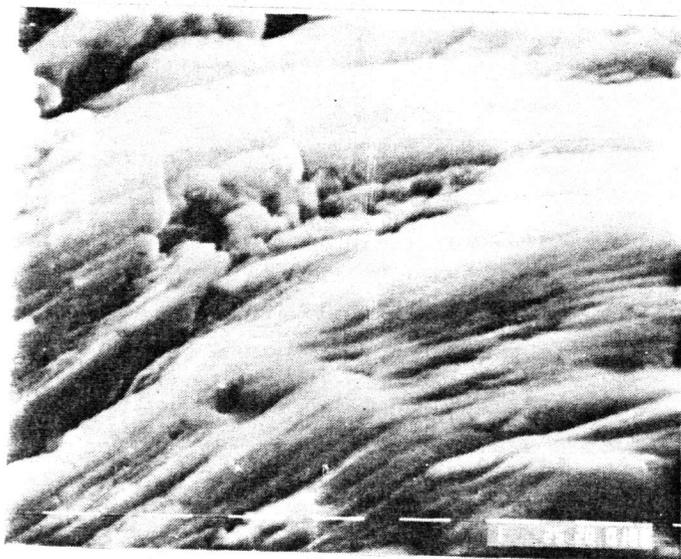
Figure 6 - Fine striation formation in the aluminium-rich constituent at low frequency (10000x)
