INFLUENCE OF POST WELD HEAT TREATMENT ON THE HAZ TOUGHNESS  
OF A C-Mn MICROALLOYED STEEL

HAZ toughness of a ASTM A537 C1 steel thick plate is evaluated in the as welded condition and after PWHT at 650°C for 5 hours. Charpy impact test was carried out for both conditions and temperature × absorbed energy and temperature × % ductile fracture curves were drawn. Micrographs were taken from CGHAZ and impact test results are discussed on the basis of the microstructure found.

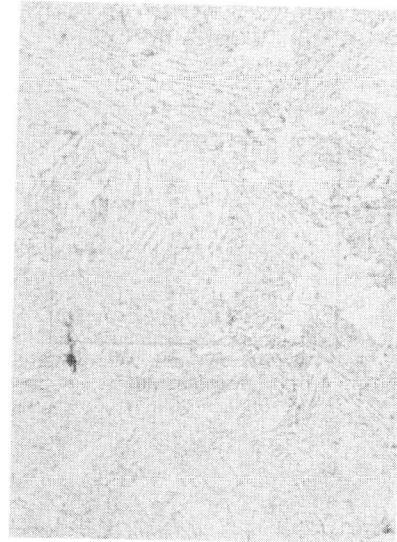
Figure 6: Unreheated CGHAZ, as welded condition. Magnification: 300×

HAZ micrographs are shown in figures 6 - 8. The microstructure found was similar to those found by Sparkes (6) when studying a similar steel after PWHT. In the as welded condition ferrite with aligned second phase (FS(A)) and martensite were found (figure 6). In PWHT condition, one can observe that intragranular microstructure is less defined and colony boundaries are more pronounced (figure 7). At a higher magnification of the same region (figure 8), the presence of precipitates can be observed.

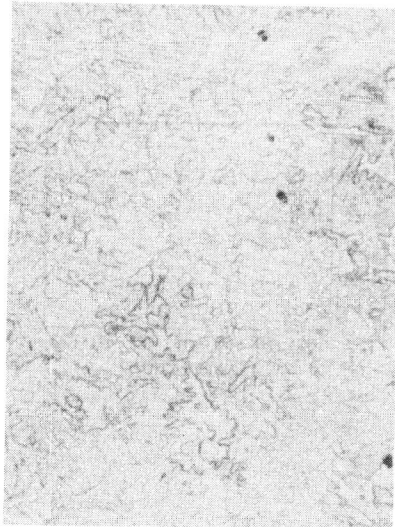
Figure 7: Unreheated CGHAZ, PWHT condition. Magnification: 300×

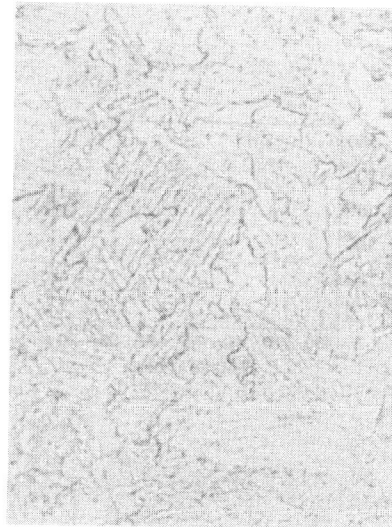
Figure 8: Unreheated CGHAZ, PWHT condition. Magnification: 700×
