Fatigue behavior of lubricated Ni-Ti endodontic rotary instruments

A. Brotzu, F. Felli, C. Lupi, C. Vendittozzi

Dipartimento ICMA, Sapienza Università di Roma, Roma (Italy)

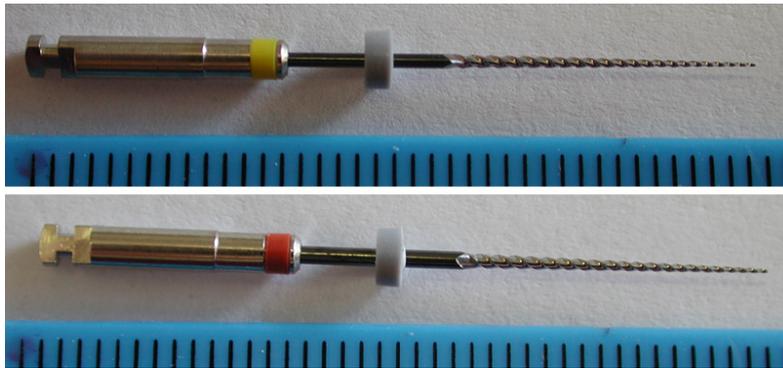
This study has been carried out on two different Ni-Ti rotary instruments manufactured by MICRO-MEGA® and named HERO 642®. The two instruments, shown in Fig. 1 (red, the biggest, and yellow, the smallest), present as main difference the root cross sectional diameter, the yellow instrument is 0.75 mm in diameter while the red is 1.0 mm in diameter. Both instruments have been observed with a Scanning Electron Microscope (SEM HITACY S-2500, KEVEX EDS microprobe). DSC analysis has been carried out in order to identify possible phase transition of the Ni-Ti material.

Figure 1: Investigated MICRO-MEGA HERO642 rotary instruments.

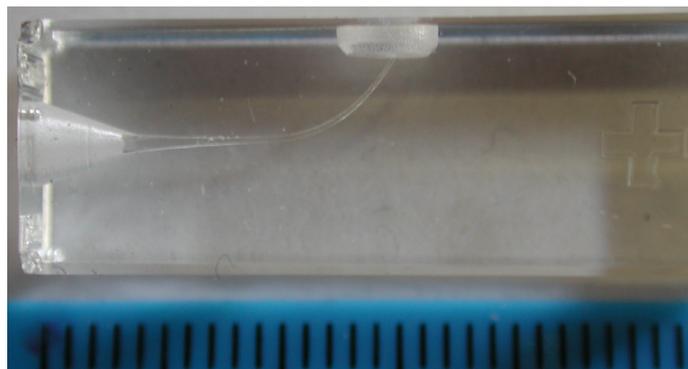
In order to test these instruments, root canal treatments have been simulated employing the Perspex simulator shown in Fig. 2. Tests have been carried out with an equipment for root canal treatment manufactured by NSH (ENDO-MATE DT) with the following standard settings: rotation speed 140 rpm, torque 3.0 Ncm. Tests have been carried out at room temperature with or without the use of an aqueous lubricant gel whose composition is object of a patent request. Yellow instruments were also tested with another lubricant available off the shelf, based on Urea Peroxide and Ethilene Diamine Tetracetic Acid. Rheological analyses were performed at 23 °C using a rheometer equipped with a Peltier system for temperature control and a measurement system at parallel plates, to highlight the differences between the two types of lubricant by deformation control. In addition, heat capacities of the two gels at different temperatures were measured. The fatigue test procedure consists in the repetition of 30 second cycles. After each cycle the instruments is removed from the Perspex simulator and cleaned in order to eliminate plastic debris and to identify potential macroscopic defects.

Figure 2: ENDO-TRAINING-BLOC employed as simulator.

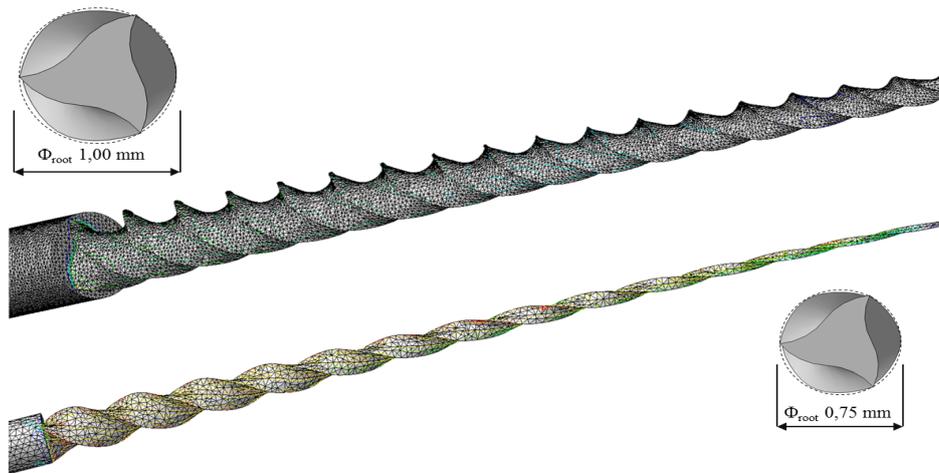
An accurate three-dimensional solid model of Ni-Ti rotary file was created by reconstructing its 3D geometric shape using a computer aided design software (CATIA, Dassault System). Then finite element (FE) model of the instrument was obtained by meshing the pre-established solid model. The geometric models are made by rotating the characteristic cross section, shown in Fig. 3, through 360 degrees over the whole length.

Even if the performed tests do not allow us to confirm, in literature it is reported that continuous unidirectional rotation causes development of complex stresses in nickel titanium rotary instruments. The finite element analysis is aimed to study and compare stress distribution and behavior of two rotary instruments, of same shape, same taper but different root cross section diameter, as shown in Fig. 3. Both instruments were tested under equal loads.

The models are divided into discrete tetrahedral elements (a ten-nodes iso-parametric solid element). The total numbers of elements are 863972 (for 1302293 nodes) for the biggest file and 139863 (for 217475 nodes) for the smallest one.

Figure 3: Detail of the root cross section of the 3D model and the tetrahedral meshes.

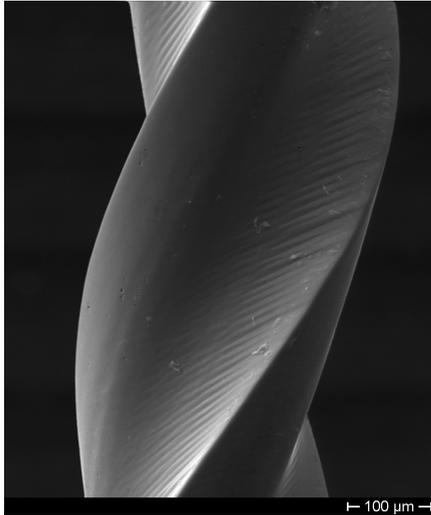
The EDS analysis of the HERO 642 instruments gives the following results: Ni 54,9%_w (49.9 %_a) , Ti 45,32%_w (50.1%_a) as a Ni-Ti superelastic alloy (NiTiNol). The SEM observations of the instruments - as provided by the manufacturer - show that the surfaces of all instruments are covered for the entire length by parallel signs (quite perpendicular to the file, Fig. 4) and by a high quantity of micro-cavities (Fig. 5).

Figure 4: SEM micrograph of as received instruments surfaces.

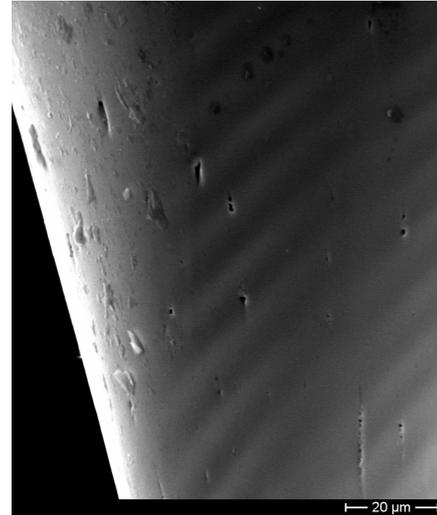
Figure 5: SEM micrograph of as received instruments surfaces.

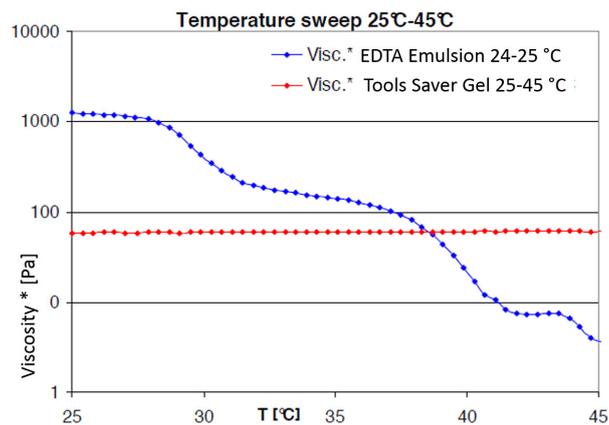
Compared to the EDTA based lubricant, the aqueous gel shows a remarkable stability to the temperature change in the temperature range of use. Fig. 6 shows, in fact, between 25 and 45 ° C the viscosity of the aqueous gel remains constant while that of the EDTA based emulsion decreases considerably. Such behavior is probably due to solid-liquid components separation: it can be also noted that the viscosity of the emulsion initially is substantially higher than that of the aqueous gel, which definitely involves a lower lubricating effect.

Figure 6: Comparison of viscosity between EDTA emulsion and Tool Saver Gel vs. Temperature.

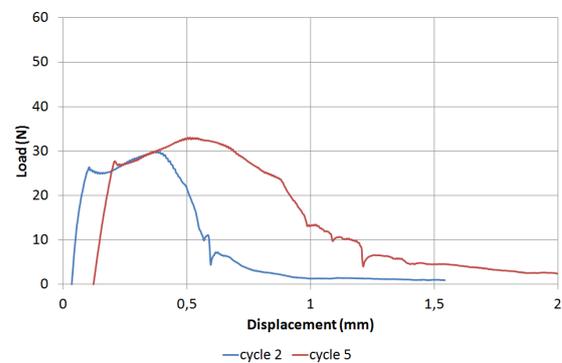
Table 3 reports the results of the test performed on the yellow instruments. Fig. 7 and 8 show the load vs. displacements curves of the extraction test carried out with and without the lubricant use.

Figure 8: Load vs displacements plot of the extraction test carried out without gel lubricant.

The study of the load vs. displacement curves allows pointing out the effect of the lubricant gel. During the extraction test carried out without the use of gel the load rises linearly up to a value of about 27 N. At this point, the tool is free and a sudden load drop can be observed. Then the load rises again, but slower than before, and with a typical serrated curve up to the maximum load (approximately 32 N). This last load rise is due to the friction between the canal surface and the instrument. Instead, during extraction test carried out with gel, the load drop, which occurs at the detachment between instrument and canal, is never observed. Both the detachment and the maximum loads are lower than those measured

during the test without lubricant. The gap between detachment and maximum loads and the displacement necessary to reach the maximum load are reduced.

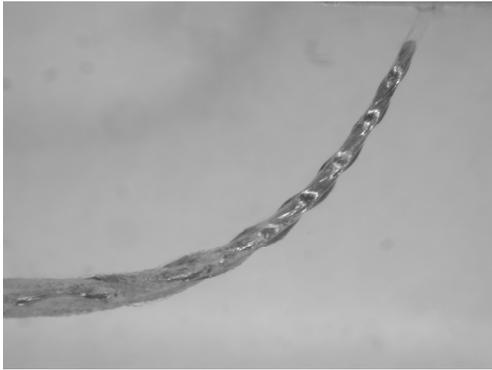
Instruments tested without lubricant gel fail in two different ways. Instrument number 13 shows a macroscopic unwinding (Fig. 9 and 10). It can be observed that unwinding is clearly visible already before the extraction test. This kind of damage is probably caused by rotation of instruments inside the canal and not by tensile load applied during the extraction phase. The instrument number 16 instead suddenly breaks, approximately at the tip, without showing any macroscopic failure signs before the last test cycle. The instruments tested with lubricant gel have shown this last kind of failure, observed by SEM.

Figure 9: Instrument 13 inserted into the simulator.

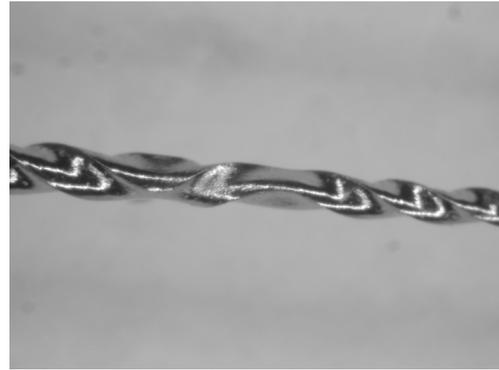
Figure 10: Instrument 13 after the extraction test.

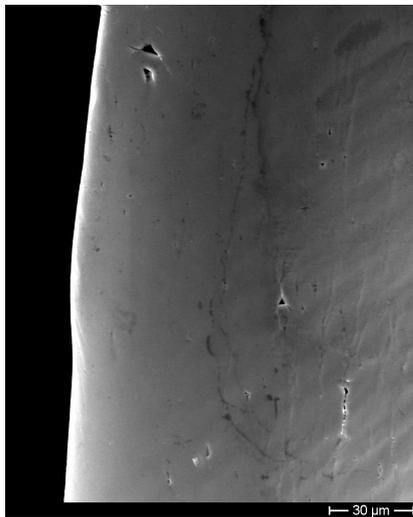
The microcavities observed on the instrument surfaces have evolved producing microcracks since the early test cycles (Fig. 11). Often, these microcracks joint together producing cracks usually in the axial direction. However failure occurs only when this kind of defects develops on the file or in its proximity (Fig. 12). In this point the stress concentration is particularly high.

Figure 11: SEM micrographs of instrument number 16.

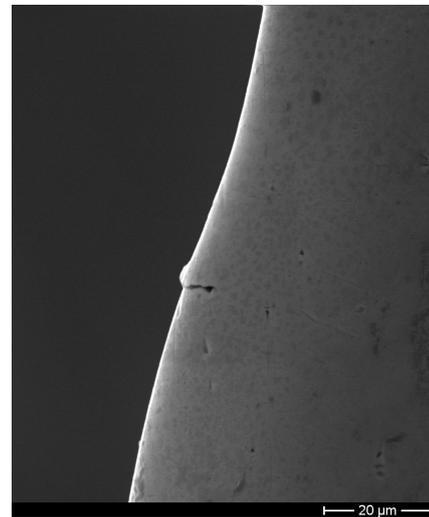
Figure 12: SEM micrographs of instrument number 15.

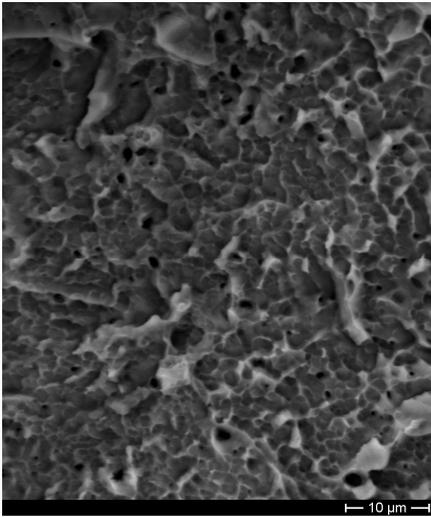
The fracture surfaces are characterized by a wide central area with an extensive network of dimples, indicating a fracture due to overload (Fig 13). The fracture surfaces in proximity of the edges are usually highly worn. Such morphology is due to the fact that the instrument, after the failure, continues to rotate within the Plexiglas canal, until extraction. This makes it difficult to identify the failure mode in these areas. Taking into account that this problem does not allow to observe any signs of fatigue failure, some tests have been performed carefully removing the instrument from the simulacrum as soon as failure takes place, extracting from the plexiglas channel, the cutter broken tip and to observe it with SEM. This specimen part, when broken, does not rotate over and if the instrument is rapidly removed from the canal, it does not even suffers damages resulting from the rubbing of the two fracture surfaces. The morphology of the fracture surface near the edges was studied on those specimens. Particularly, it has been observed on two well preserved specimens that near the cutting edges, dimples are not present, but typical failure striations due to fatigue can be clearly identified (Fig 14). It was also possible to measure the rate of crack propagation in these areas, which is very high, about $0.5 \mu\text{m}/\text{cycle}$.

Figure 13: Fracture surface – dimples.

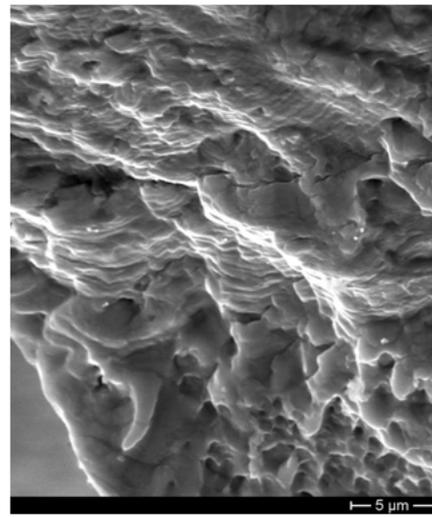
Figure 14: Fracture surface – striations.

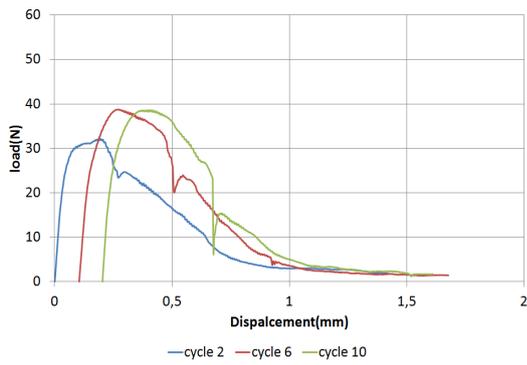
Tab. 4 reports the results of the test performed on the red instruments. Fig. 15 and 16 show the load vs. displacements curves of the extraction test carried out with and without the lubricant use.

Figure 15: Load vs displacements plot of the extraction test carried out with gel lubricant.

Also in this case the fracture surface are characterized by a dimples network without the presence of any fatigue sign (Fig. 22). Concerning the load vs. displacements extraction curves, the consideration taken for the yellow instruments can be extended to the red one. The differences observed concern both the detachment load and the maximum load, which in this case are quite higher.

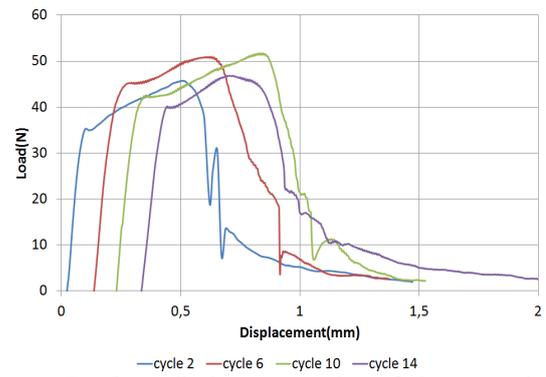
Figure 16: Load vs displacements plot of the extraction test carried out without gel lubricant.

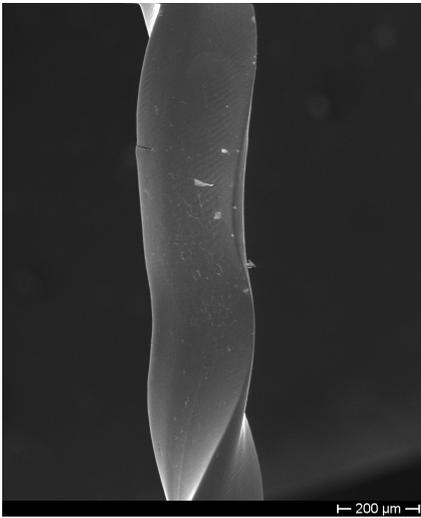
The behaviour of the larger instruments is similar to those observed for the yellow instruments. Particularly, the failure mechanism for the red instruments working without lubricant is the unwinding (Fig. 17). It can be observed the formation of:

Figure 17: Unwinding failure mechanism on instrument no. 9.

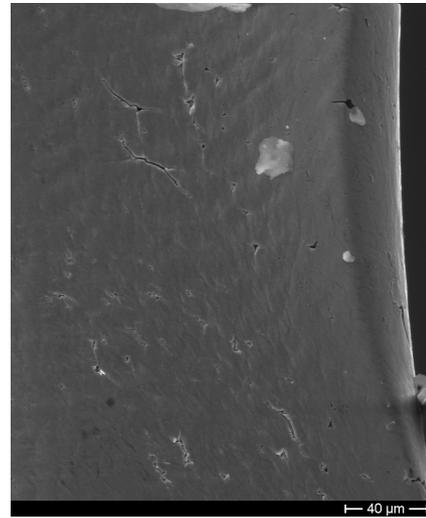
- Several micro cracks on the instrument surface (Fig. 18).
- Deep cracks on the instrument file (Fig. 19).

Figure 18: Micro cracks on instrument no. 9 surface.

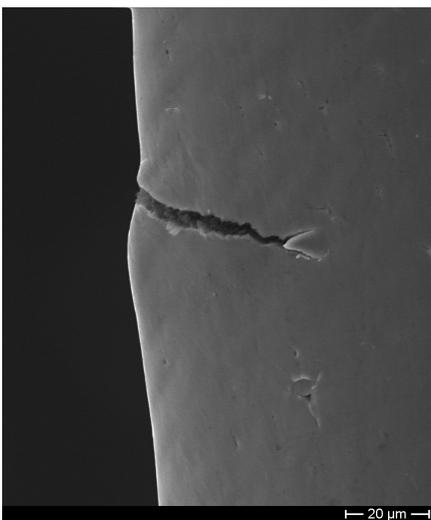
Figure 19: Deep cracks of instrument no. 9.

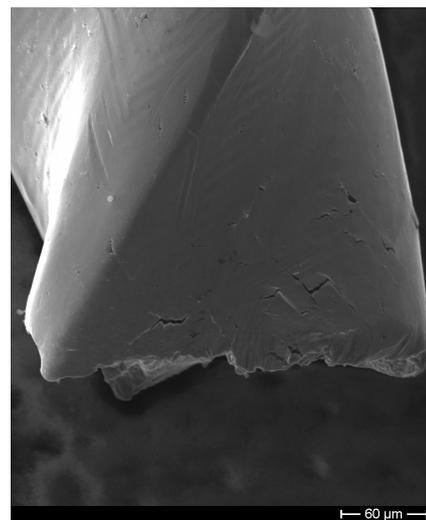
Instead, for test performed with lubricant, the instrument fails suddenly without any macroscopic previous sign. On the surface and on the file of the instruments appear the usual micro crack (Fig. 20 and 21).

Figure 20: micro crack of instrument no. 7.

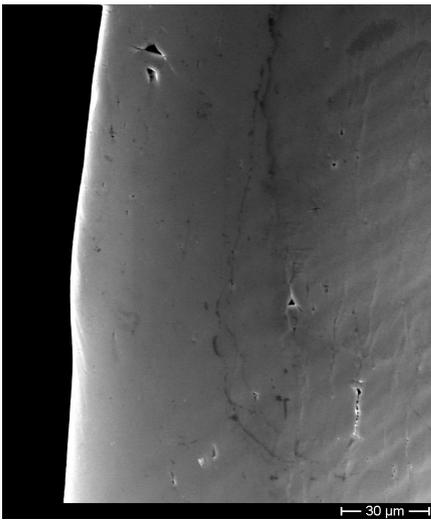
Figure 21: Micro crack on instrument no. 7 surface.

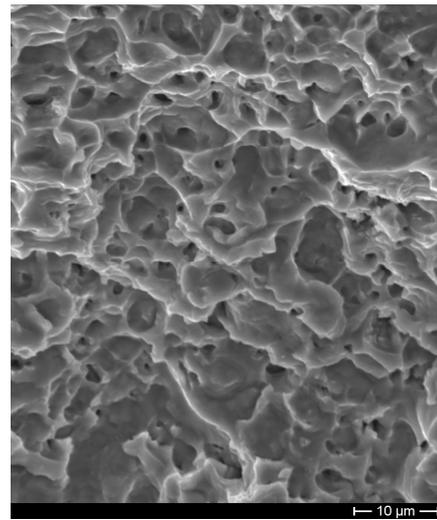
Figure 22: Fracture surface of instrument number 7.

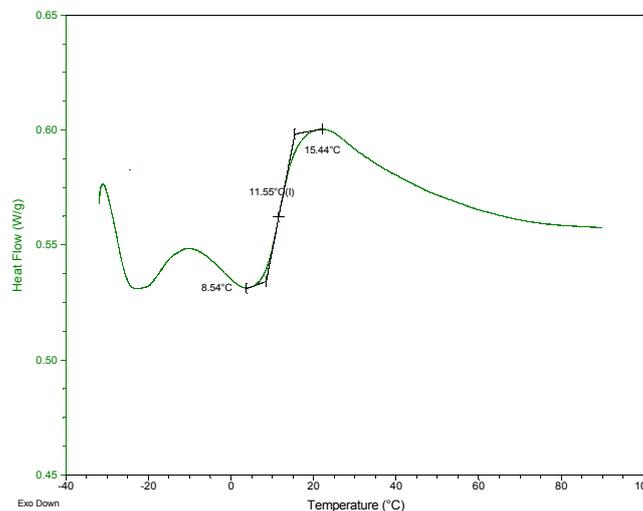
The Ni-Ti alloys can show both superelastic behaviour or shape memory effects. It depends on the manufacturing process. The materials employed for the realization of rotary instruments must show a superelastic behaviour. In order to verify if an eventual phase transition - which could modify the Ni-Ti alloy properties- happens in operation, a DSC analysis in the range of temperature - $30 \div 100$ °C has been performed. Fig. 23 shows the DSC plot with the four typical phases transformation which characterize the SMA/superelastic alloys. In particular the higher transformation temperature, which usually is the Austenitic Finish Temperature (AF), is 11.55 °C. The material then operates in the superelastic field in which the high recoverable deformations are due to the austenite- detwinned martensite transformation.

Figure 23: DSC Plot.

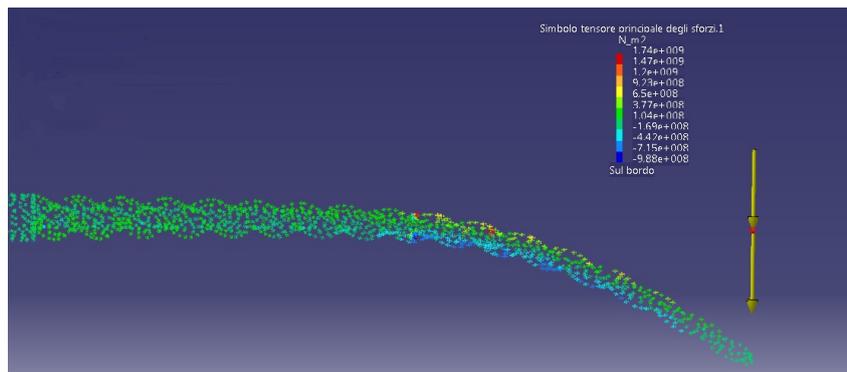
The first consists in applying a load of 1 N on the end of the instrument perpendicularly to the axis of the instrument itself. This load was assessed by flexion test, performed by a tensile machine, blocking the cutter with a straight canal of length equal to that of the straight stretch of the simulacrum and applying a displacement of the tip 3 mm in the direction perpendicular to the axis of the cutter. The applied load vs. tip displacements has been recorded.

Figure 24: FEM simulation with the Tip applied load.

The second, instead, consists in inserting the tip and imposing a 3 mm failure of the bond. The two simulations gave similar results with the development of a stress state characterized by fibers stretched in the upper part of the instrument and compressed fibers in the lower part. The displacement of the tip of the instrument obtained in the first simulation is slightly less than the desired 3 mm. Fig. 24 and 25 show the results of the two simulations expressed as stresses calculated assuming a homogeneous material with 40 GPa Young modulus. The maximum values are detected near the area where it begins the curvature of the instrument. Tab. 5 shows the calculated maximum tensile and compressive strains. In the simulation with load applied at the tip a $\Delta\epsilon$ of 4.1% is obtained, while with the displacement imposed $\Delta\epsilon$ is significantly higher and amounted to 7.4%.

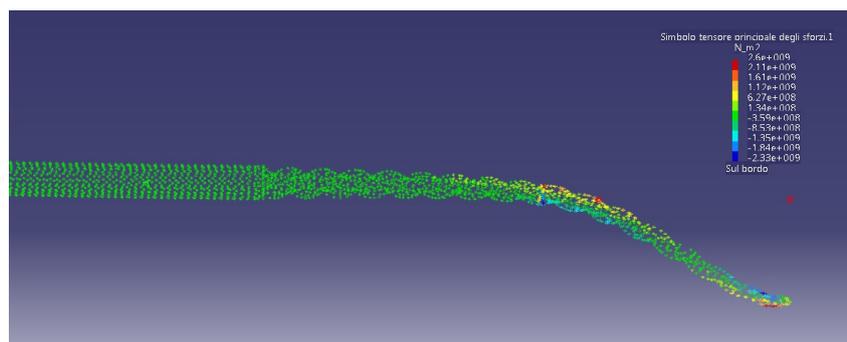
Figure 25: FEM simulation of the TIP constrain failure.
