## Effect of corrosion and sandblasting on the high cycle fatigue behavior of reinforcing B500C steel bars

Marina C. Vasco, Panagiota Polydoropoulou, Apostolos N. Chamos, Spiros G. Pantelakis.

*Department of Mechanical Engineering & Aeronautics, University of Patras, Greece*

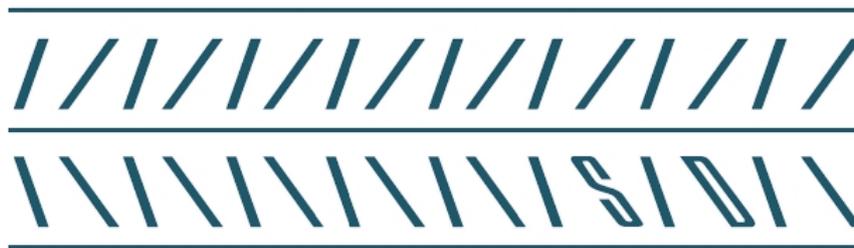
Figure 2: Ribs pattern.

The selected material was hot-rolled concrete reinforcing steel B500C, which is widely used since 2006 in civil constructions (buildings, bridges etc.), according to the Hellenic standard ELOT 1421-3 [26]. The material has been produced by Sidenor Group (SD) according to DIN488 [27]. SD B500C has two longitudinal ribs and additional transverse ribs on two sides. Moreover, SD Steel bears the clear "SD" mark, for identification. A schematic drawing of the ribs pattern is given in Fig. 2.

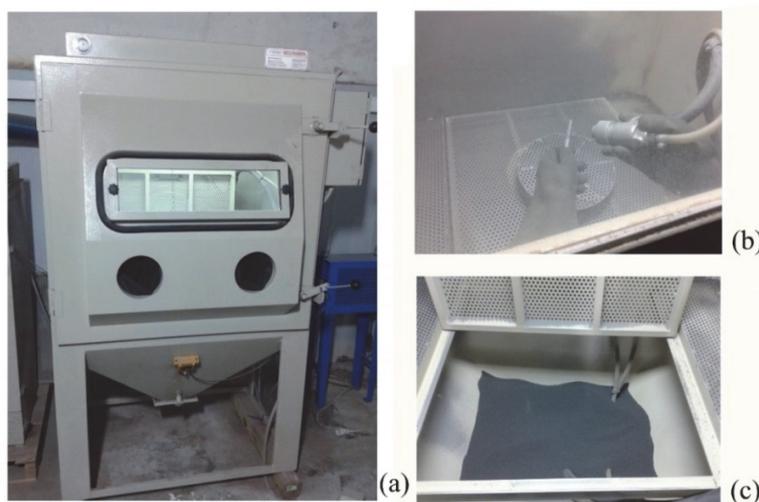
Figure 4: Sandblasting cabinet (a), process (b) and material (c).

For the surface treatment an ordinary sandblasting facility was employed to retain the costs as low as possible and avoid the use of expensive equipment. Yet, it is acknowledged that the applied sandblasting method is associated to increased scatter of mechanical properties. The sandblasting method was performed by propelling a stream of abrasive material against the steel bar surface under high pressure in a blast cabinet, as shown in Fig. 4a. A blast cabinet is a closed loop system that allows the operator to blast the part and recycle the abrasive. It usually consists of four components; the cabinet (Fig. 4a), the abrasive blasting system (Fig. 4b), the abrasive recycling system (Fig. 4c) and the dust collection. In this work, the process of sandblasting was performed manually; the operator blasts the parts for about one minute from the outside of the cabinet by placing his arms in gloves attached to glove holes on the cabinet, viewing the part through a view window. The material used as a sintershot was a common aluminum oxide of compound with spherical shape of 1.2 mm mean diameter, hardness value of 2035 HV and density of 2100 Kg/m<sup>3</sup>. For flat surfaces the selected sintershot is suitable for achieving a uniform and clean surface as well as uniform compressive layers in the surface of the blasted material. Yet, the ribs of the investigated bars do not allow achieving a uniform blasting and compressive layer.
