OVERVIEW ON FAILURE INVESTIGATION: FATIGUE AND STRESS-CORROSION CRACKING ON IAF FLEET

Lt. F. Bagnoli, Lt. L. Allegrucci
Chemistry Department – Flight Test Center
“M. De Bernardi Airport”
00040 Pratica di Mare (RM) Italy
rc.gms@tiscali.it

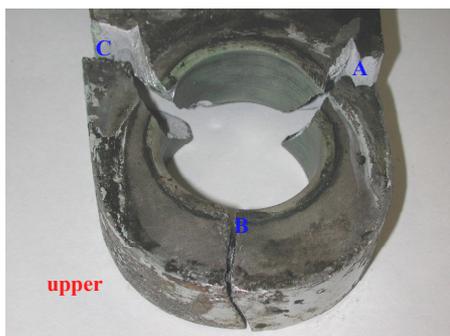
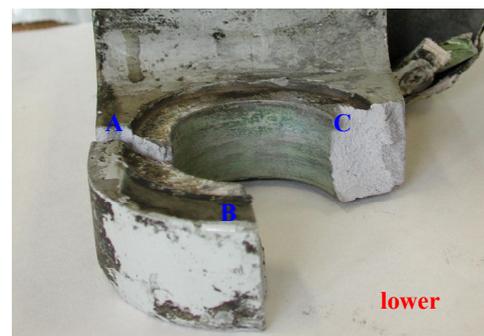
Figure 3

After many *touch and go* manoeuvres, suddenly a the main landing gear of an aircraft had not been retracted. The visual inspection pointed out the failure of *Lower Side Strut*. In particular, both upper and lower holes, linked to the main landing gear by the lower universal, as indicated in Figures 1 and 2, were found broken in three pieces, each hole showing six fracture surface, Figure 3. During maintenance operations, steel bushings are located in the holes to make up for the lack of the right thickness of the holes modified to remove corrosion products.
