Some practical crack path examples

Les P. Pook

Department of Mechanical Engineering, University College London, Torrington Place, London WC1E 7JE, UK

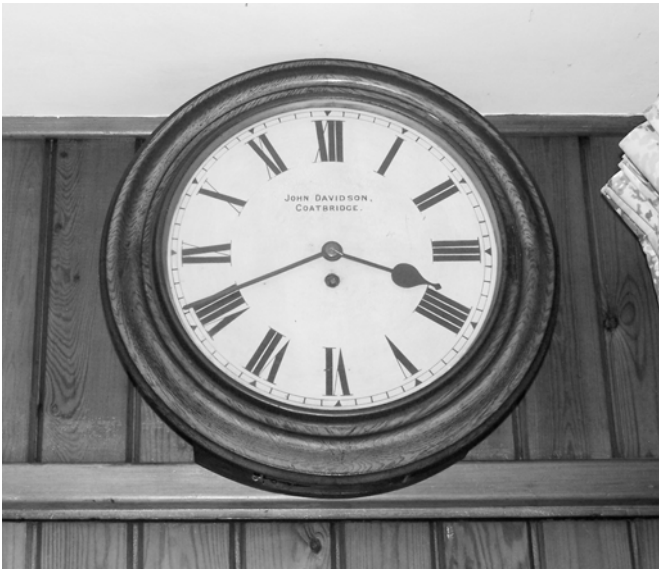
Figure 9. Wall clock by John Davidson, Coatbridge.

ple shown in Figure 9 was originally used in a school, but since 1968 it has been in use in the author's kitchen. In 1994 the mainspring failed while the clock was being wound. Examination showed that this was the final failure following fatigue crack growth. A general view of the failed mainspring is shown in Figure 10. Fatigue has been a problem in clock mainsprings for centuries, and traditionally they are designed using rules of thumb based on experience [12], rather than by detailed analysis. The total fatigue life is not known, but the clock is wound weekly so it must be thousands of cycles.
