Structural integrity assessment and rehabilitating of Hercilio Luz bridge

ABSTRACT. The Hercílio Luz suspension bridge, built in 1926, has been out of service since 1991 due to high corrosion levels and structural element impairment. A complete rehabilitation project was developed which included the replacement of the impaired items and foundation strengthening. For this, an auxiliary structure was employed to support the central span during the rehabilitation process. A carefully studied load transfer process, where the central span loading is transferred from the eye-bar towards the auxiliary structure will be performed. For this purpose, a synchronized jacking sequence will be used, which was predefined by means of numerical model analysis. All structural elements had their designs evaluated and some geometric changes were implemented. This paper presents all the methodology developed in the rehabilitation project of Hercilio Luz bridge, as well as the development stages up to the present date.

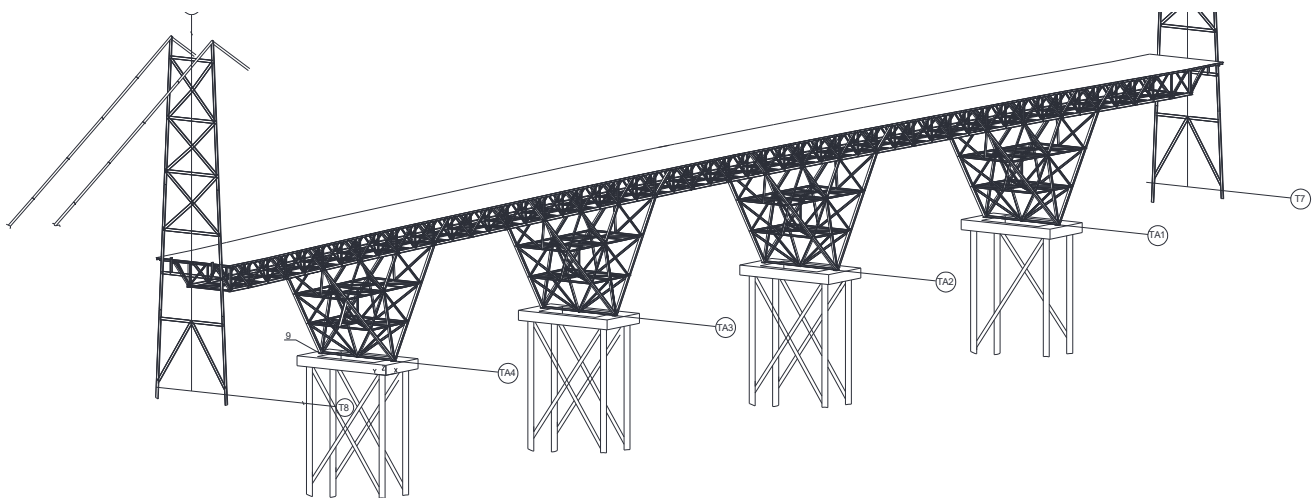
A state of minimal structure loading should be reached so that the steel elements replacement and foundation retrofit may take place. For that purpose, a solution where the main span is supported by an auxiliary structure was designed. This approach makes the rehabilitation process safe, once the main span is completely supported by the auxiliary structure. This structure is composed by a space truss with four bases, supported by independent foundations (Fig. 14).

Figure 14: Inferior auxiliary structure supporting the main span.

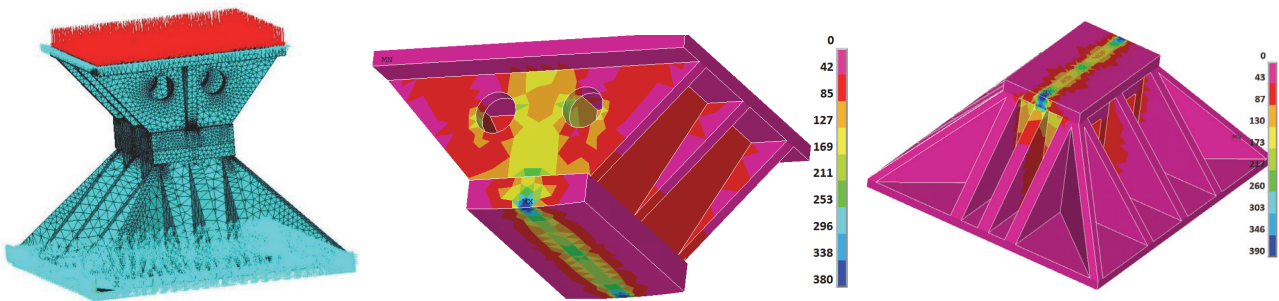
Figure 17: Numerical model and von Mises stress distribution at pylons bases [MPa].

The Hercilio Luz Bridge steel structures were the most affected by the time effect. The bridge deck, initially composed by steel beams covered by wood plates, will be replaced by an orthotropic steel deck. All the elements with complex geometries had their resistance evaluated based on FEM models. The cast parts, such as the pylon base and the eye-bar supports will be replaced by new cast parts. Fig. 17 presents the stress diagram at the pylon base. Figs. 18 and 19 present the stress diagrams of the eye-bar support and the eye-bar anchorage on the massif, respectively.

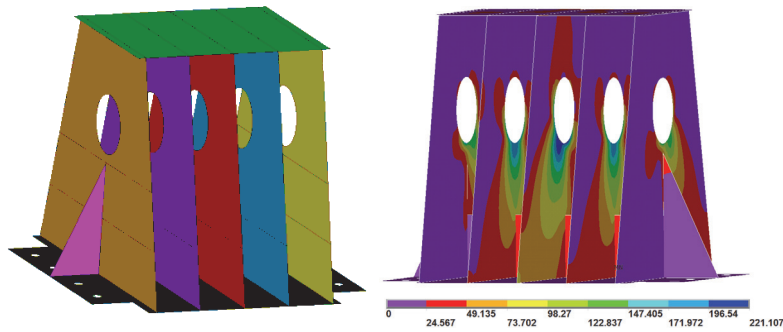
Figure 18: Eye-bar support numerical model and von Mises stress distribution [MPa].

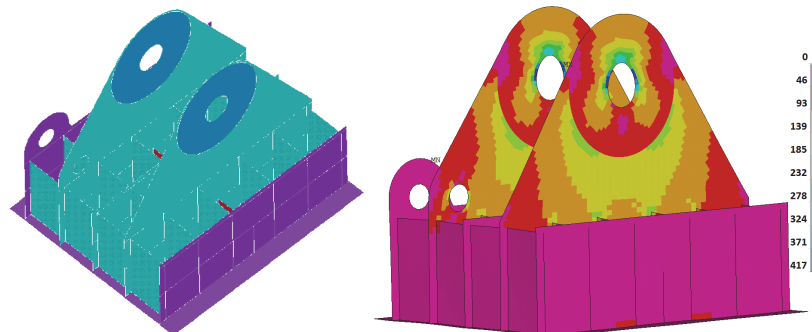
Figure 19: Eye-bar anchorage numerical model and von Mises stress distribution [MPa].

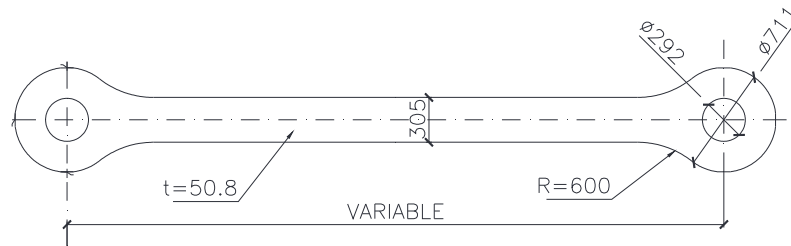
Figure 20: Geometry adopted for the whole eye-bar [mm].

The eye-bars will be replaced by new machined bars, made by high resistance steel with yield limit equal to 980 MPa. Some changes in the eye-bar geometry were analyzed, but the original design with circular hole was maintained. Fig. 20 presents the geometry for the whole eye-bar, which total length is equal to, approximately, 15000 mm.

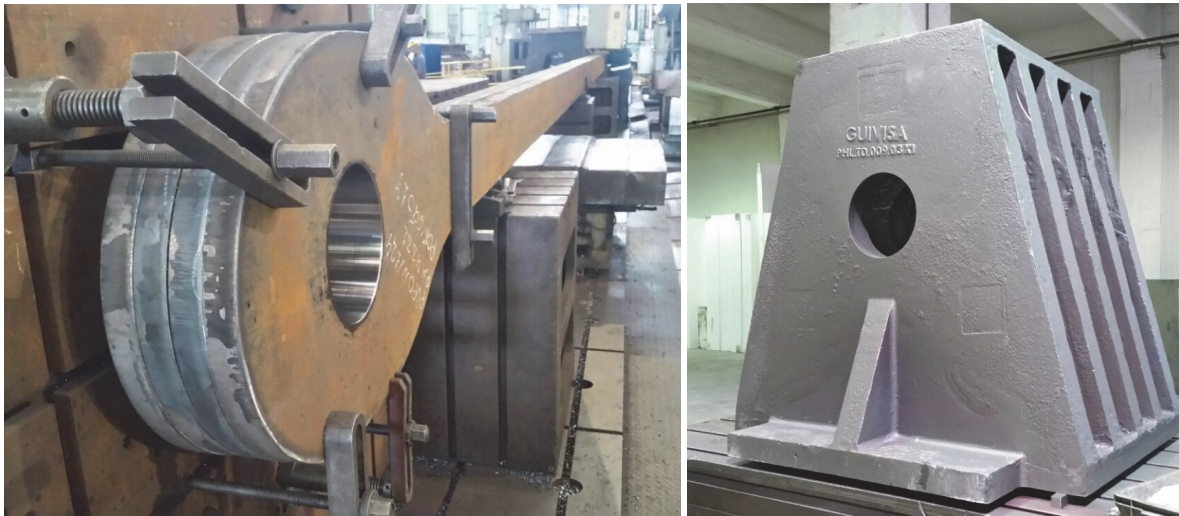
Figure 24: Eye-bar and saddles during manufacture process.
